# PROPERTY INSPECTION REPORT

**0000 Near me, Neverland CA 94000**  
**Inspection Prepared For: Smith Sam**  
**Agent: Not Applicable -**

**Date of Inspection: 9/24/2026**  
**Age: 23 - Size: 2274**  
**NACHI24041526 / CLSB #1158251**

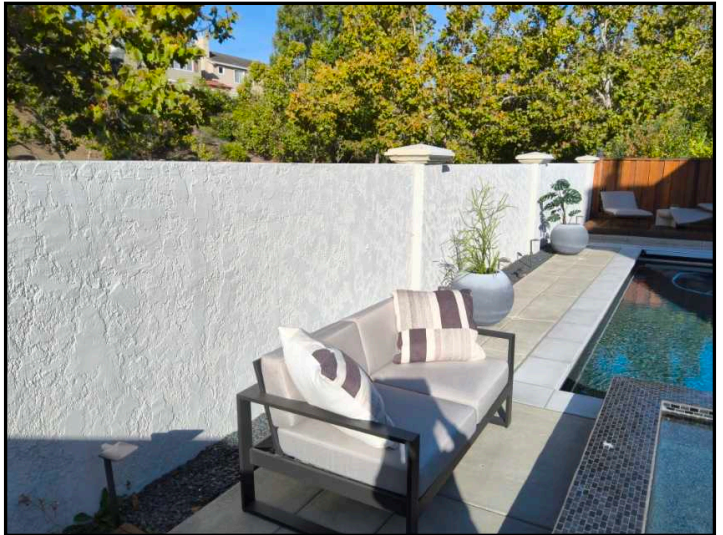
• **LOOSE FENCE COMPONENTS:** Fence posts, panels, boards, or other fencing components were observed to be loose. Continued movement may contribute to progressive deterioration or instability. It is recommended that the affected components be properly secured, repaired, or replaced as necessary.

| Page 14 Item: 6 | Fence Condition | <ul style="list-style-type: none"> <li>• <b>LOOSE FENCE COMPONENTS:</b> Fence posts, panels, boards, or other fencing components were observed to be loose. Continued movement may contribute to progressive deterioration or instability. It is recommended that the affected components be properly secured, repaired, or replaced as necessary.</li> </ul> |

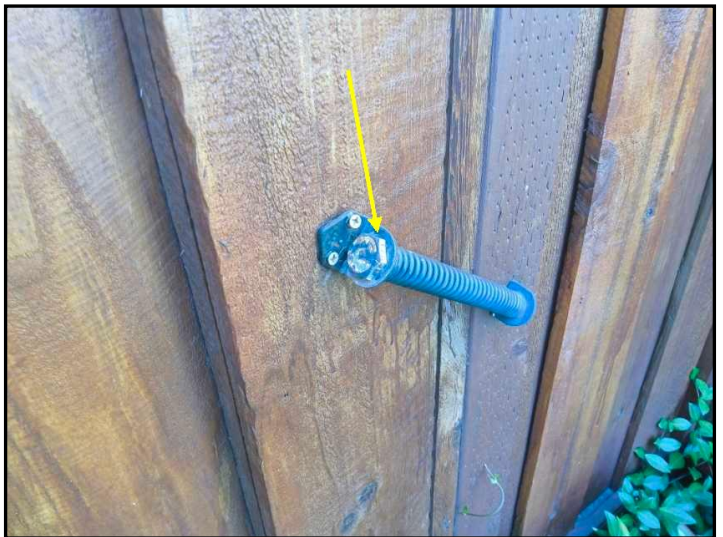
**MINOR SERVICE:** TThe gate at the side of the property exhibited minor operational or maintenance-related deficiencies.

| Page 15 Item: 7 | Gate Condition | <ul style="list-style-type: none"> <li>• <b>MINOR SERVICE:</b> TThe gate at the side of the property exhibited minor operational or maintenance-related deficiencies. It is recommended that the gate be serviced or adjusted as necessary to maintain proper operation and help prevent further deterioration.</li> </ul> |

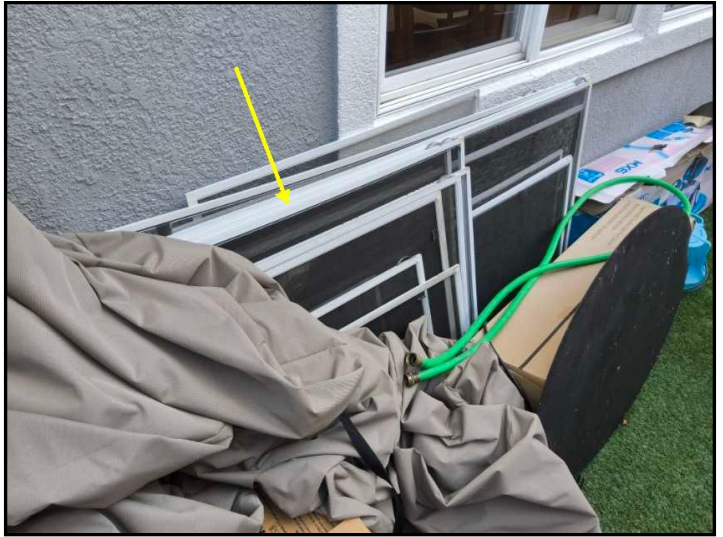
**SCREENS REMOVED FOR STAGING –**  
**INFORMATIONAL:** The window and/or door  
screens were removed for staging purposes and  
were not installed at the time of the inspection.

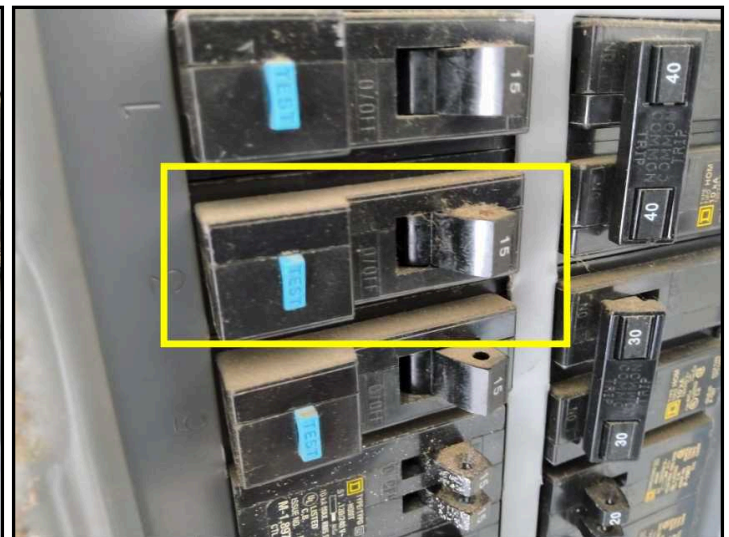
**AFCI BREAKER FAILED TEST:** An AFCI-protected circuit breaker at the electrical panel did not respond when tested using the manufacturer's built-in test button.

| Safety/Item of Concern | | |
|---|---|---|
| Page 34 Item: 7 | AFCI & GFCI Protection | <ul style="list-style-type: none"> <li>• <b>AFCI BREAKER FAILED TEST:</b> An AFCI-protected circuit breaker at the electrical panel did not respond when tested using the manufacturer's built-in test button. This may indicate that the AFCI protection is not functioning properly. It is recommended that a qualified electrical contractor evaluate the affected circuit and repair or replace the AFCI breaker as necessary for proper protection.</li> </ul> |

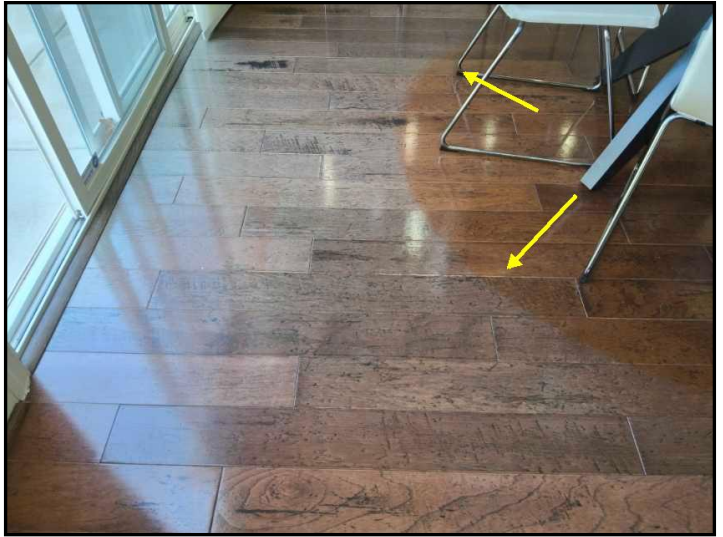
**DISCOLORATION AT WOOD FLOORING NEAR SLIDING DOOR:** Discoloration was observed at the wood flooring near the sliding door.

| Interior Areas | | |
|---|---|---|
| Page 52 Item: 2 | Floor | <ul style="list-style-type: none"> <li>• <b>DISCOLORATION AT WOOD FLOORING NEAR SLIDING DOOR:</b> Discoloration was observed at the wood flooring near the sliding door. The condition appeared consistent with prolonged exposure to sunlight. Refinishing or other cosmetic correction may be considered as desired, and the area should be monitored for changes.</li> </ul> |

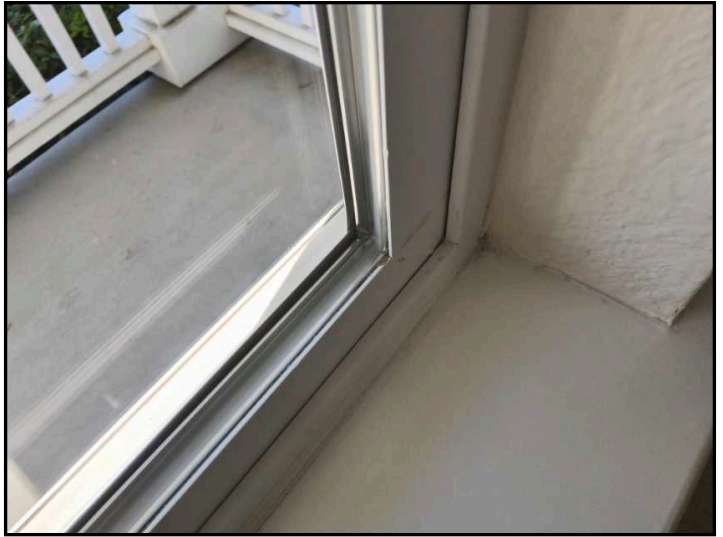
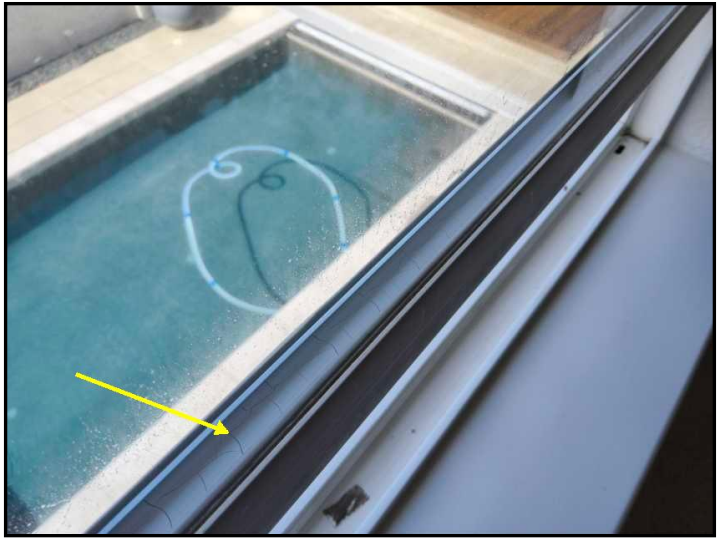
**FAILED THERMO-PANE SEAL:** Fogging or condensation was observed between the panes of one or more insulated windows.

| Interior Areas | | |
|---|---|---|
| Page 54 Item: 5 | Window Condition | <ul style="list-style-type: none"> <li>• <b>FAILED THERMO-PANE SEAL:</b> Fogging or condensation was observed between the panes of one or more insulated windows. This condition indicates failure of the seal between the glass panes, allowing moisture to enter the insulated glass unit and reducing its insulating performance. It is recommended that the affected glass units be evaluated and repaired or replaced as necessary.</li> </ul> |

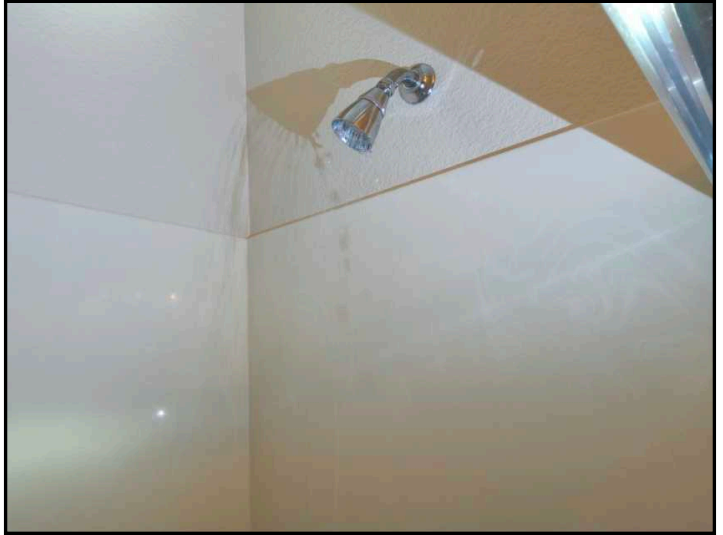
**SHOWER DIVERTER VALVE NOT SEALING PROPERLY:** The shower diverter valve did not seal properly when operated.

| Interior Areas | | |
|---|---|---|
| Page 64 Item: 3 | Tub-Showers | <ul style="list-style-type: none"> <li>• <b>SHOWER DIVERTER VALVE NOT SEALING PROPERLY:</b> The shower diverter valve did not seal properly when operated, allowing water to continue flowing from the unintended outlet. This condition may reduce shower performance and waste water. It is recommended that the diverter valve be serviced, repaired, or replaced as necessary for proper operation.</li> </ul> |

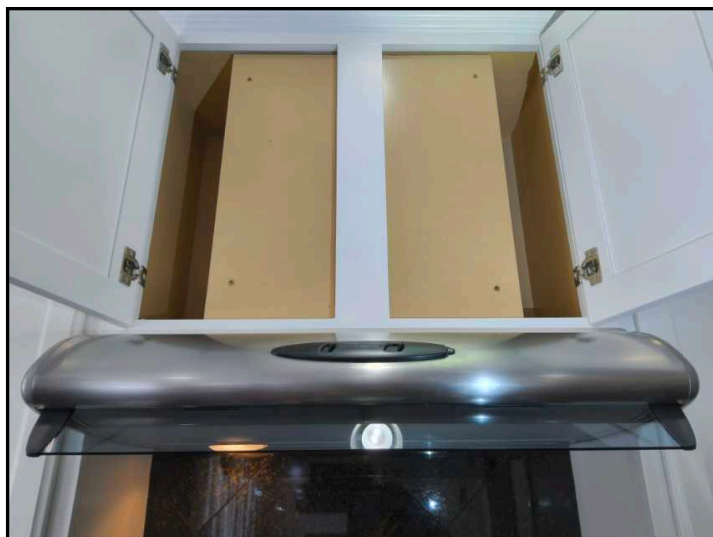
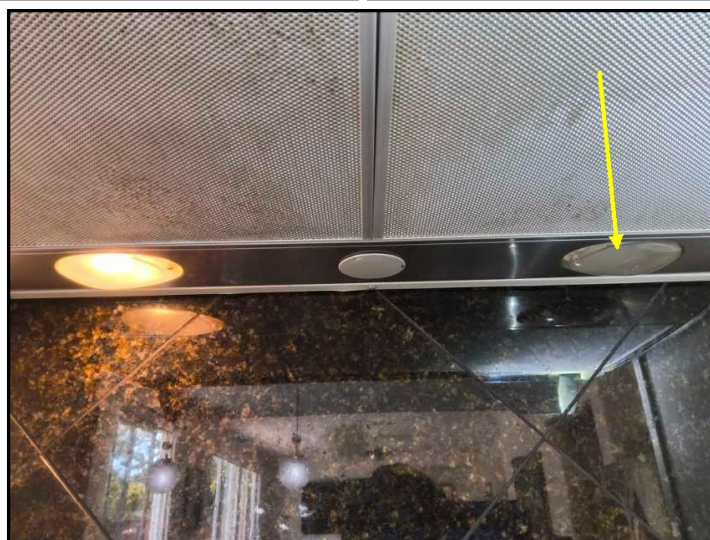
**VENT HOOD LIGHT NOT FUNCTIONAL:** A light at the kitchen vent hood did not respond during testing.

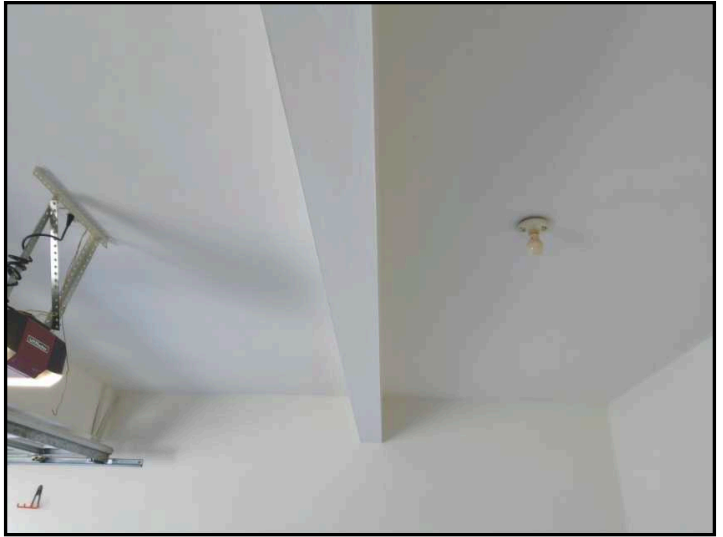
**WATER STAINS AT GARAGE CEILING:** Water stains or other evidence of moisture intrusion were observed at portions of the garage ceiling.

| Interior Areas | | |
|---|---|---|
| Page 87 Item: 8 | Wall & Ceiling | <ul style="list-style-type: none"> <li>• <b>WATER STAINS AT GARAGE CEILING:</b> Water stains or other evidence of moisture intrusion were observed at portions of the garage ceiling. The staining appeared older or inactive at the time of the inspection; however, the source and current activity could not be conclusively determined. Monitor the affected areas during and after rainfall or plumbing use for evidence of recurring moisture. If moisture reappears, identify and correct the source and repair damaged materials as necessary.</li> </ul> |

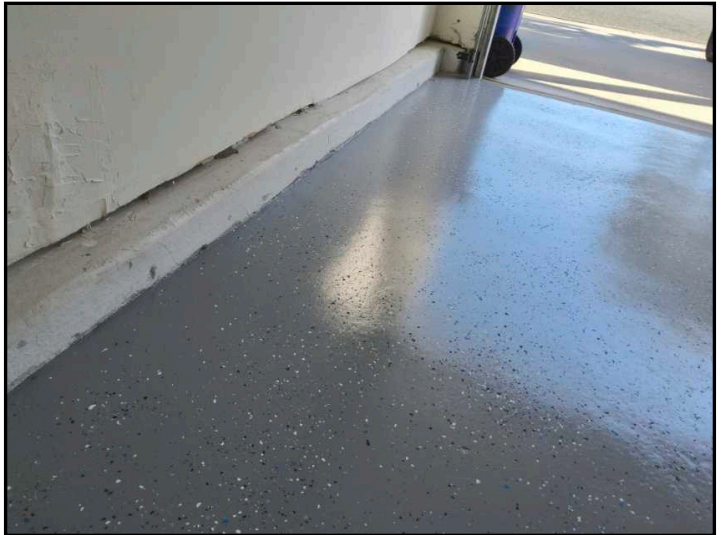
**COMMON CONCRETE CRACKS:** Common cracks were observed in the garage slab.

| Page 89 Item: 10 | Floor Condition | <ul style="list-style-type: none"> <li>• <b>COMMON CONCRETE CRACKS:</b> Common cracks were observed in the garage slab. This type of cracking is frequently associated with normal concrete shrinkage, settlement, expansion, or minor movement. Monitor the cracks for widening, displacement, or additional movement and seal or repair them as necessary.</li> </ul> |

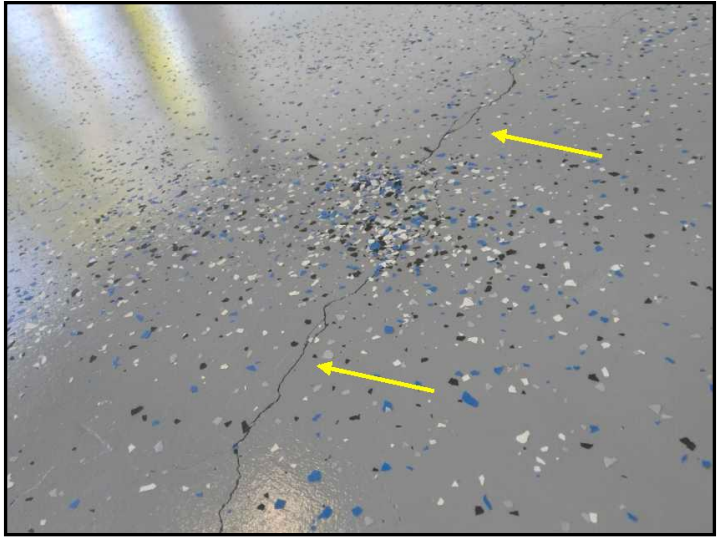
**COMMON CONCRETE CRACKS:** Common cracks were observed in the garage slab.
