# FOUNDATION INSPECTION REPORT

**TK Contracting & Consulting Inc.**

**xxx Near me St. Neverland CA 94xxx,  
Inspection Prepared For: Sam Super  
Agent: Not Applicable -**

**Date of Inspection: 7/29/2026**

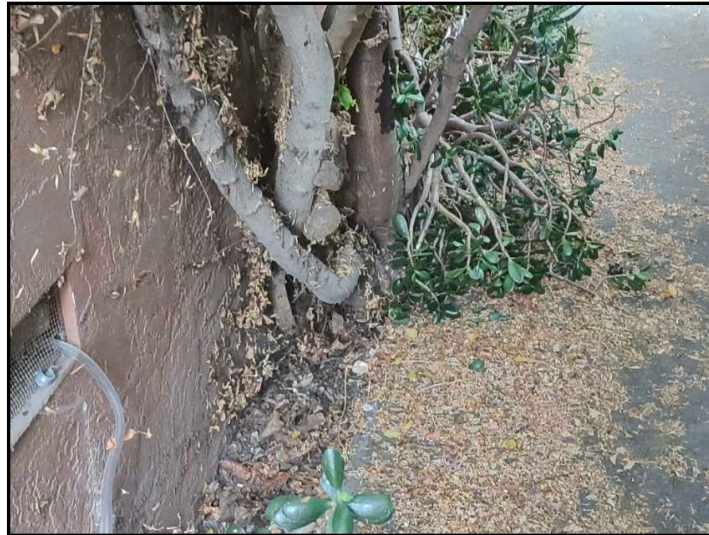
- **TREE NEAR FOUNDATION:** Trees are within 6 feet of foundation. Monitor for potential root damage.

**TREE NEAR FOUNDATION:** Trees are within 6 feet of foundation. Monitor for potential root damage.

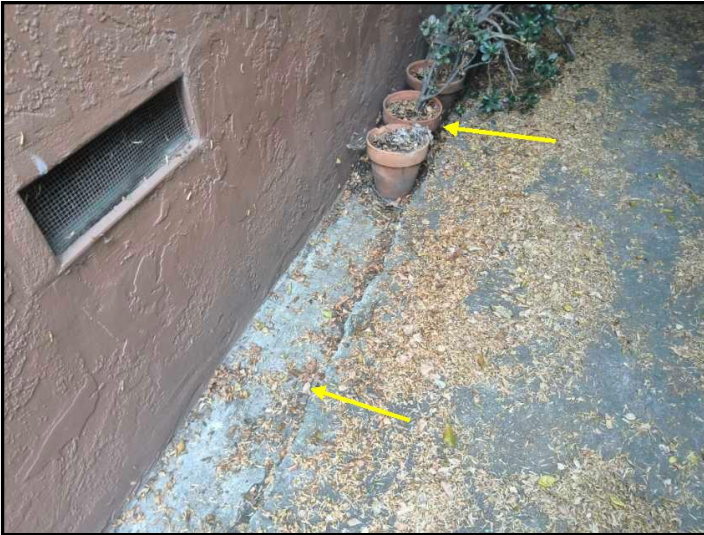
- A gap was left between the concrete sidewalk and the foundation when the new foundation was constructed. Water can collect and remain within this space, allowing prolonged moisture exposure against the foundation stem wall. This condition may soften or erode the supporting soil and contribute to localized soil instability or foundation movement over time. It is advisable to seal or properly fill the gap and improve the drainage so that water flows away from the foundation. A qualified drainage or foundation contractor should evaluate the area and perform the appropriate corrective work.
- **GRADING AGAINST FOUNDATION:** The exterior grading is improperly sloped towards the foundation. Water can intrude into the interior. Recommend creating the proper slope away from the foundation to allow for proper drainage.

A gap was left between the concrete sidewalk and the foundation when the new foundation was constructed.

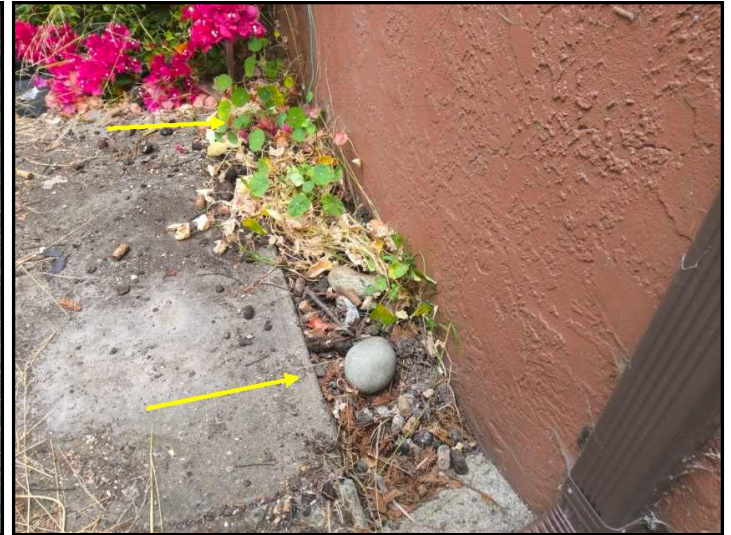
Water can collect and remain within this space, allowing prolonged moisture exposure against the foundation stem wall.

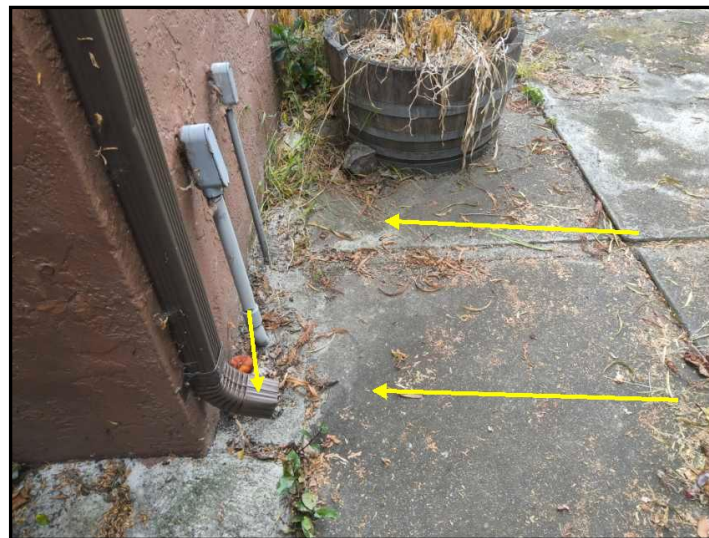
**GRADING AGAINST FOUNDATION:** The exterior grading is improperly sloped towards the foundation.

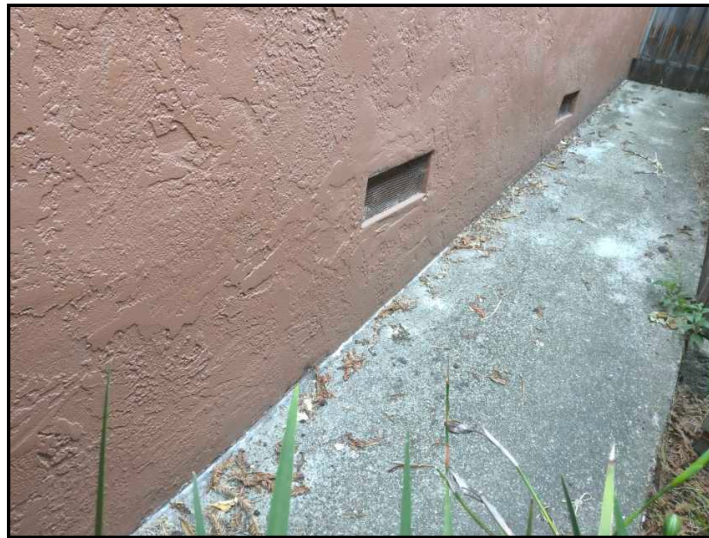
- The stucco wall coverings extend down to the soil without a weep-screed. Although this was customary at the time the residence was built, this can lead to cracking and/or bulging of the stucco at the connection between the concrete foundation and the wood framing. These materials expand and contract at different rates causing cosmetic damage and irregularities at this junction of dissimilar building materials. You may wish to have the areas evaluated by a qualified specialist for additional recommendations and repairs.

The stucco wall coverings extend down to the soil without a weep-screed.

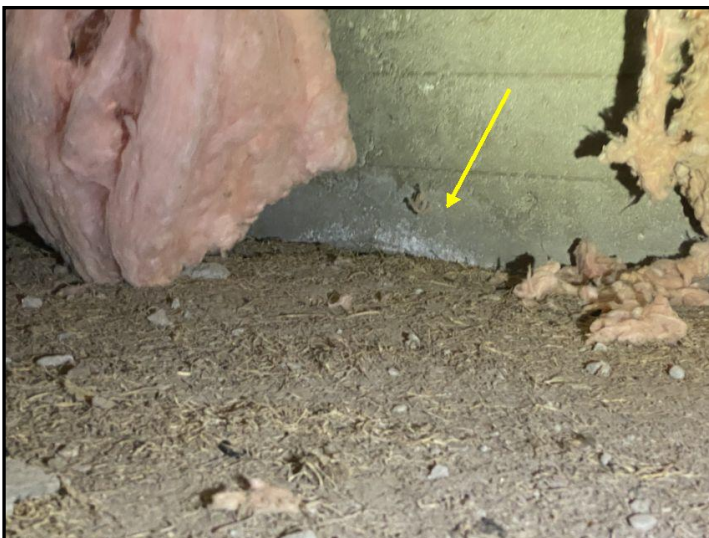
- The poured concrete foundation walls appear to be functional, indicating that they are performing as expected and providing adequate structural support. Regular inspections are recommended to maintain their condition and address any future issues promptly.
- Efflorescence observed; this is a mineral deposit left behind from exterior water infiltration. This is an indication of moisture penetration and could be the result of inadequate above ground water management. This may be corrected by improving site grading and/or drainage. Excessive moisture can contribute to differential settling and facilitate the growth of a variety of molds or fungi that can promote unhealthy conditions.

Efflorescence observed.

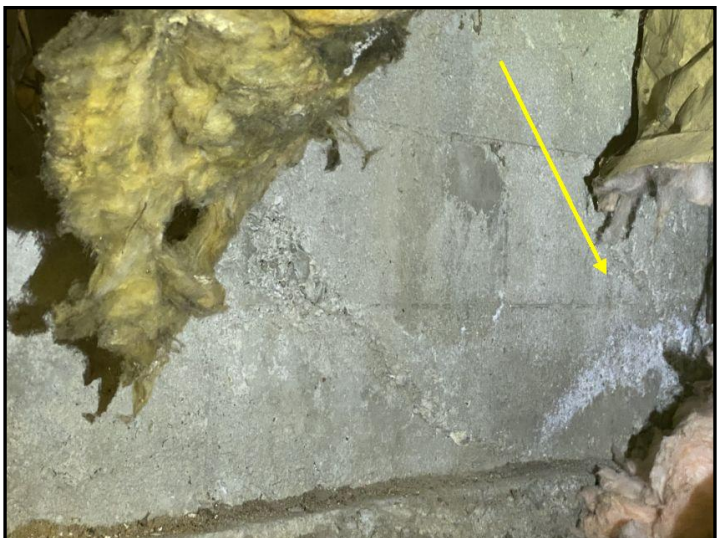
Efflorescence observed.

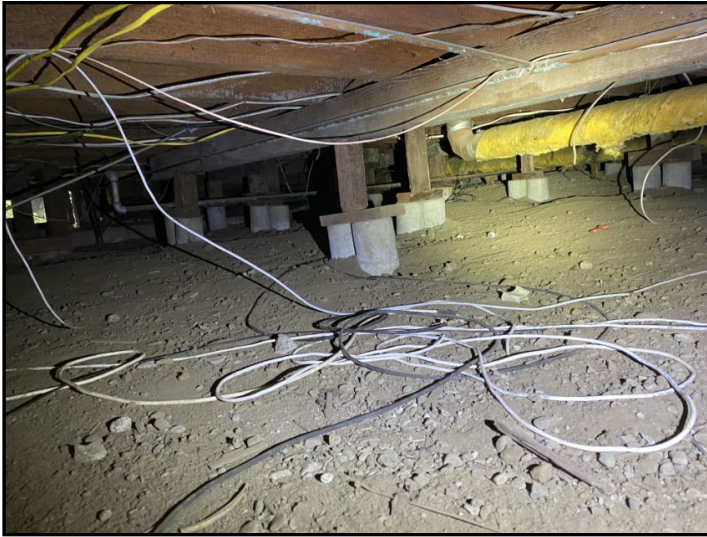
- Unconventional supplemental supports were observed beneath the older section of the house. Although these supports appeared to be providing some effective support at the time of the inspection, several did not meet generally accepted support practices. Conditions included amateur installation, the use of 2×4 wood members without proper brackets or mechanical connections, and uneven or inadequately prepared bearing surfaces. These conditions may reduce the stability of the supports and allow localized movement or settlement. It is advisable to have a qualified foundation contractor evaluate the supplemental support system and properly repair, reinforce, or replace the deficient components as necessary.

Unconventional supplemental supports were observed beneath the older section of the house.

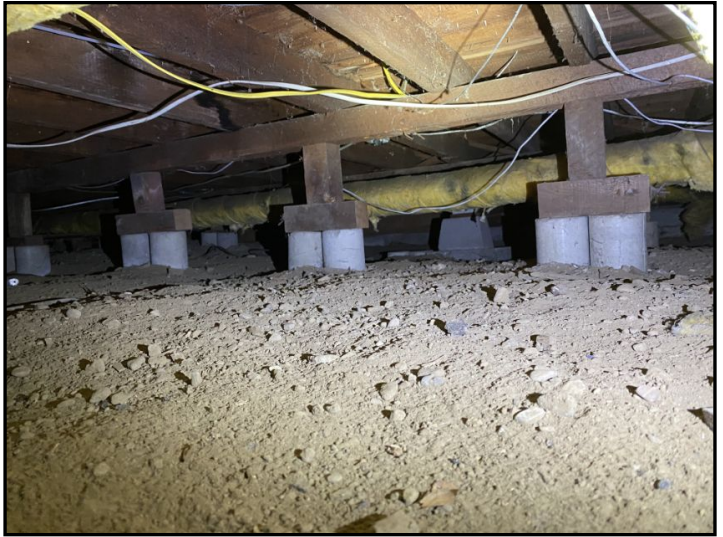
Unconventional supplemental supports were observed beneath the older section of the house.

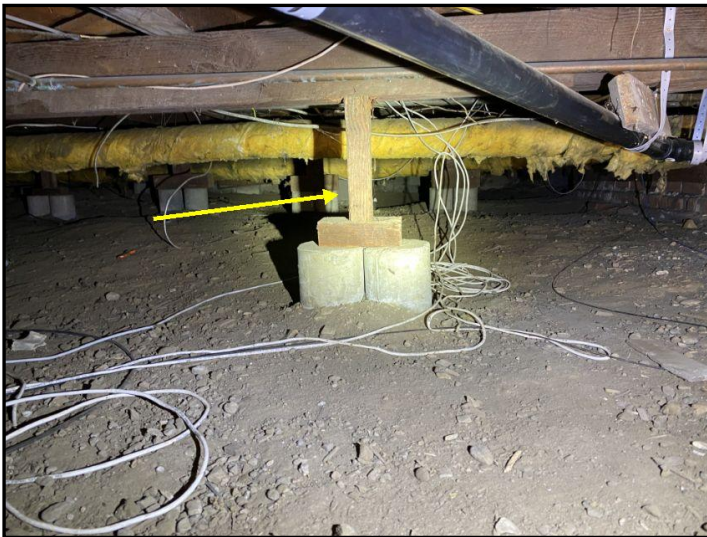
Unconventional supplemental supports were observed beneath the older section of the house.

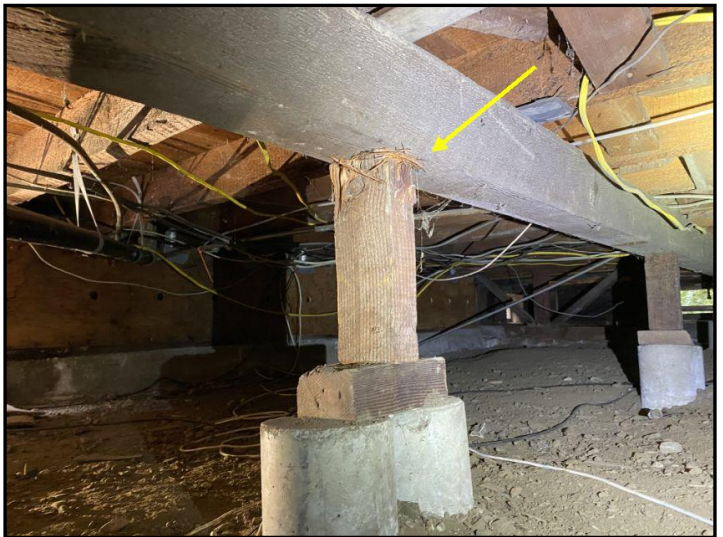
Conditions included amateur installation, the use of 2x4 wood members without proper brackets or mechanical connections.

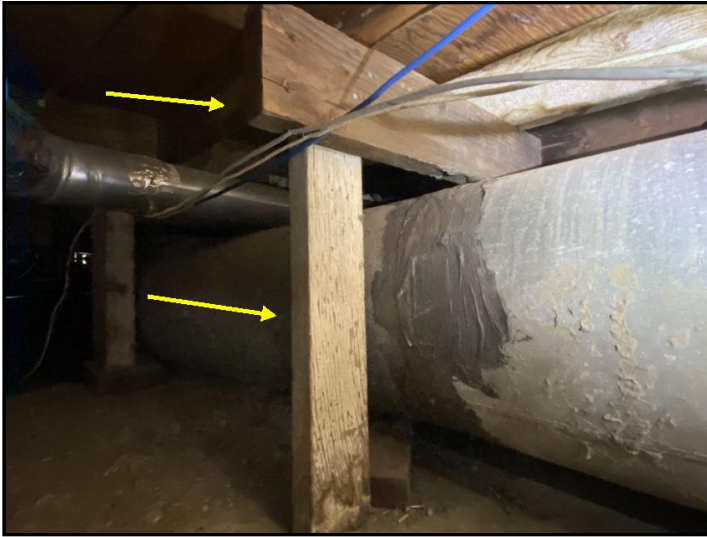
Unconventional supplemental supports were observed beneath the older section of the house.

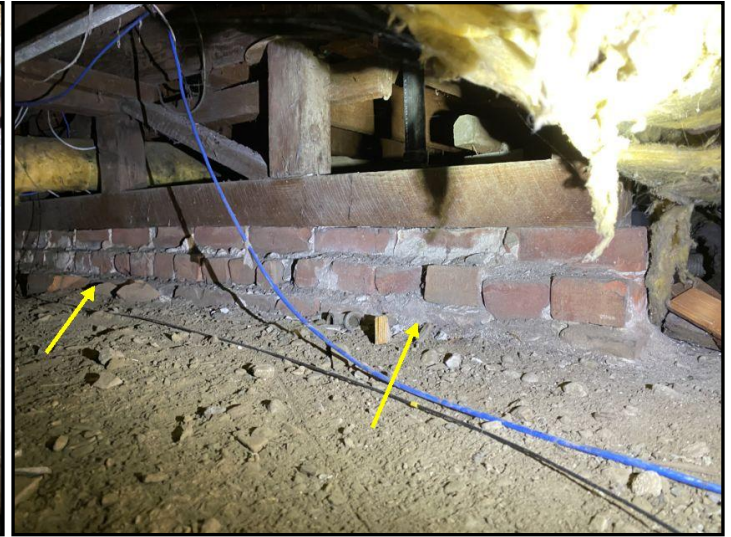
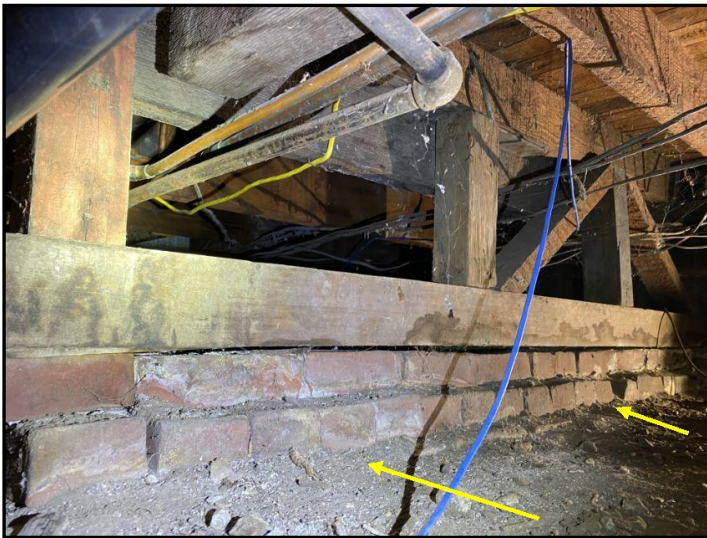
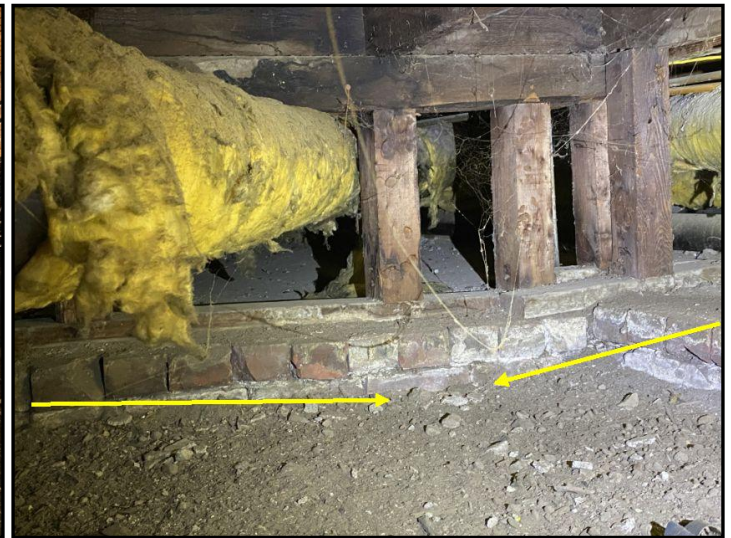
- One or more supplemental foundation support walls were constructed with unreinforced mortared brick. Although these supports may currently be performing their intended function, unreinforced masonry is seismically vulnerable and generally lacks the strength and stability of modern reinforced concrete supports. The mortar joints may also deteriorate over time, potentially resulting in cracking, displacement, localized failure, structural damage, or settlement. It is advisable to have a qualified foundation contractor or structural engineer evaluate these supports and determine whether reinforcement or replacement with properly designed and anchored reinforced-concrete supports is necessary.

One or more supplemental foundation support walls were constructed with unreinforced mortared brick.

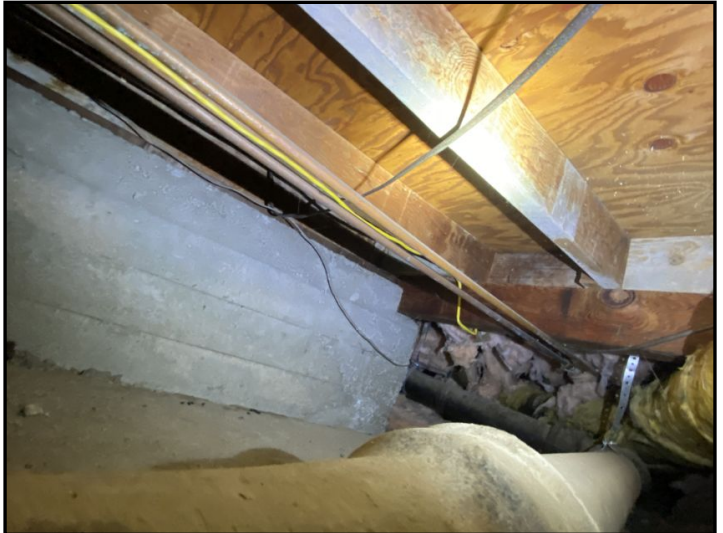
- There are areas under the property that are not insulated. While this may not have been required when the property was originally built, retrofitting these areas with insulation can significantly improve the property's energy efficiency. Adding insulation can help reduce heating and cooling costs, improve comfort, and increase overall energy performance. Consider consulting a qualified professional to evaluate and recommend appropriate insulation solutions for these areas.

There are areas under the property that are not insulated.

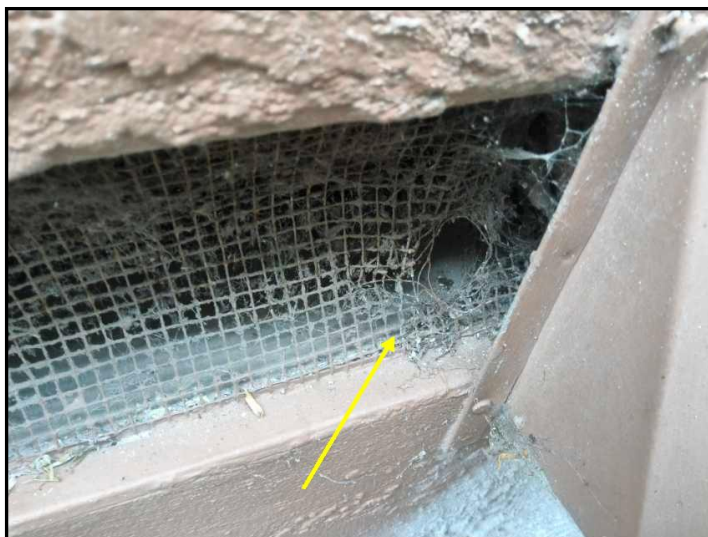
- One of the foundation ventilation screens are damaged or missing, and should be repaired or replaced to keep rodents and other pests out.

One of the foundation ventilation screens are damaged or missing.

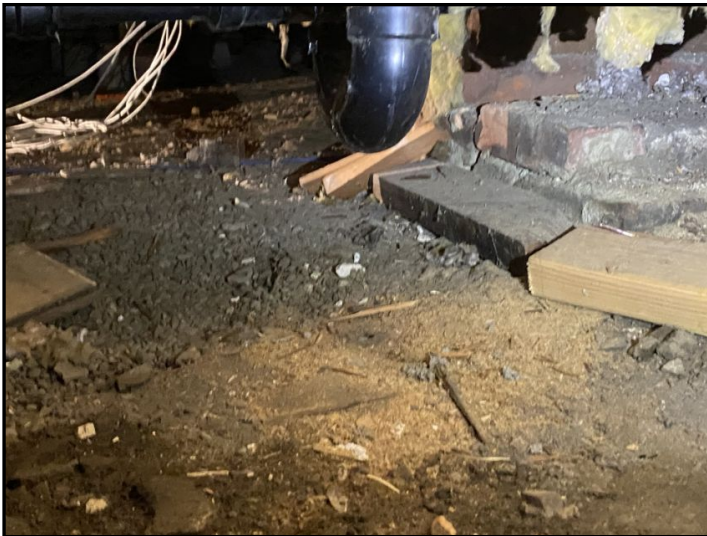
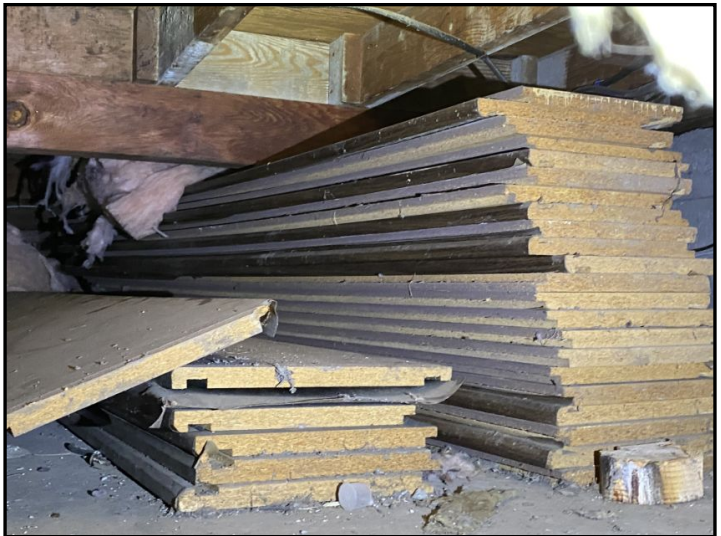
There are cellulose products in the crawlspace.

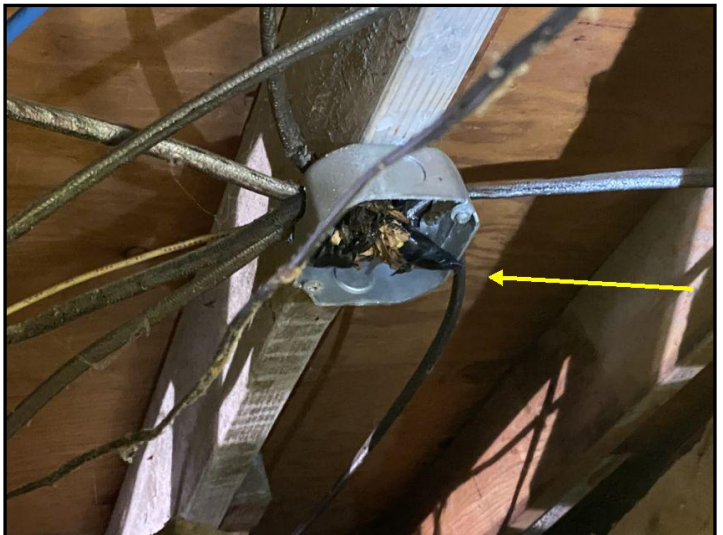
- Open electrical box was noted during the inspection. Electrical boxes are required to have properly installed covers to protect energized wiring from accidental contact, contain sparks or electrical arcing, and help prevent moisture, dust, and debris from entering the enclosure.

Open electrical box was noted during the inspection.

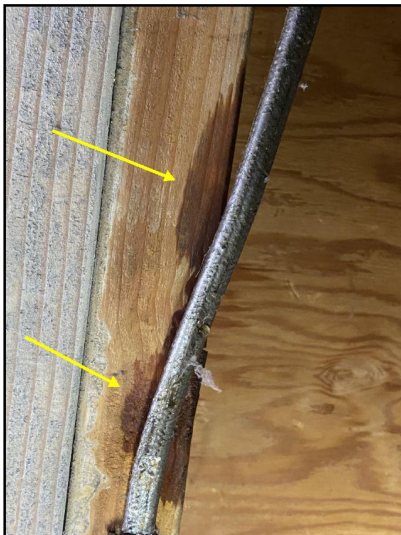
- Visible evidence of an active water leak was observed dripping from the subfloor in the crawlspace, approximately beneath the laundry area, at the time of the inspection. The exact source of the leak could not be determined during this visual inspection. Active leaks can result in damage to structural framing, insulation, and finish materials, create conditions conducive to mold growth and wood decay, and may attract wood-destroying organisms. It is recommended that a qualified plumbing contractor promptly determine the source of the leak and complete the necessary repairs.

Visible evidence of an active water leak was observed dripping from the subfloor.

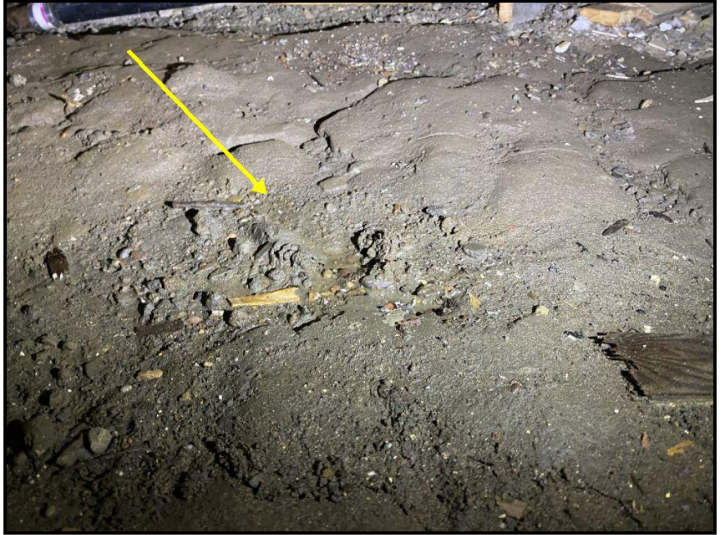
- An active leak was observed from the potable water supply piping beneath the kitchen/bathroom area at the time of the inspection. Active water leaks can result in water damage to building materials, promote mold growth, and increase water consumption if left uncorrected. It is recommended that a qualified plumbing contractor promptly perform the necessary repairs.

An active leak was observed from the potable water supply piping.

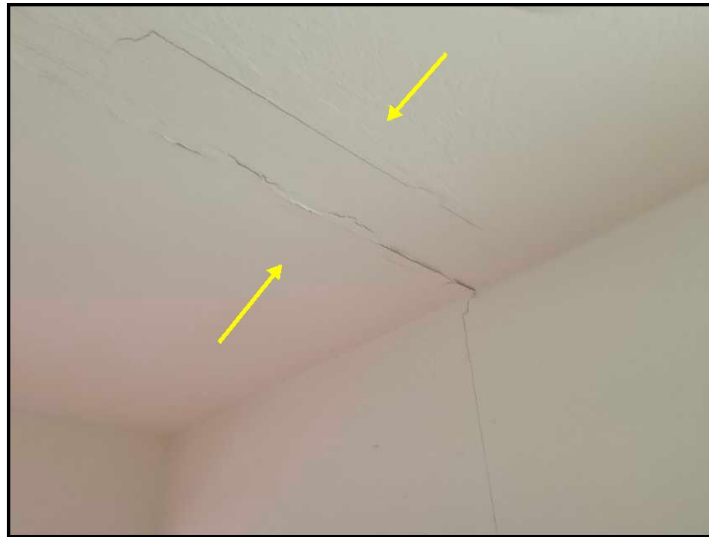
- Minor drywall separation and cracking were observed at the ceiling, primarily along the joints between adjacent drywall sheets. This condition is relatively common in older homes and is often associated with normal long-term settlement, framing movement, and seasonal expansion and contraction.

The observed cracking appeared cosmetic at the time of the inspection. It is advisable to repair the affected finishes as needed and monitor the areas for additional movement. If the cracks widen, repeatedly reopen after repair, or are accompanied by other signs of structural movement, further evaluation is recommended.

Minor drywall separation and cracking were observed at the ceiling.
