# ROOF INSPECTION REPORT

Inspector: Tina Kirkpatrick  
**TK Contracting & Consulting Inc.**

**xxx Near me St, Neverland CA 94xxx**  
**Inspection Prepared For: Sam Super**  
**Agent: Not Applicable -**

**Date of Inspection: 7/22/2026**  
**Year Built: 1930 Size: 1500**  
**NACHI24041526 / CLSB #1158251**

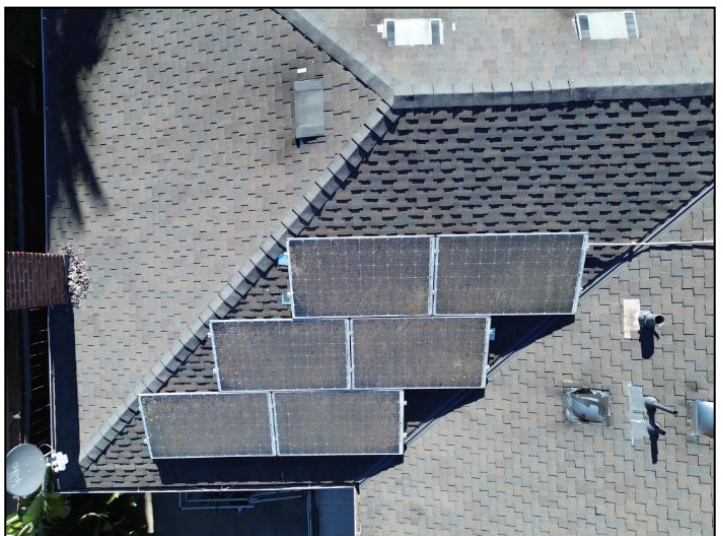
The roof is equipped with photovoltaic (solar) panels.

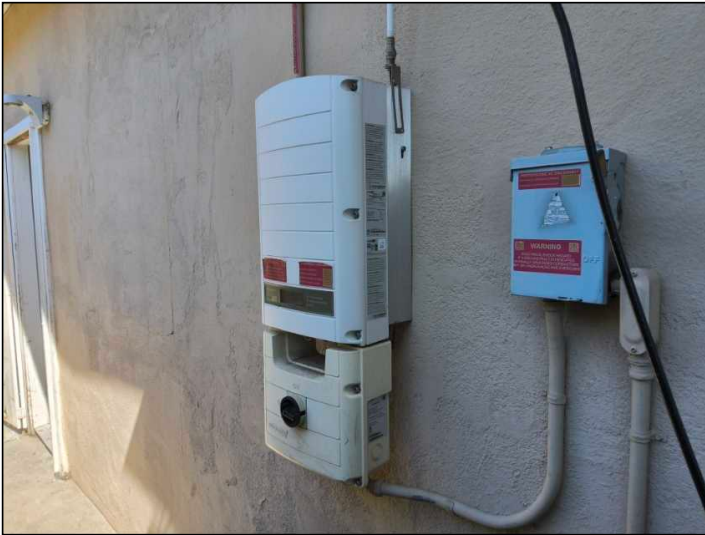
The roof is equipped with photovoltaic (solar) panels.

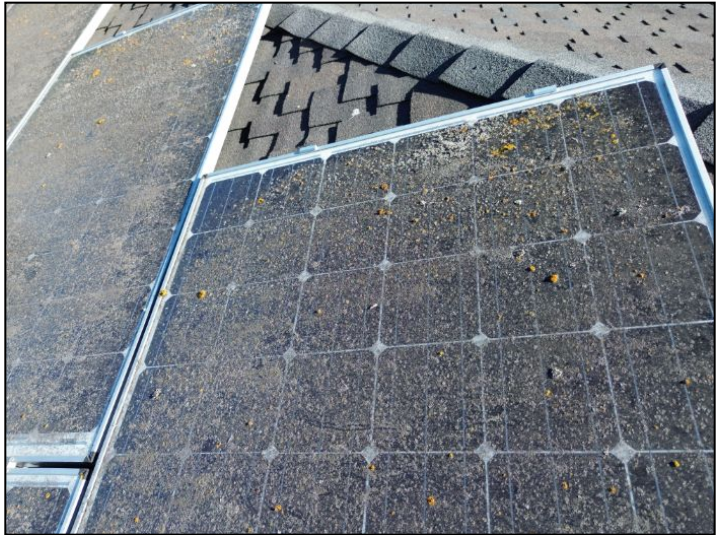
- The solar panels were observed to be dirty. Accumulated dirt, dust, pollen, bird droppings, and other debris can reduce the efficiency and energy production of the solar photovoltaic system. Periodic cleaning and routine maintenance, following the manufacturer's recommendations, are advised to help maintain optimal performance.

The solar panels were observed to be dirty.

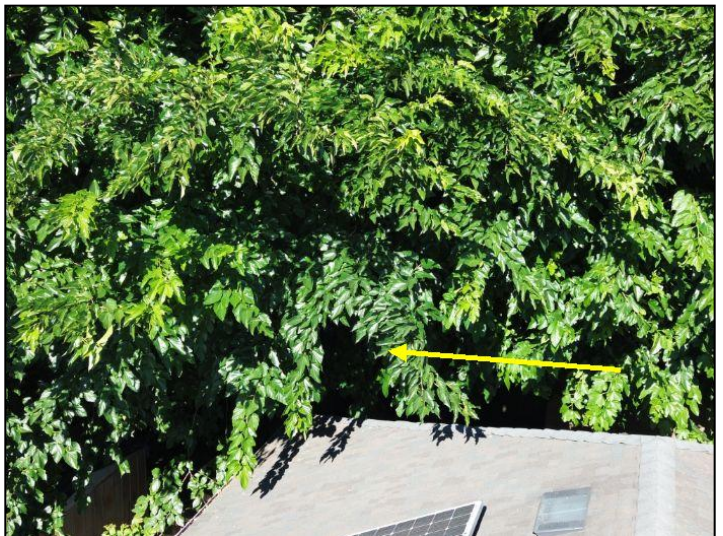
- The premium composition shingle roofing material appeared to be in satisfactory condition relative to its age.
- FOLIAGE NOTED: Foliage was observed growing over or in proximity to the roof. Overhanging vegetation can accelerate roof wear, trap moisture, obstruct drainage, and provide access for pests. Recommend trimming back vegetation to maintain adequate clearance from the roof and help prolong the life of the roofing system.
- DEBRIS ON THE ROOF: Leaves and debris were observed in portions of the roof near the chimney. Accumulated debris can impede proper drainage, trap moisture, and accelerate deterioration of roofing materials. Recommend cleaning the affected areas and maintaining the roof free of debris to help ensure proper roof drainage and prolong the life of the roofing system.

FOLIAGE NOTED: Foliage was observed growing over or in proximity to the roof.

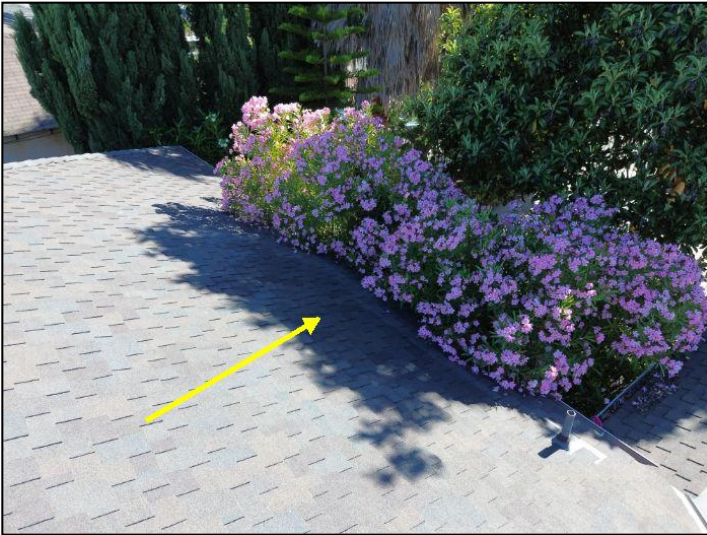
**FOLIAGE NOTED:** Foliage was observed growing over or in proximity to the roof.

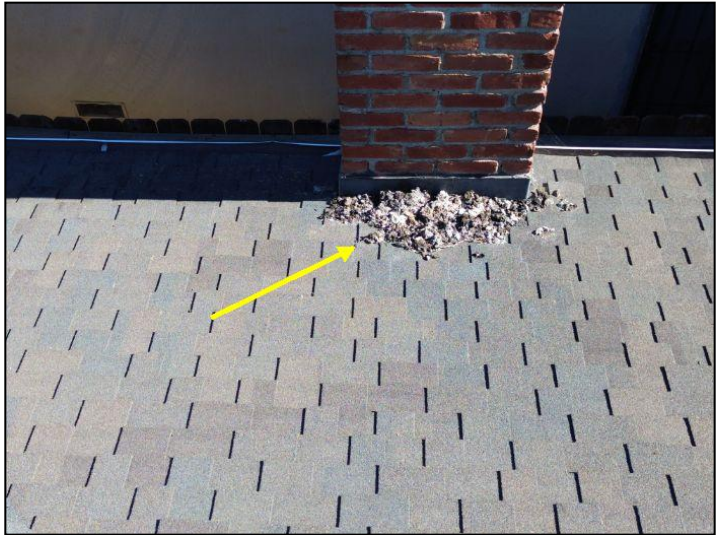
**DEBRIS ON THE ROOF:** Leaves and debris were observed in portions of the roof near the chimney.

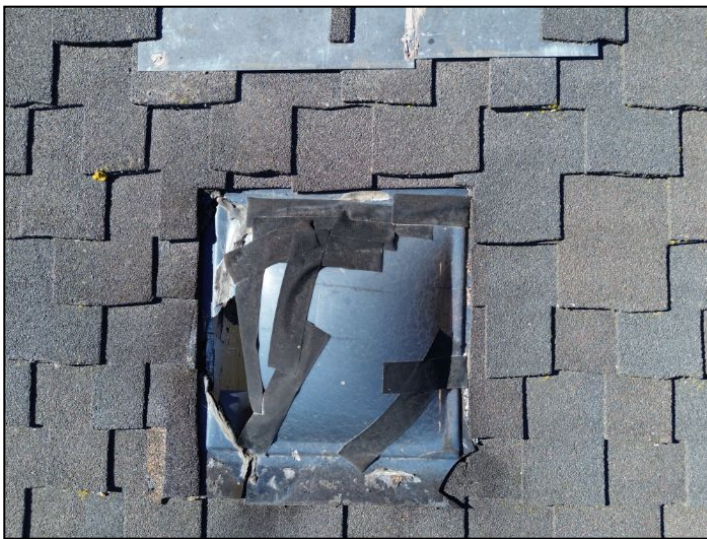
There is a crack, or multiple cracks, in a skylight.

- There is a crack, or multiple cracks, in a skylight that should be addressed by a qualified specialist. Our office can facilitate this service upon request to ensure proper replacement and maintain the integrity and safety of the skylight.
- There is evidence of moisture intrusion at the interior of a skylight. We recommend replacing the skylight before rain season.

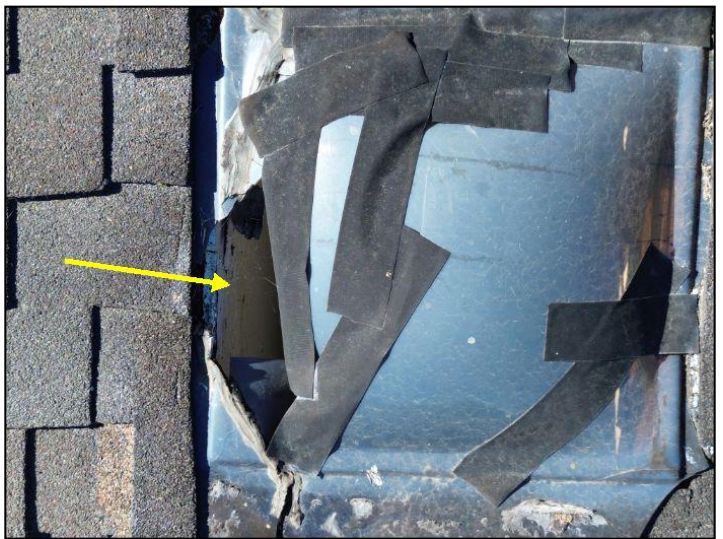
There is a crack, or multiple cracks, in a skylight.

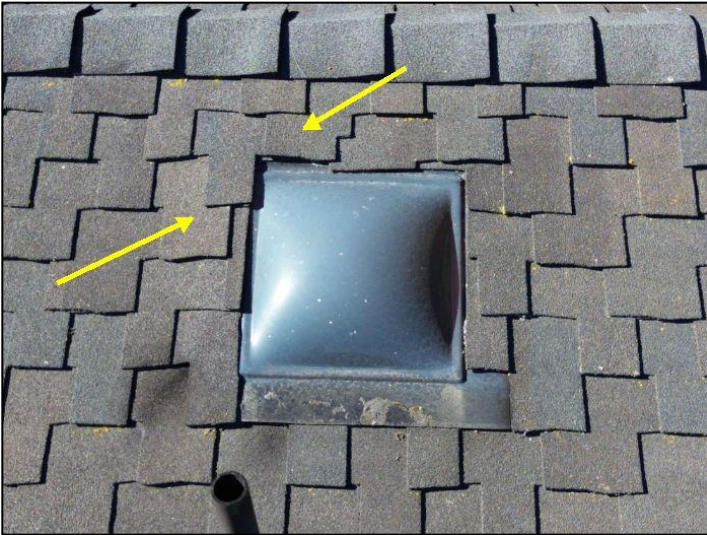
There is a crack, or multiple cracks, in a skylight that should be addressed by a qualified specialist. Our office can facilitate this service upon request to ensure proper replacement and maintain the integrity and safety of the skylight.

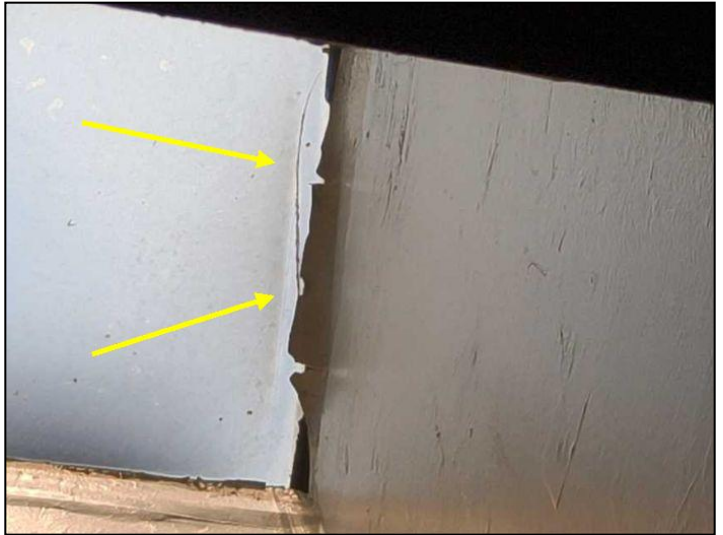
There is a crack, or multiple cracks, in a skylight.

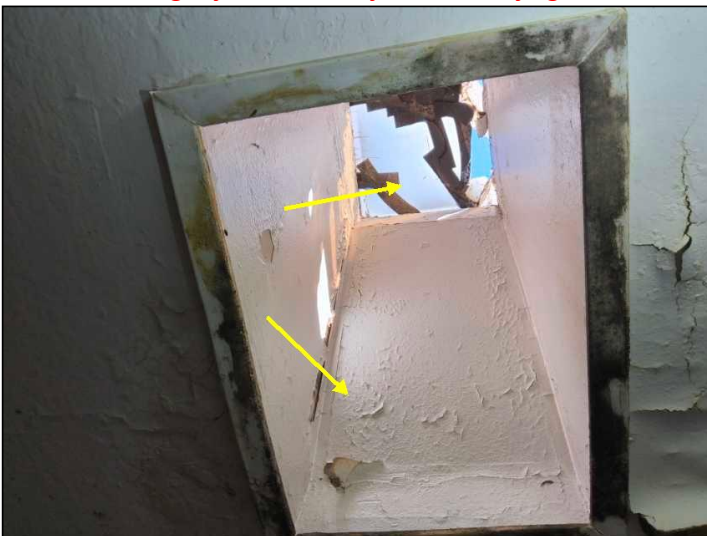
There is a crack, or multiple cracks.

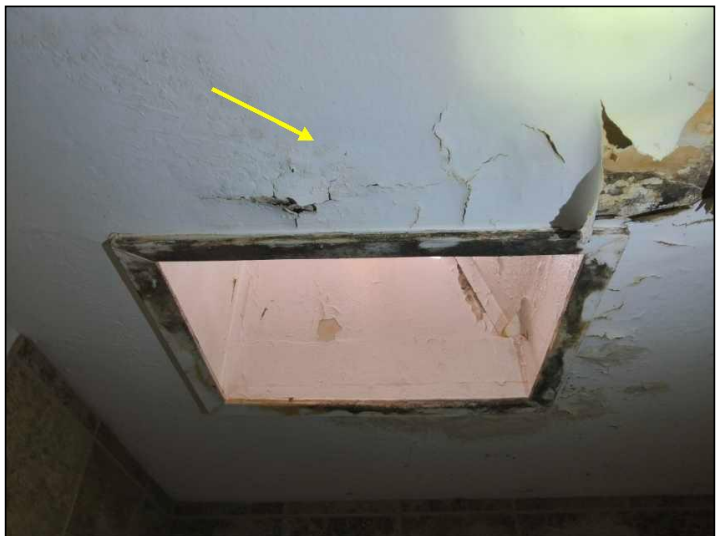
There is evidence of moisture intrusion at the interior of a skylight.

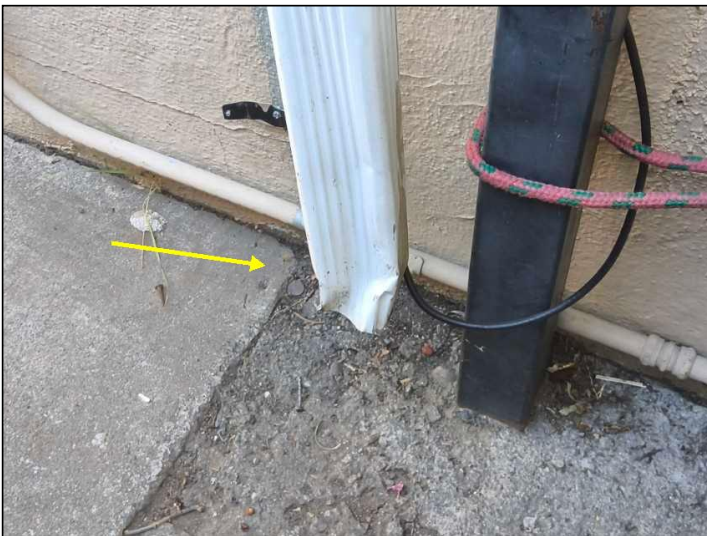
Some downspouts are missing or need to be reconnected or serviced.

- The majority of the gutters and downspouts appeared to be clear and in satisfactory condition.
- The roof gutters require cleaning to function effectively. Regular maintenance will help ensure proper drainage and prevent water damage to the property.
- Some downspouts are missing or need to be reconnected or serviced. This will divert water away from the residence and its foundation to prevent moisture under the home and reduce the chance of the foundation settling.
- We recommend you have diverters or splash blocks installed at the bottom of all downspouts or have downspouts connect to underground drain lines. This will divert water away from the residence and its foundation to prevent moisture under the home and reduce the chance of the foundation settling.

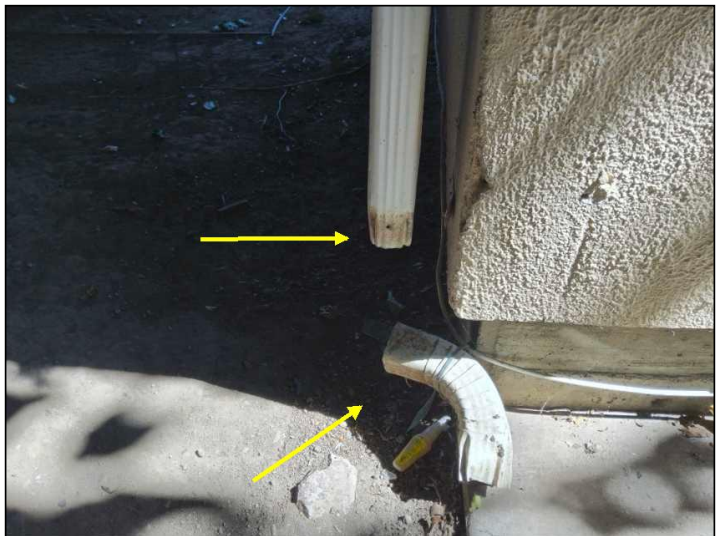
Some downspouts are missing or need to be reconnected or serviced.

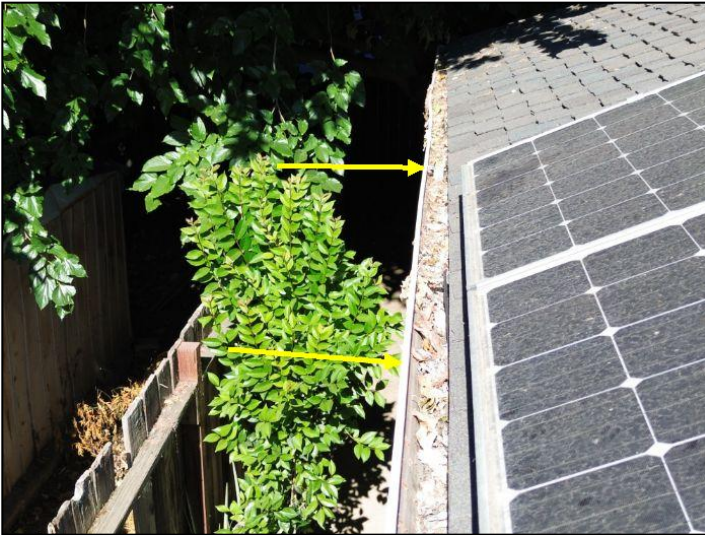
The roof gutters require cleaning to function effectively.

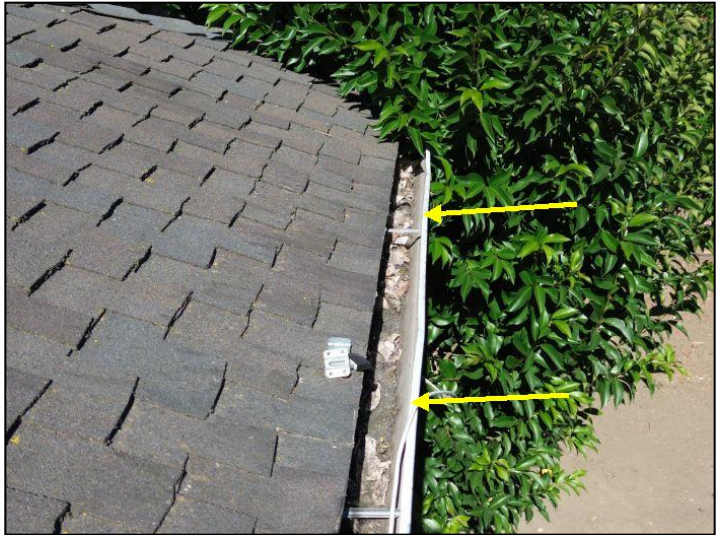
The roof gutters require cleaning to function effectively.

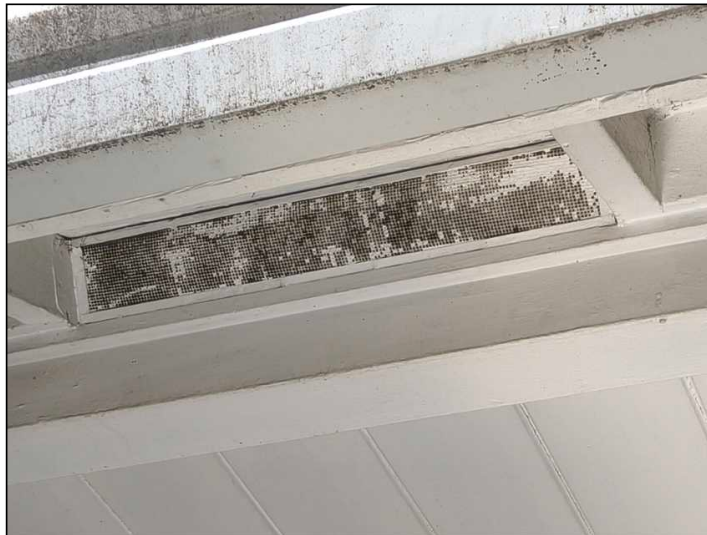
- Vent screens noted as functional.
- Vent screens noted painted over. The screens covering the vent openings were painted over in some areas, which reduces the amount of air flow/circulation through the attic. You may therefore wish to have the screens cleaned or replaced.

Vent screens noted painted over.

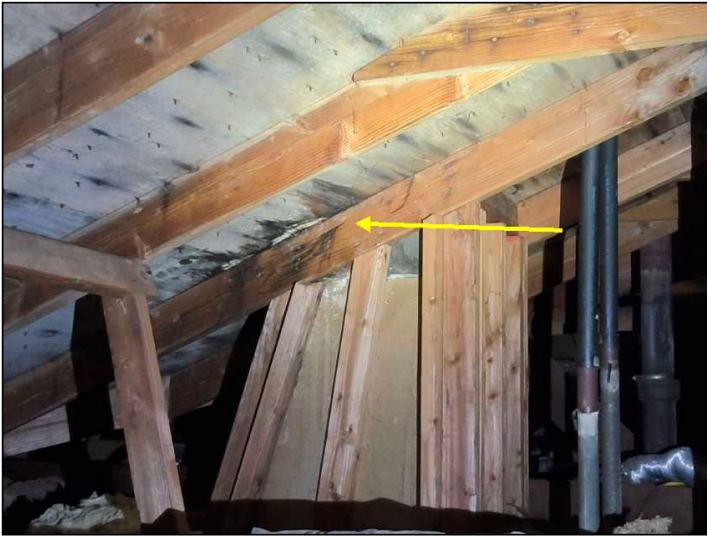
Moisture stains were observed on the attic framing and sheathing.

- Moisture stains were observed on the attic framing and sheathing. The staining near the skylight appeared consistent with an active leak at the time of the inspection. Prompt replacement of the skylight is recommended to help prevent continued moisture intrusion and reduce the potential for further damage to the roof structure and interior finishes. After repairs are completed, the affected attic areas should be monitored to confirm the leak has been successfully corrected.

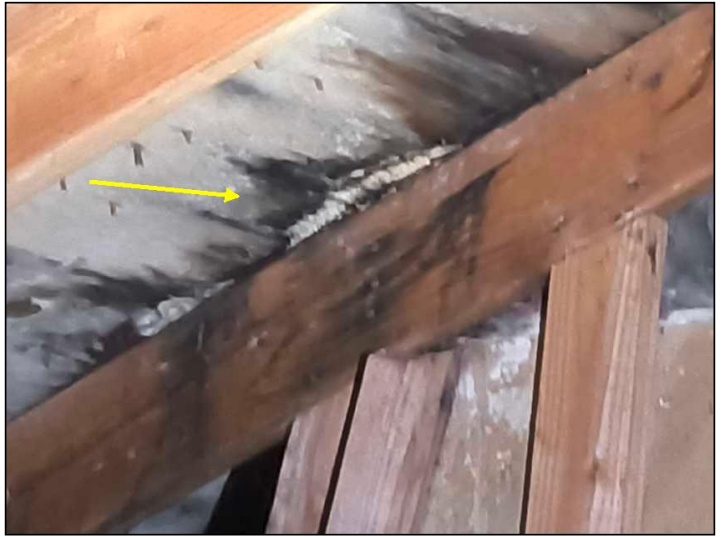
The staining near the skylight appeared consistent with an active leak at the time of the inspection.
