# FOUNDATION INSPECTION REPORT

**TK Contracting & Consulting Inc.**

**xxx Near me St. Neverland CA 94xxx,  
Inspection Prepared For: Sam Super  
Agent: Not Applicable -**

**Date of Inspection: 7/29/2026**

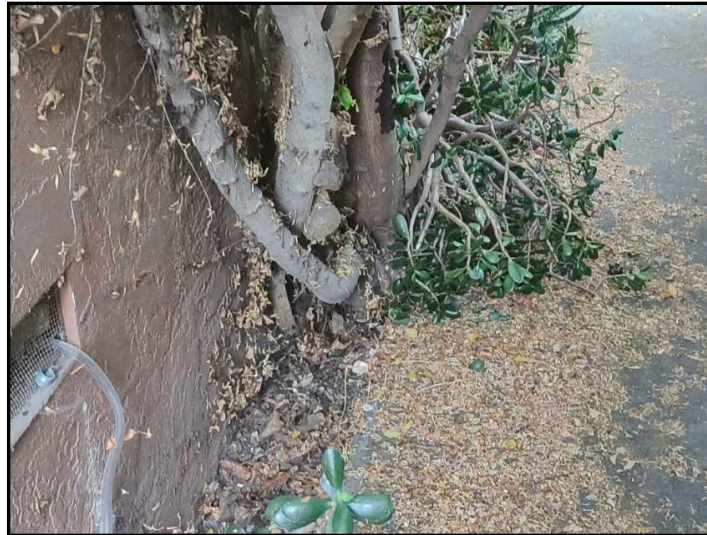
- **TREE NEAR FOUNDATION:** Trees are within 6 feet of foundation. Monitor for potential root damage.

**TREE NEAR FOUNDATION:** Trees are within 6 feet of foundation. Monitor for potential root damage.

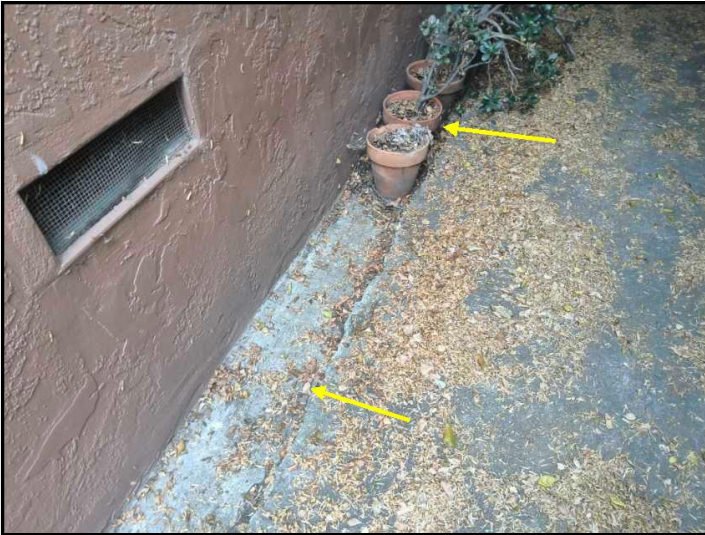
- A gap was left between the concrete sidewalk and the foundation when the new foundation was constructed. Water can collect and remain within this space, allowing prolonged moisture exposure against the foundation stem wall. This condition may soften or erode the supporting soil and contribute to localized soil instability or foundation movement over time. It is advisable to seal or properly fill the gap and improve the drainage so that water flows away from the foundation. A qualified drainage or foundation contractor should evaluate the area and perform the appropriate corrective work.
- **GRADING AGAINST FOUNDATION:** The exterior grading is improperly sloped towards the foundation. Water can intrude into the interior. Recommend creating the proper slope away from the foundation to allow for proper drainage.

A gap was left between the concrete sidewalk and the foundation when the new foundation was constructed.

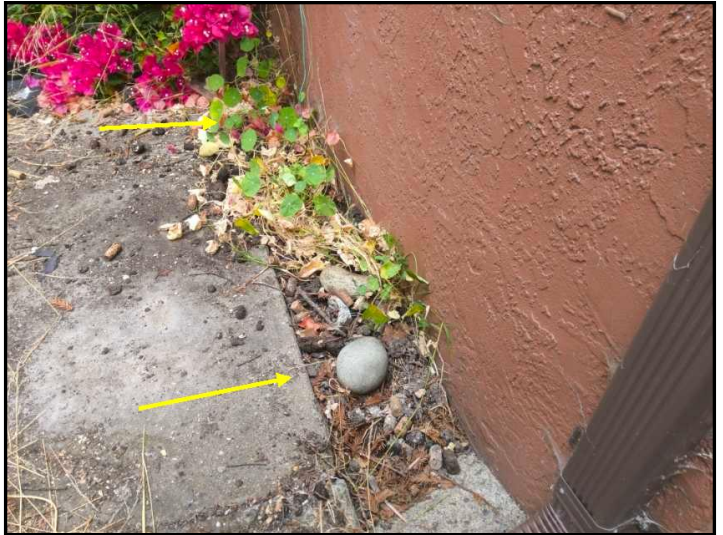
Water can collect and remain within this space, allowing prolonged moisture exposure against the foundation stem wall.

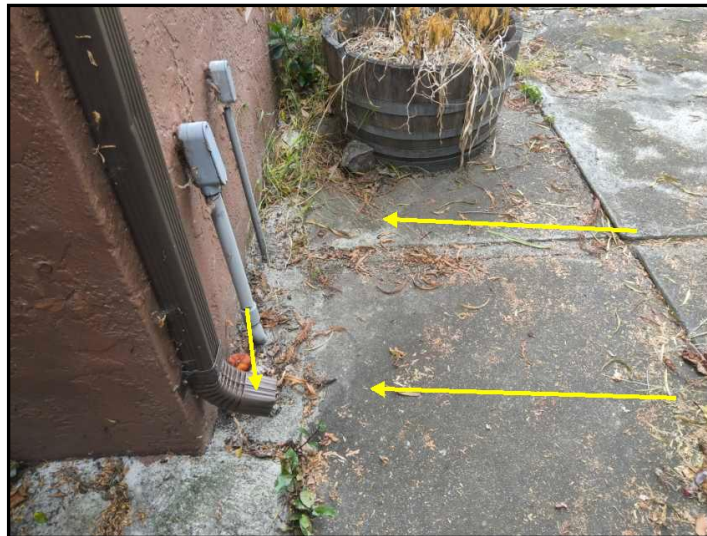
**GRADING AGAINST FOUNDATION:** The exterior grading is improperly sloped towards the foundation.

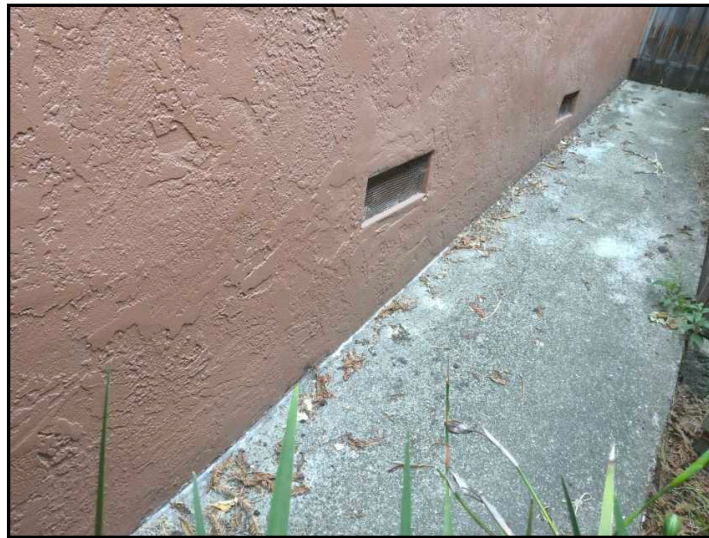
- The stucco wall coverings extend down to the soil without a weep-screed. Although this was customary at the time the residence was built, this can lead to cracking and/or bulging of the stucco at the connection between the concrete foundation and the wood framing. These materials expand and contract at different rates causing cosmetic damage and irregularities at this junction of dissimilar building materials. You may wish to have the areas evaluated by a qualified specialist for additional recommendations and repairs.

The stucco wall coverings extend down to the soil without a weep-screed.

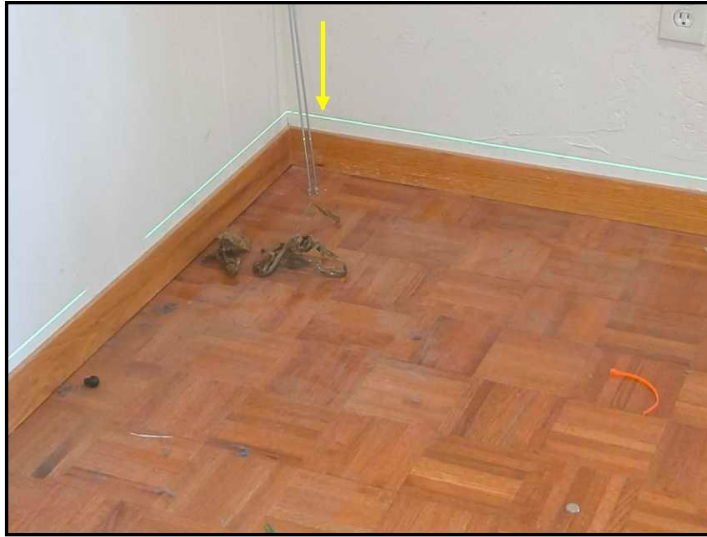
- The floor within the newly added section was observed to be out of level, with a slight slope toward the exterior. This condition appears to be related to differential settlement of the supporting foundation system. The addition was constructed partially over an existing concrete slab, with some supplemental supports bearing on the slab and others bearing directly on the soil. The concrete foundation appears to have settled approximately 1"1/2 inches from its original position. Although some settlement is common as supporting soils consolidate over time, the supplemental supports bearing on the existing slab did not settle at the same rate. This uneven movement has created different support elevations, resulting in the sloping floor observed inside the addition. This type of condition is relatively common in older homes and is often primarily an aesthetic concern. However, it is important to monitor the area over time for evidence of additional movement. If the slope increases or new cracking, separation, or other signs of movement develop, a structural engineer should evaluate the foundation to determine whether movement is ongoing and whether leveling, stabilization, or modification of the support system is necessary.

The floor within the newly added section was observed to be out of level, with a slight slope toward the exterior.

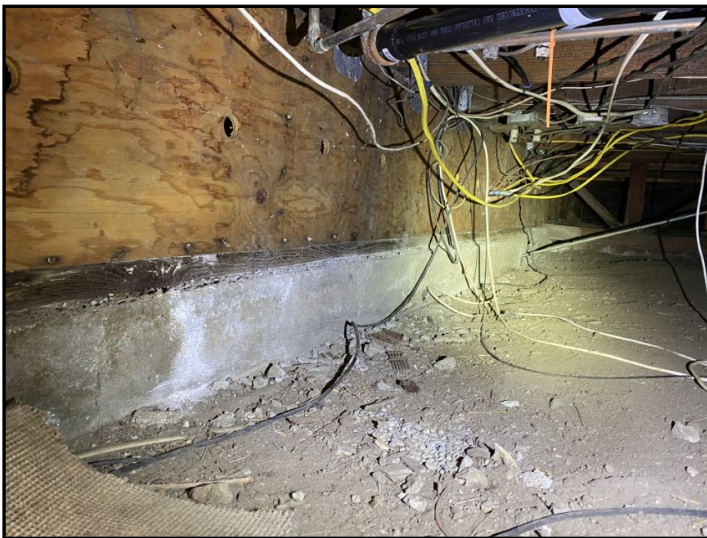
The poured concrete foundation walls appear to be functional.

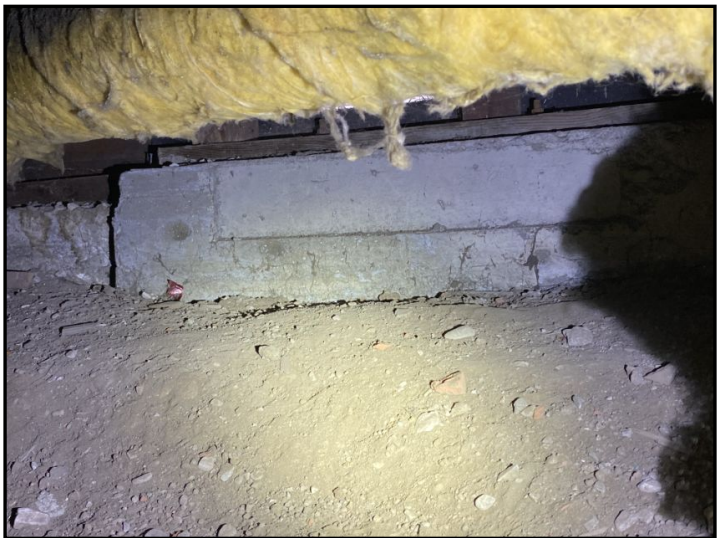
The poured concrete foundation walls appear to be functional.

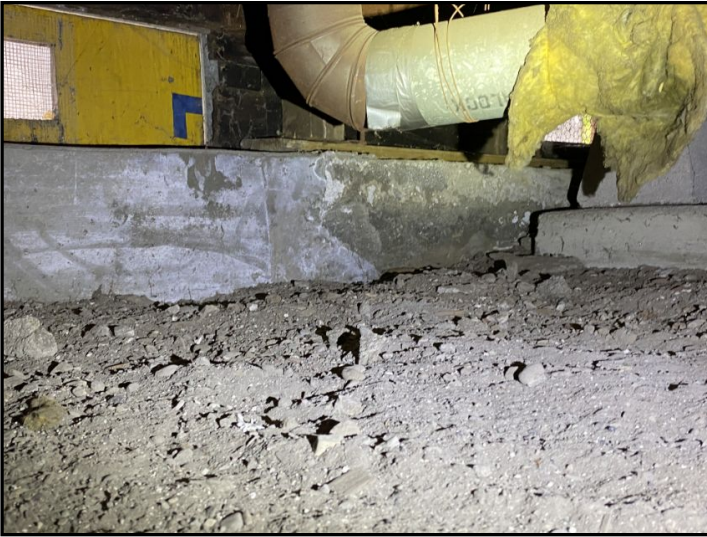
The poured concrete foundation walls appear to be functional.

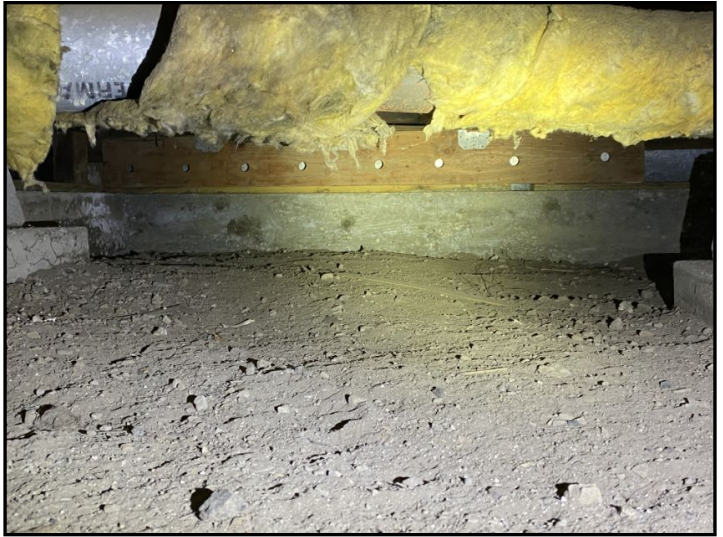
The poured concrete foundation walls appear to be functional.

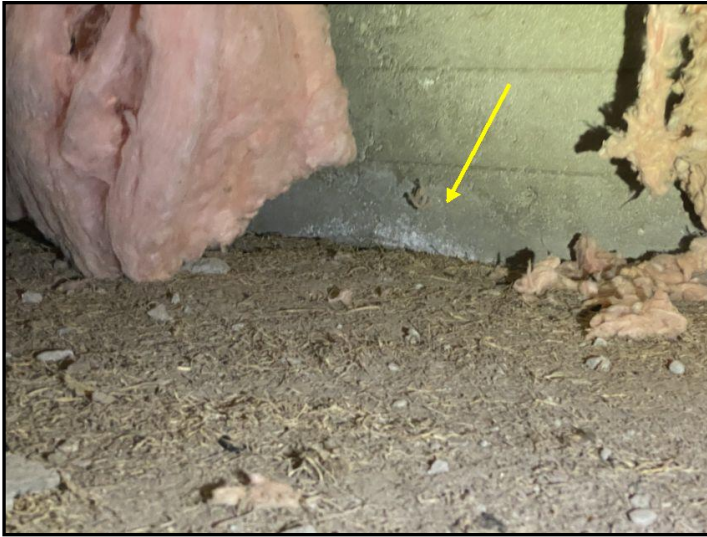
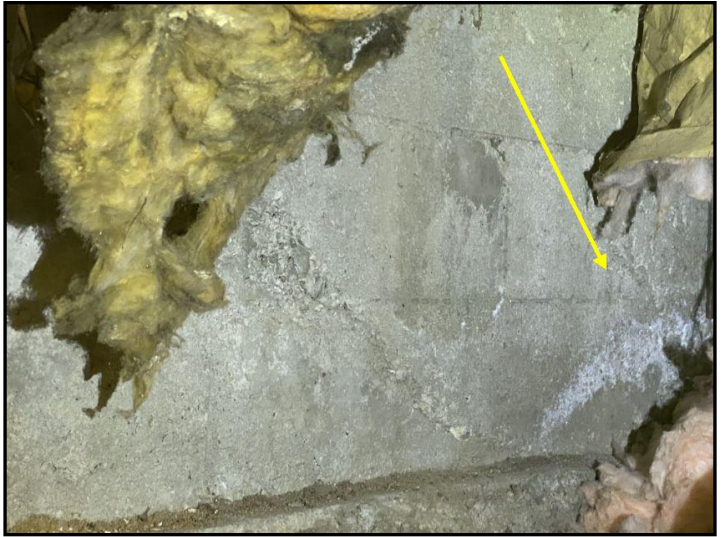
- The poured concrete foundation walls appear to be functional, indicating that they are performing as expected and providing adequate structural support. Regular inspections are recommended to maintain their condition and address any future issues promptly.
- Efflorescence observed; this is a mineral deposit left behind from exterior water infiltration. This is an indication of moisture penetration and could be the result of inadequate above ground water management. This may be corrected by improving site grading and/or drainage. Excessive moisture can contribute to differential settling and facilitate the growth of a variety of molds or fungi that can promote unhealthy conditions.

Efflorescence observed.

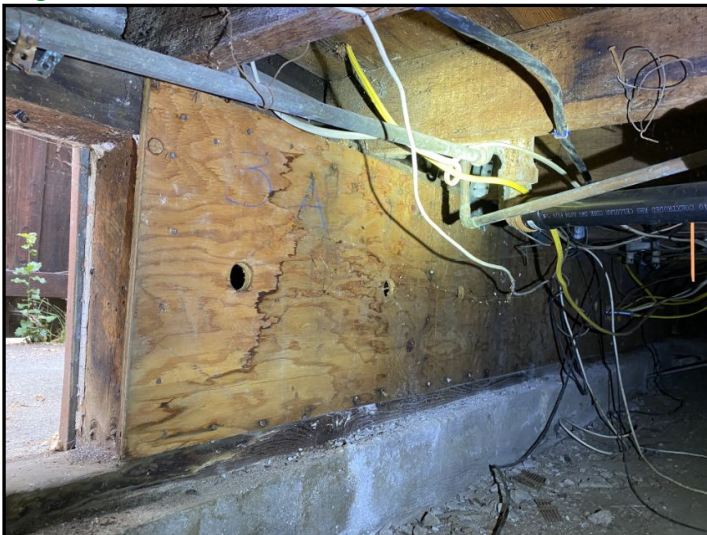
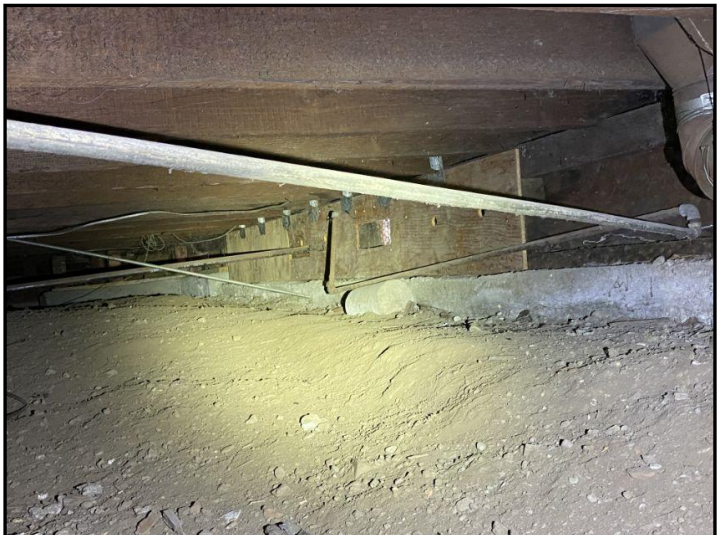
- Some areas of the foundation has been retrofit with visible Plywood/OSB sheathing. A cripple wall foundation retrofit involves adding anchor bolts to secure the mud sill to the foundation and installing plywood or OSB sheathing to brace the walls. This process turns the cripple wall into a rigid shear wall.

Some areas of the foundation has been retrofit with visible Plywood/OSB sheathing.

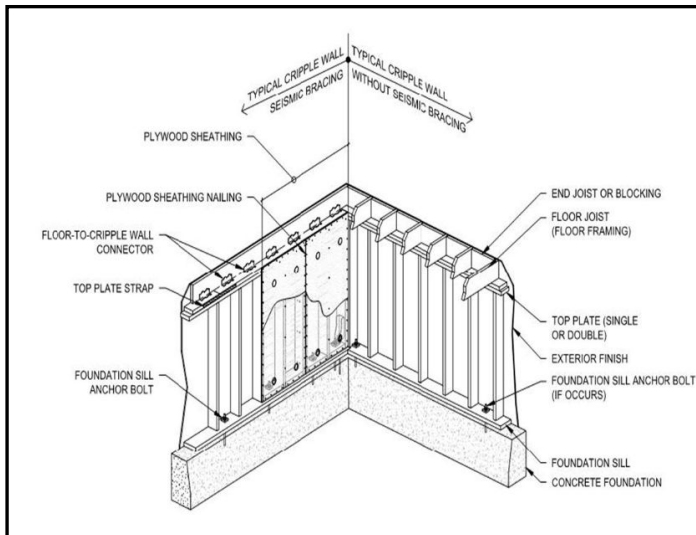
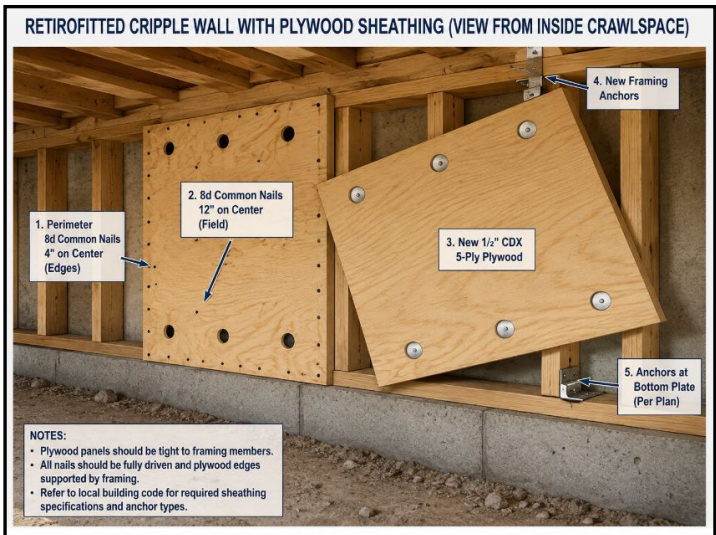
This process turns the cripple wall into a rigid shear wall.

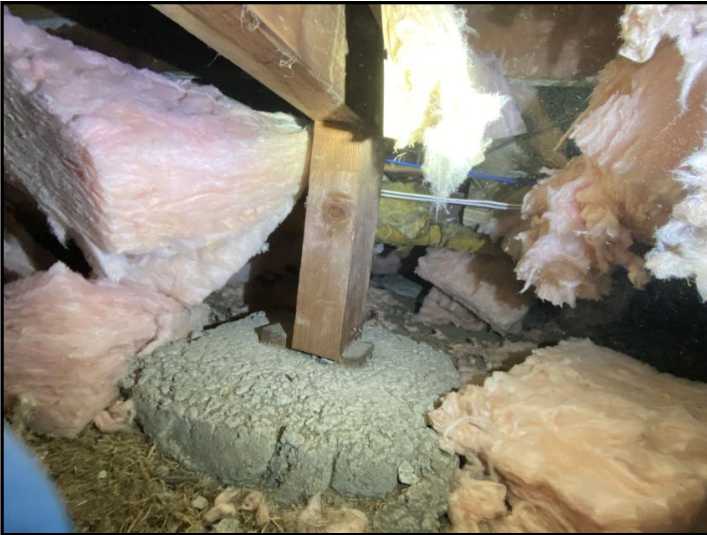
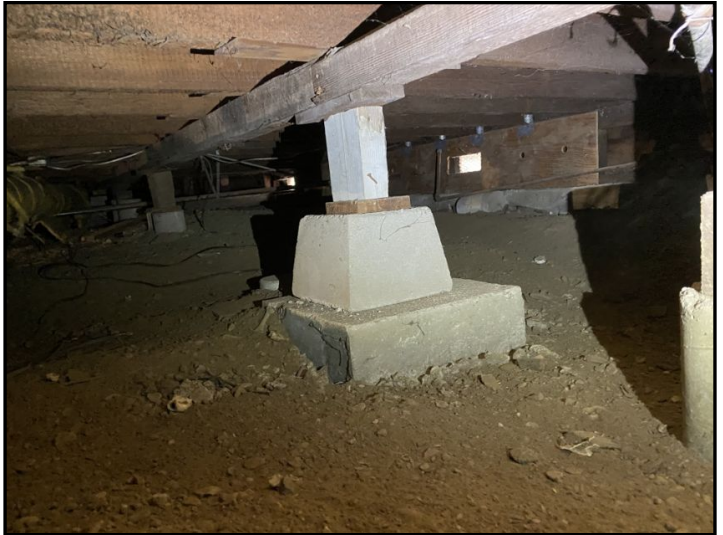
The majority of the supplemental support posts in the newer section of the property are properly placed.

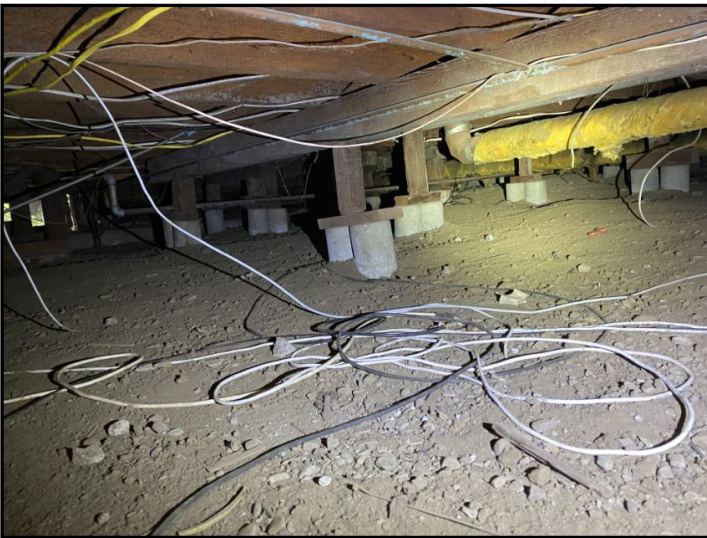
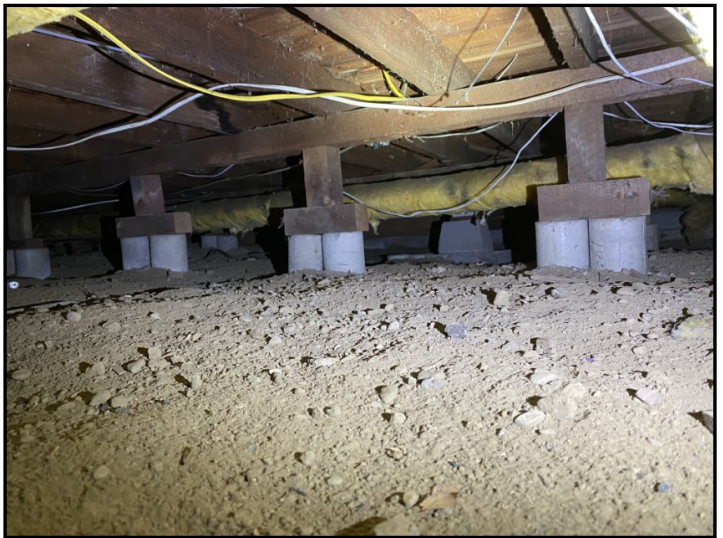
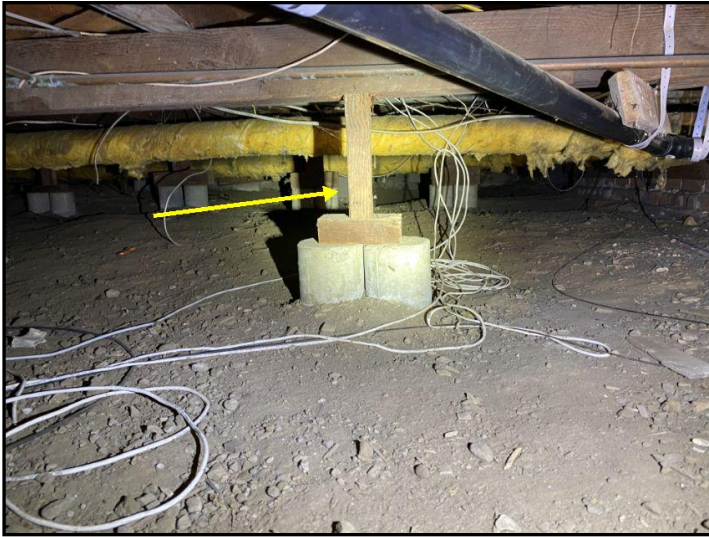
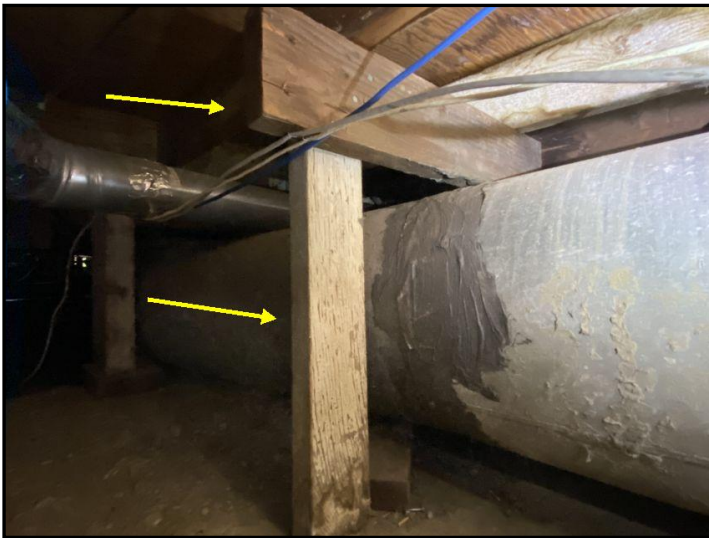
- Unconventional supplemental supports were observed beneath the older section of the house. Although these supports appeared to be providing some effective support at the time of the inspection, several did not meet generally accepted support practices. Conditions included amateur installation, the use of 2×4 wood members without proper brackets or mechanical connections, and uneven or inadequately prepared bearing surfaces. These conditions may reduce the stability of the supports and allow localized movement or settlement. It is advisable to have a qualified foundation contractor evaluate the supplemental support system and properly repair, reinforce, or replace the deficient components as necessary.

Unconventional supplemental supports were observed beneath the older section of the house.

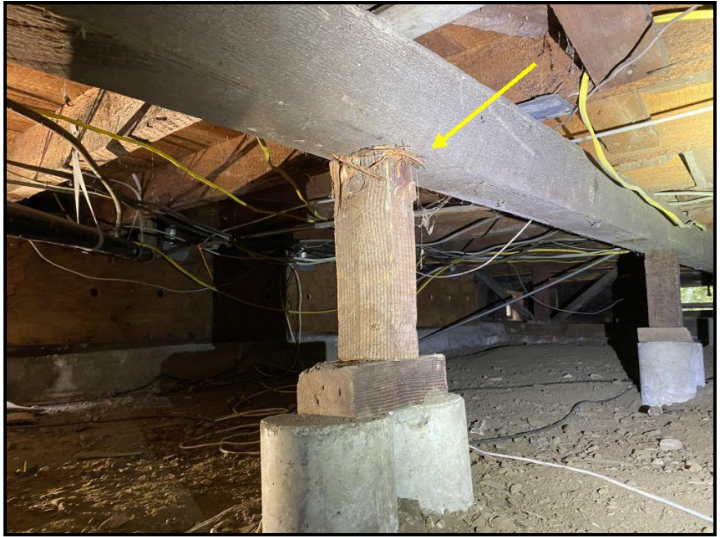
Conditions included amateur installation, the use of 2x4 wood members without proper brackets or mechanical connections.

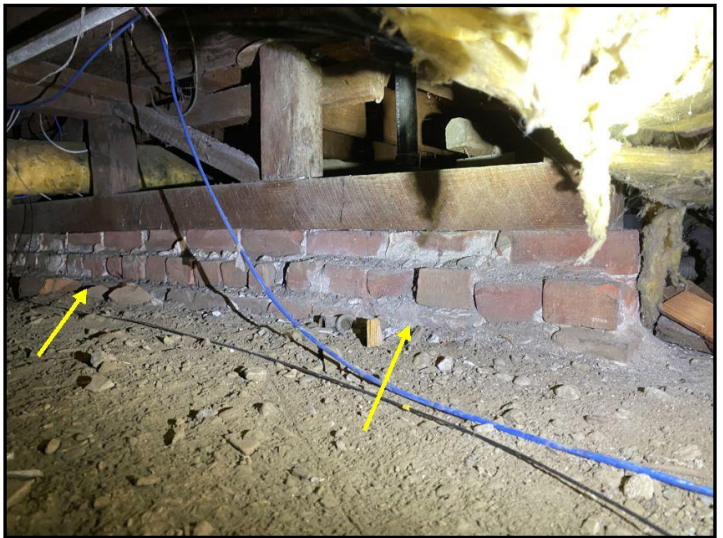
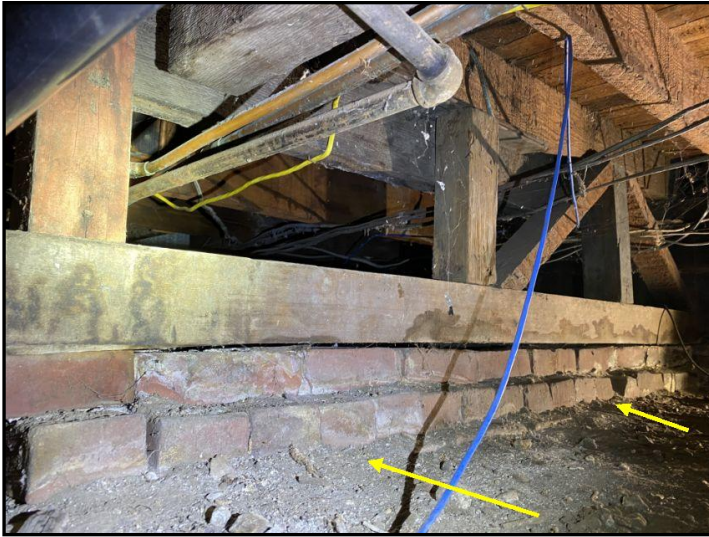
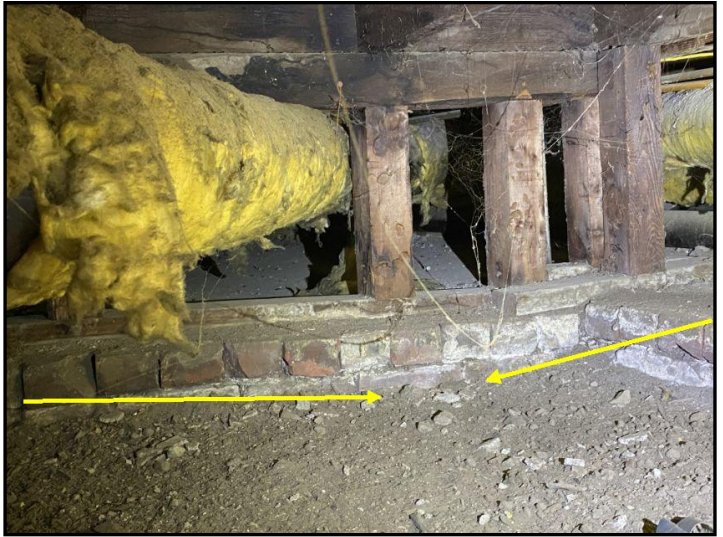
- One or more supplemental foundation support walls were constructed with unreinforced mortared brick. Although these supports may currently be performing their intended function, unreinforced masonry is seismically vulnerable and generally lacks the strength and stability of modern reinforced concrete supports. The mortar joints may also deteriorate over time, potentially resulting in cracking, displacement, localized failure, structural damage, or settlement. It is advisable to have a qualified foundation contractor or structural engineer evaluate these supports and determine whether reinforcement or replacement with properly designed and anchored reinforced-concrete supports is necessary.

One or more supplemental foundation support walls were constructed with unreinforced mortared brick.

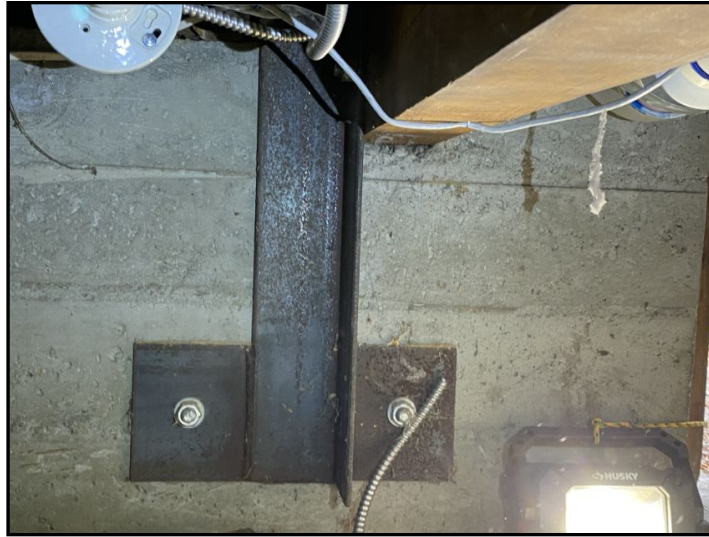
- Anchor straps noted.

Anchor straps noted.

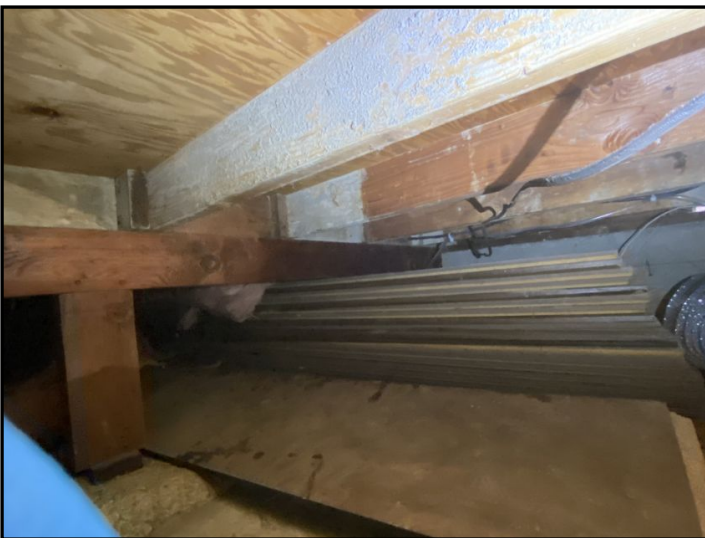
Visible areas appear satisfactory at the time of inspection.

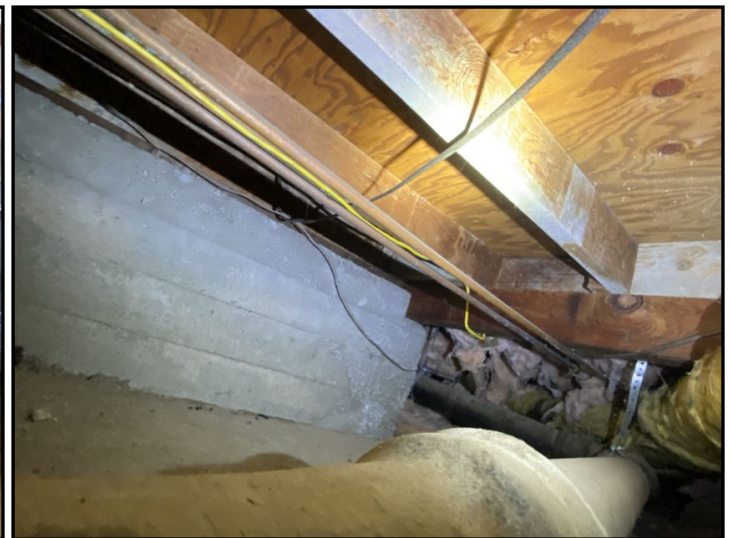
- There are areas under the property that are not insulated. While this may not have been required when the property was originally built, retrofitting these areas with insulation can significantly improve the property's energy efficiency. Adding insulation can help reduce heating and cooling costs, improve comfort, and increase overall energy performance. Consider consulting a qualified professional to evaluate and recommend appropriate insulation solutions for these areas.

There are areas under the property that are not insulated.

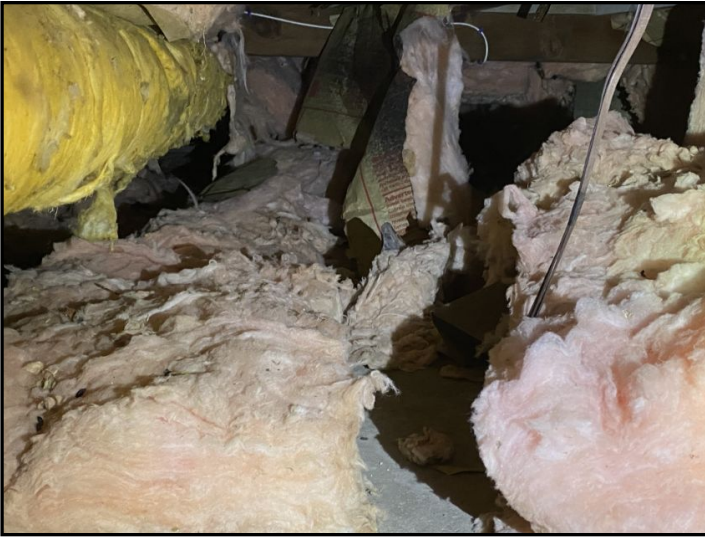
- Some pieces or sections of insulation have dropped from between the floor joists or are hanging down. This condition will not have any serious consequences, but you should have it corrected for improved energy efficiency.

Some pieces or sections of insulation have dropped from between the floor joists or are hanging down.

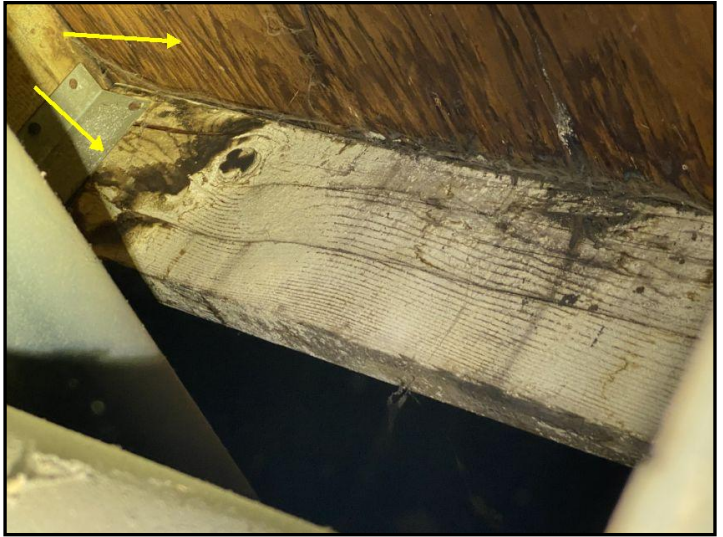
- Any stains or moisture damage to the sub-floor will need to be evaluated by a licensed pest control operator for further remarks and recommendations.

Any stains or moisture damage to the sub-floor will need to be evaluated by a licensed pest control operator for further remarks and recommendations.

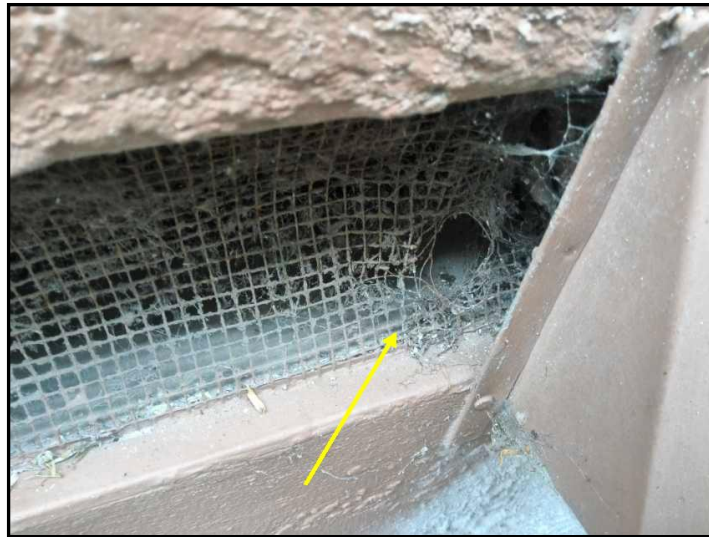
- One of the foundation ventilation screens are damaged or missing, and should be repaired or replaced to keep rodents and other pests out.

One of the foundation ventilation screens are damaged or missing.

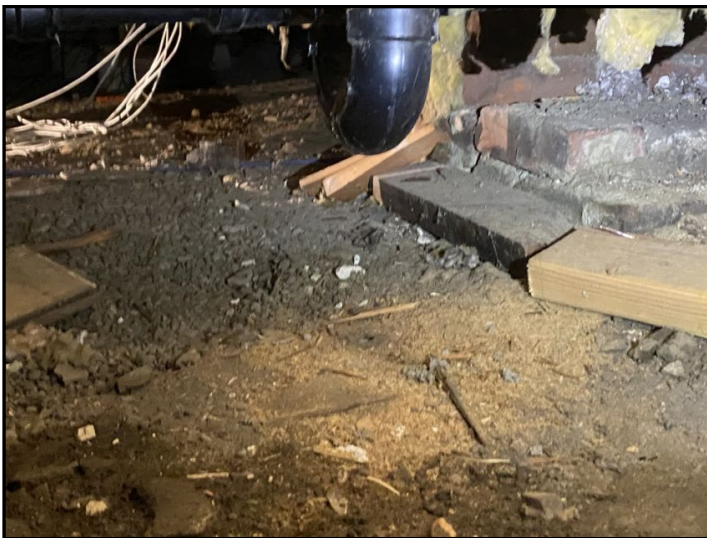
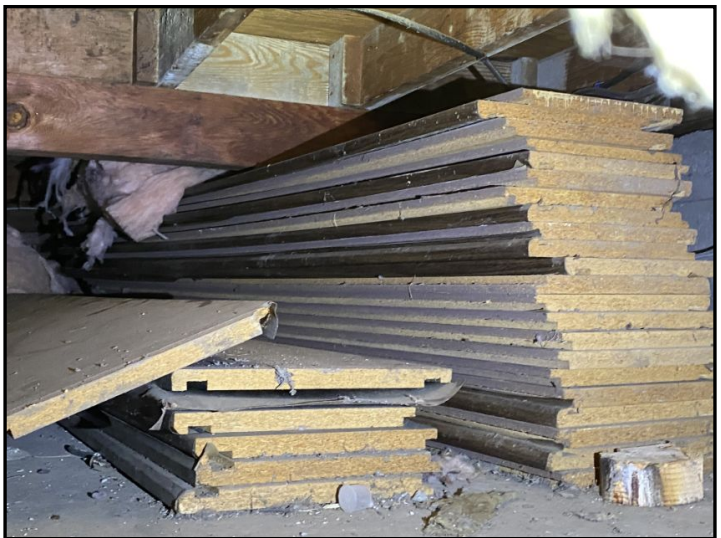
There are cellulose products in the crawlspace.

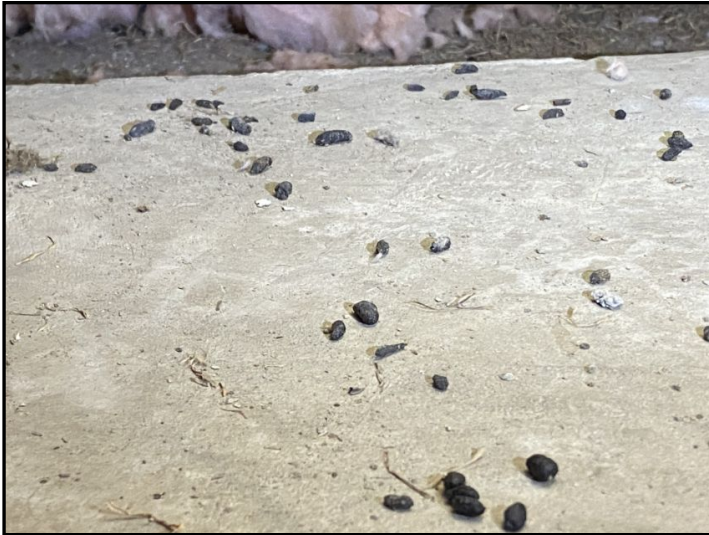
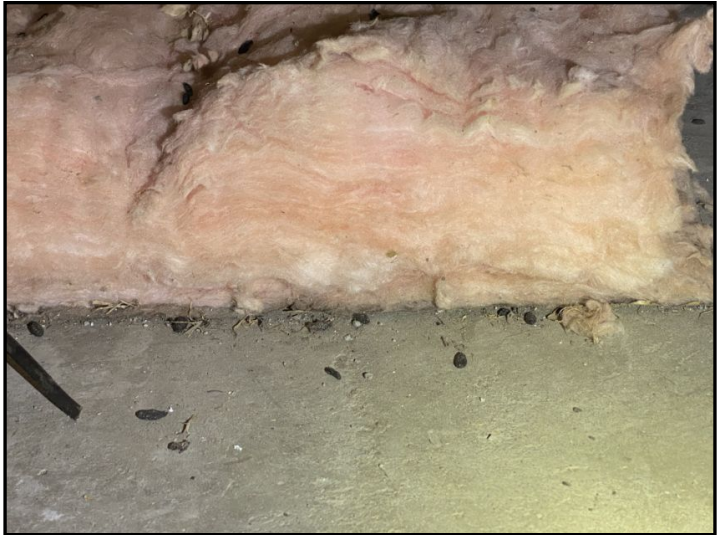
- Evidence of rodent activity was observed in the crawlspace. This could lead to a health and safety concern and warrants further evaluation by an appropriately qualified exterminator.

Evidence of rodent activity was observed in the crawlspace.

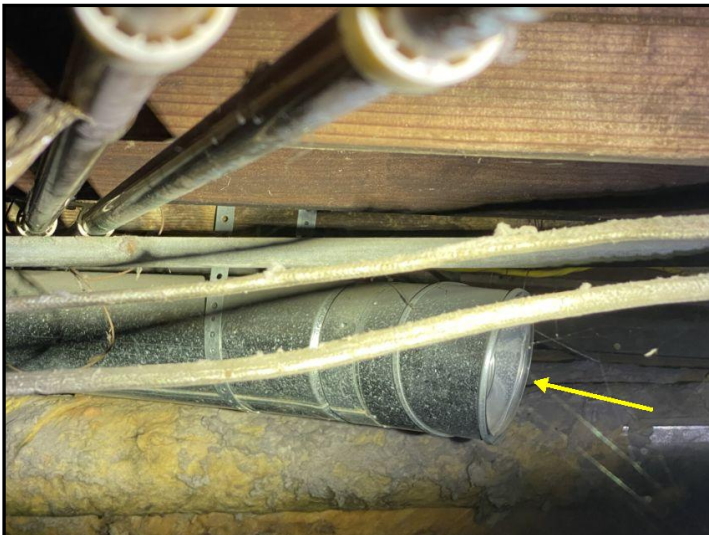
- A section of the forced-air heating duct system in the crawlspace was observed to be disconnected or unattached. Due to limited visibility, the inspector was unable to determine whether this condition was intentional or whether the duct had become detached from the air distribution system. If the duct is unintentionally disconnected, conditioned air may be discharged into the crawlspace rather than the living areas, reducing heating efficiency and system performance. It is recommended that a qualified HVAC contractor evaluate the ductwork and reconnect or properly terminate the duct as needed to ensure the system operates as intended.

A section of the forced-air heating duct system in the crawlspace was observed to be disconnected or unattached.

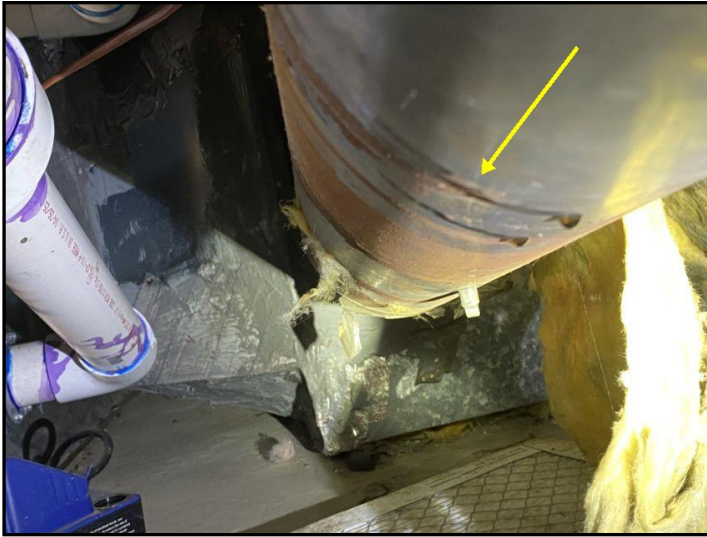
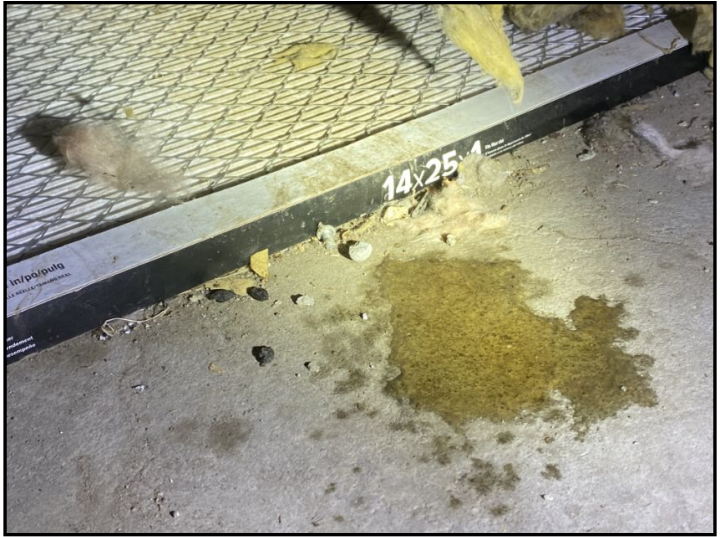
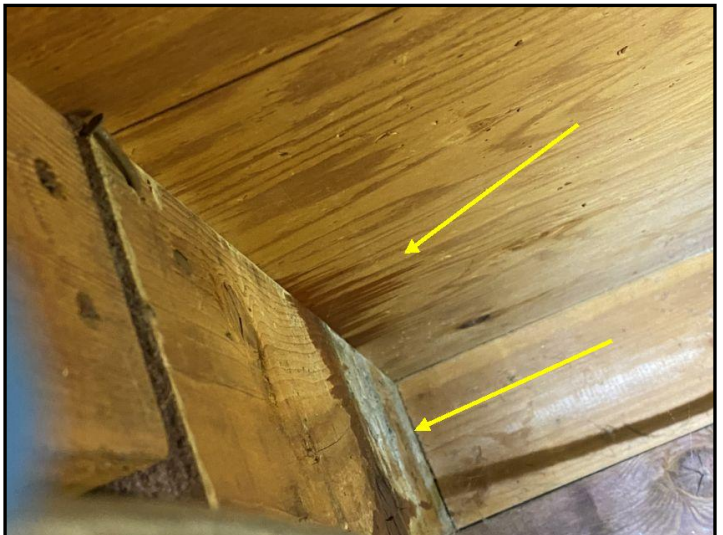
- Visible evidence of an active water leak was observed dripping from the subfloor in the crawlspace, approximately beneath the laundry area, at the time of the inspection. The exact source of the leak could not be determined during this visual inspection. Active leaks can result in damage to structural framing, insulation, and finish materials, create conditions conducive to mold growth and wood decay, and may attract wood-destroying organisms. It is recommended that a qualified plumbing contractor promptly determine the source of the leak and complete the necessary repairs.

Visible evidence of an active water leak was observed dripping from the subfloor.

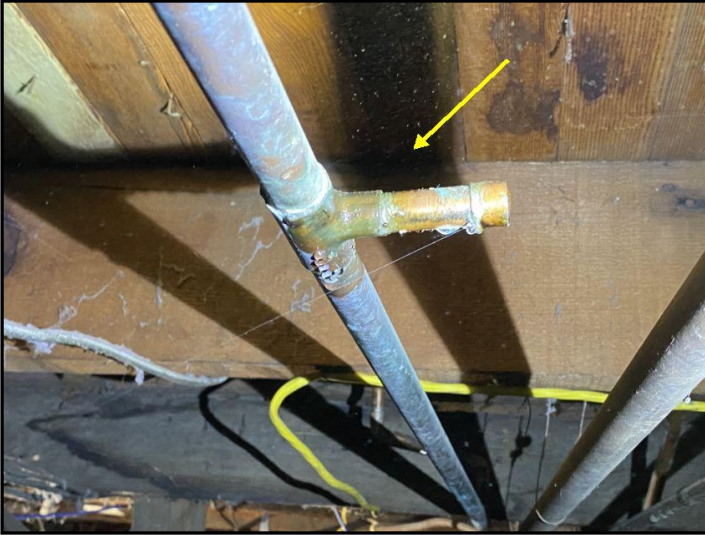
- An active leak was observed from the potable water supply piping beneath the kitchen/bathroom area at the time of the inspection. Active water leaks can result in water damage to building materials, promote mold growth, and increase water consumption if left uncorrected. It is recommended that a qualified plumbing contractor promptly perform the necessary repairs.

An active leak was observed from the potable water supply piping.

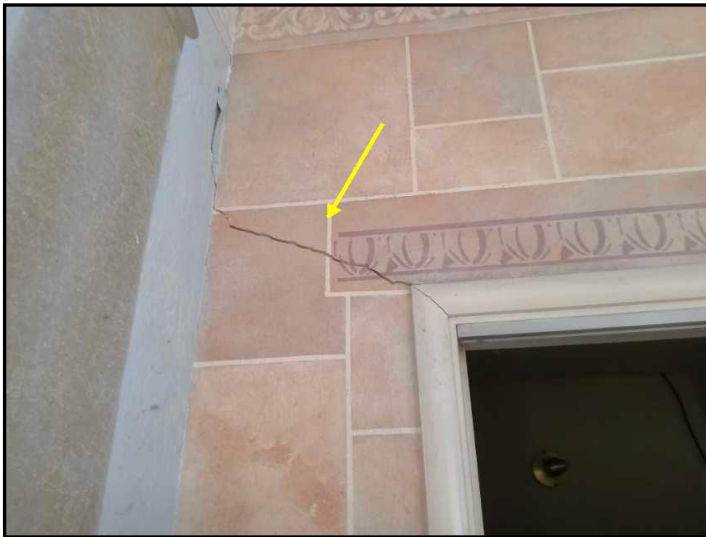
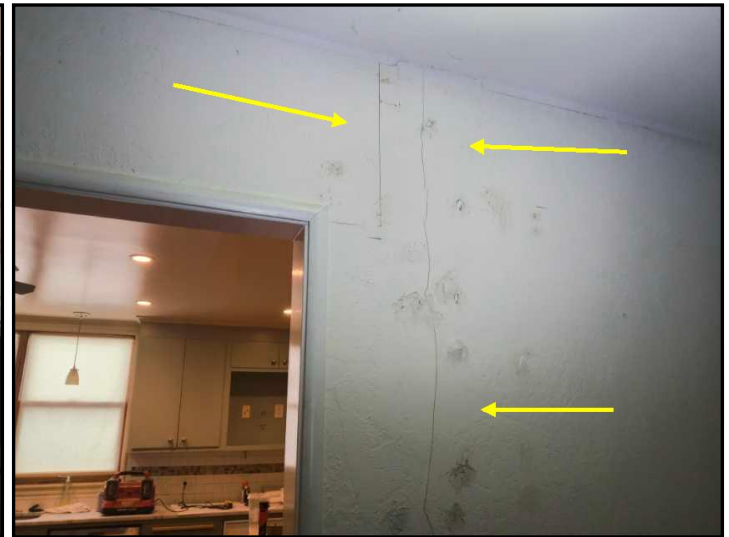
- Minor drywall separation and cracking were observed at the walls, primarily along the joints between adjacent drywall sheets and near framed openings or transitions. This condition is relatively common in older homes and is often associated with normal long-term settlement, framing movement, and seasonal expansion and contraction.

Minor drywall separation and cracking were observed at the walls.

The observed cracking appeared cosmetic at the time of the inspection. It is advisable to repair the affected finishes as needed and monitor the areas for additional movement. If the cracks widen, repeatedly reopen after repair, or are accompanied by other signs of structural movement, further evaluation by a qualified structural engineer is recommended.

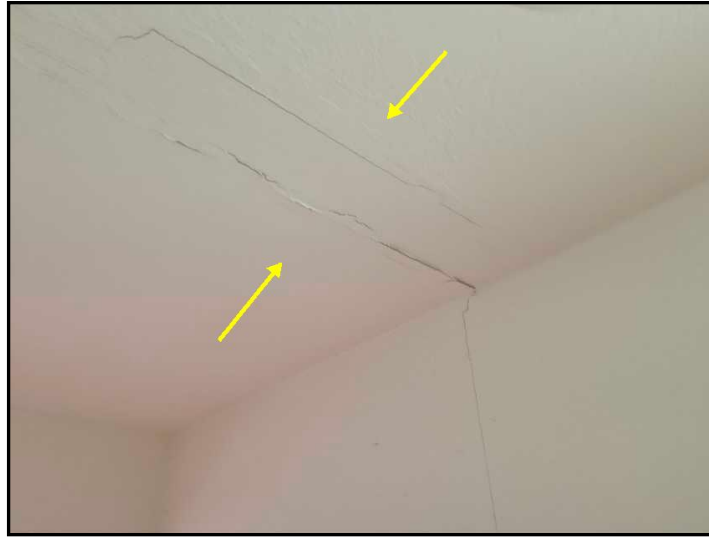
- Minor drywall separation and cracking were observed at the ceiling, primarily along the joints between adjacent drywall sheets. This condition is relatively common in older homes and is often associated with normal long-term settlement, framing movement, and seasonal expansion and contraction.

Minor drywall separation and cracking were observed at the ceiling.

The observed cracking appeared cosmetic at the time of the inspection. It is advisable to repair the affected finishes as needed and monitor the areas for additional movement. If the cracks widen, repeatedly reopen after repair, or are accompanied by other signs of structural movement, further evaluation is recommended.
