# ROOF INSPECTION REPORT

**TK Contracting & Consulting Inc.**

**0000 Near Me, Neverland 94000 CA**  
**Inspection Prepared For: Smith Sam**  
**Agent: Not Applicable -**

**Date of Inspection: 9/24/2026**

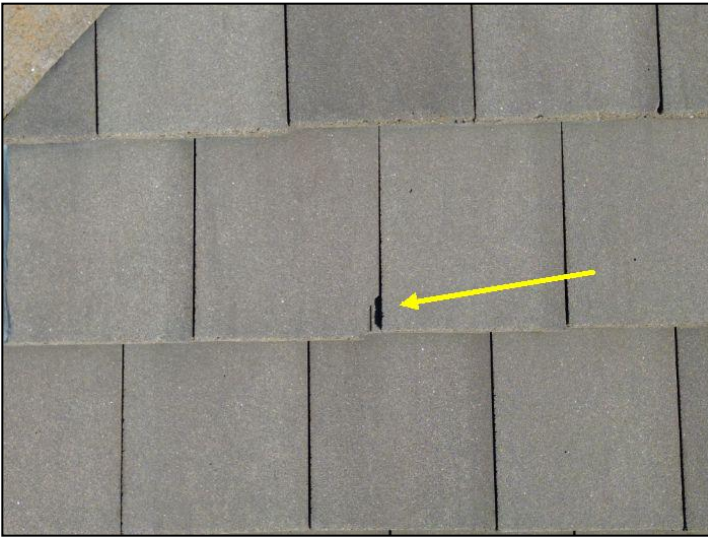
There may be the occasional cracked or chipped tiles.

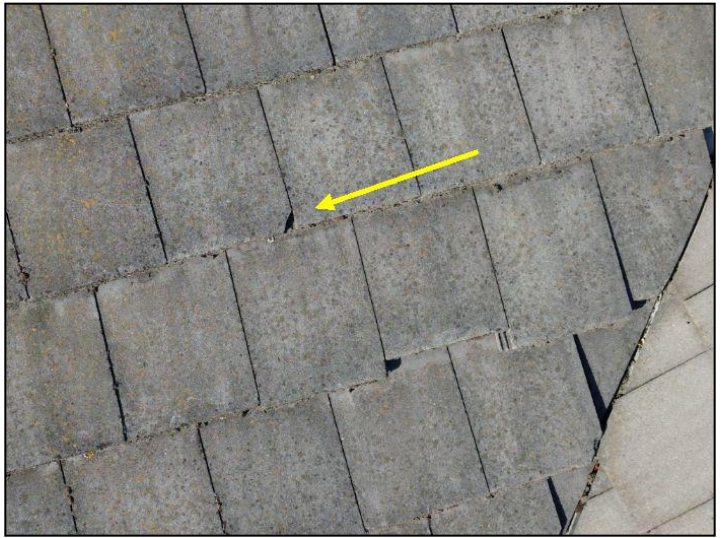
There may be the occasional cracked or chipped tiles

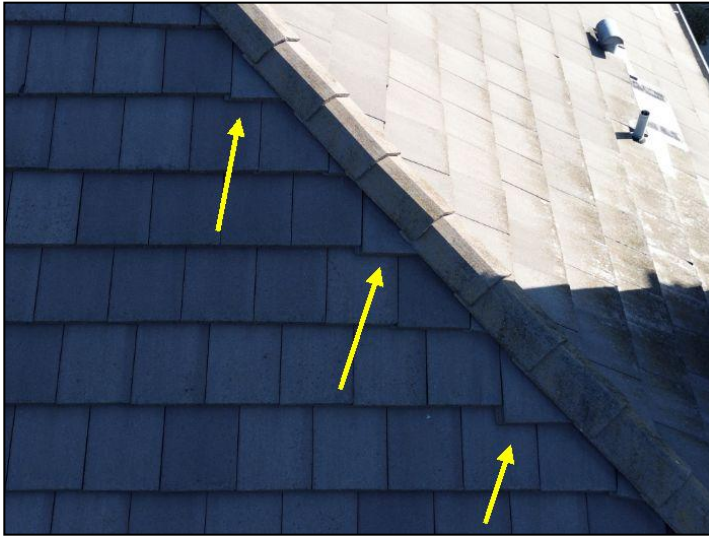
- **SLIPPED TILES:** Some roof tiles, particularly near the **valley flashing**, were loose, displaced, or had slipped from their intended positions. Although this condition is not uncommon near roof **valley**s, it may expose the underlayment and other roofing components, increasing the potential for moisture intrusion and premature deterioration. Have a qualified roofing contractor properly reposition and secure the affected tiles before the rainy season and evaluate the surrounding roof areas for additional deficiencies.

**SLIPPED TILES:** Some roof tiles were loose, displaced, or had slipped from their intended positions.

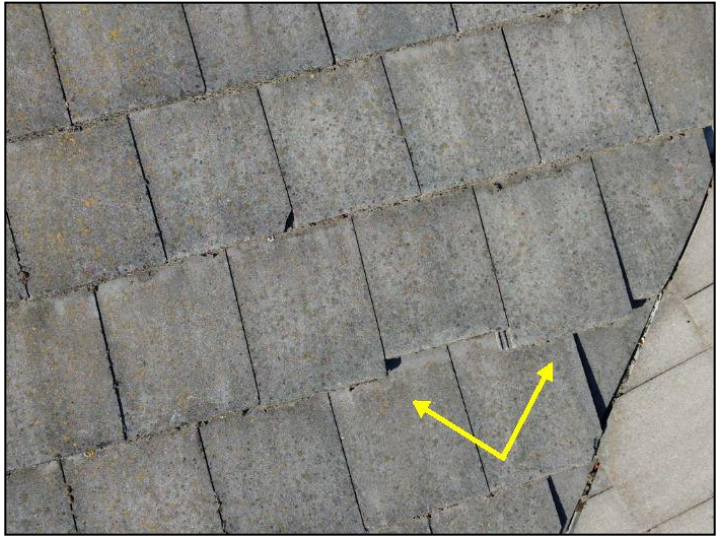
**SLIPPED TILES:** Some roof tiles, particularly near the valley flashing, were loose, displaced, or had slipped from their intended positions.

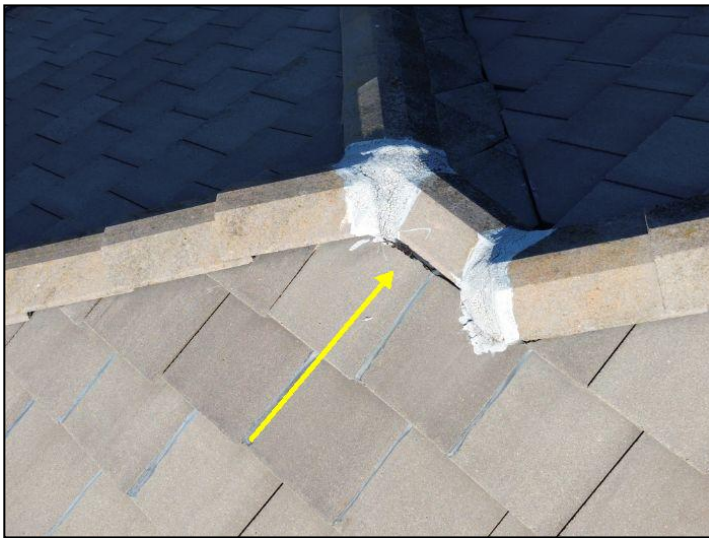
**SLIPPED TILES:** Some roof tiles were loose, displaced, or had slipped from their intended positions.

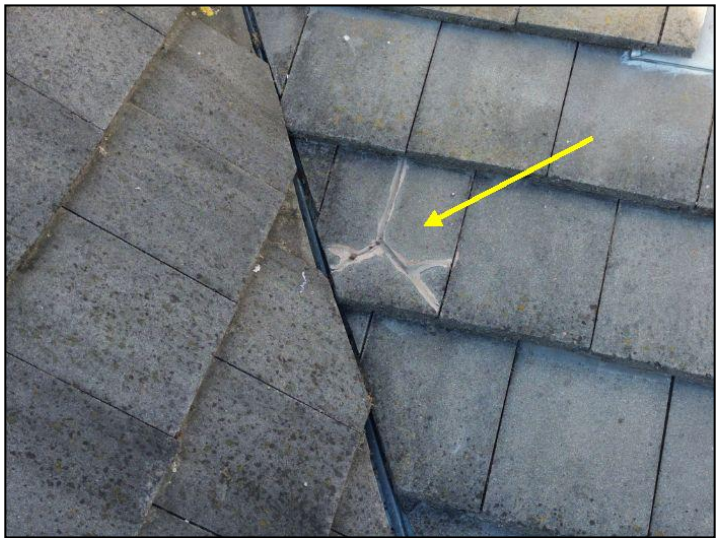
- **CRACKED TILES:** One or more cracked roof tiles were observed. Damaged tiles may expose the underlayment to accelerated weathering and increase the potential for moisture intrusion and deterioration of the underlying roofing components. Have a qualified roofing contractor repair or replace the affected tiles and evaluate the surrounding area for additional damage.

**CRACKED TILES:** One or more cracked roof tiles were observed.

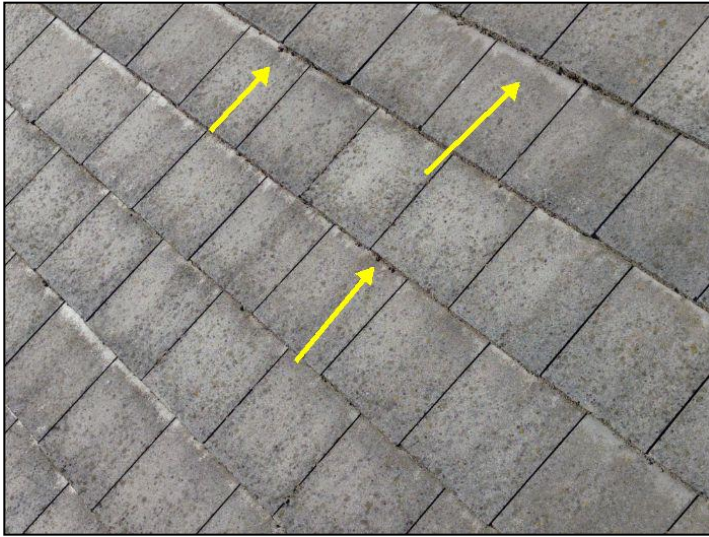
- **ROOF-TILE CLEANING:** Moss growth was observed on the roof tiles. This condition is not uncommon and routine cleaning is part of regular roof maintenance. Have the roof professionally cleaned and treated using methods appropriate for tile roofing to improve drainage and help prevent moss from spreading beneath or displacing the tiles. Avoid pressure washing, which may damage the tiles or underlying roofing components.

**ROOF-TILE CLEANING:** Moss growth was observed on the roof tiles.

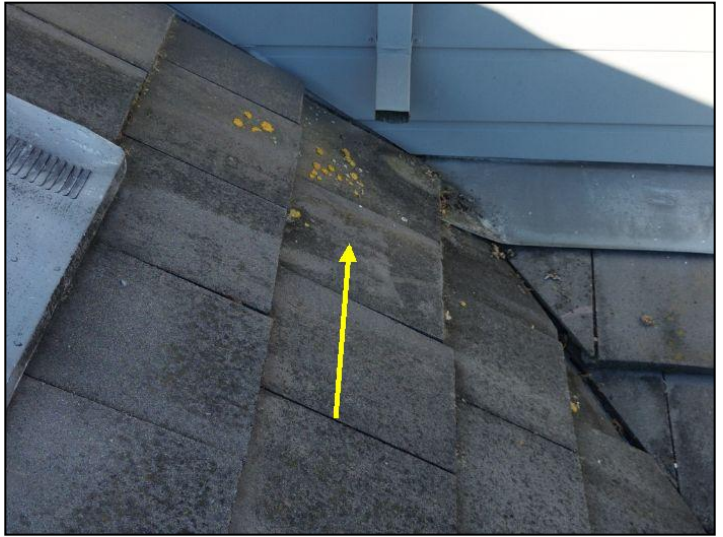
**ROOF-TILE CLEANING:** Moss growth was observed on the roof tiles.

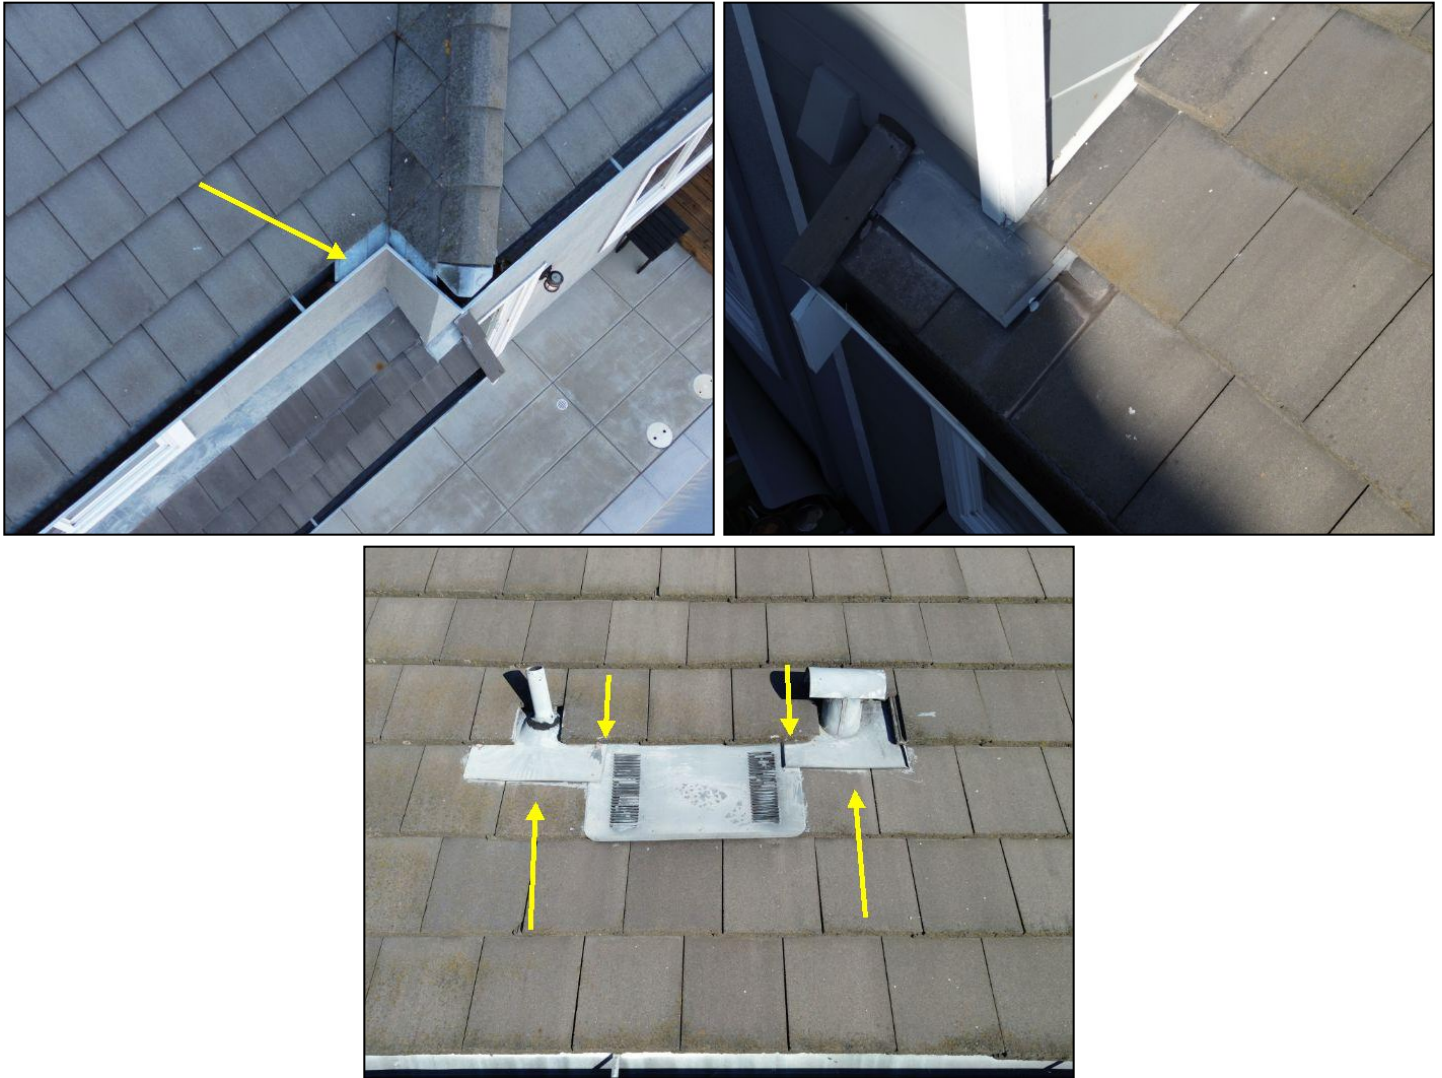
- The visible roof flashing appears to be in satisfactory condition. Flashing is an impervious material (usually galvanized sheet metal) that comes in a variety of shapes and sizes and is used to cover, waterproof, and direct water away from roof penetrations and from intersections between the roof covering and other materials.
- **CROWDED ROOF PENETRATIONS:** Multiple roof penetrations and attic vents were installed too close together, resulting in overlapping or improperly integrated flashings. This configuration may prevent proper water-shedding and increase the potential for moisture intrusion and concealed deterioration. Have a qualified roofing contractor evaluate the penetrations and reconfigure or properly integrate the flashings to provide a durable, watertight installation.

**CROWDED ROOF PENETRATIONS:** Multiple roof penetrations and attic vents were installed too close together, resulting in overlapping or improperly integrated flashings.
