# MOLD INSPECTION REPORT

**Tina Kirkpatrick NACHI24041526**  
**TK Contracting & Consulting Inc.**

**0000 Near me**  
**Inspection Prepared For: Smith Sam**  
**Agent: Not Applicable -**

**Date of Inspection: 6/23/2026**  
**Year Built: 1941 Size: 1952**

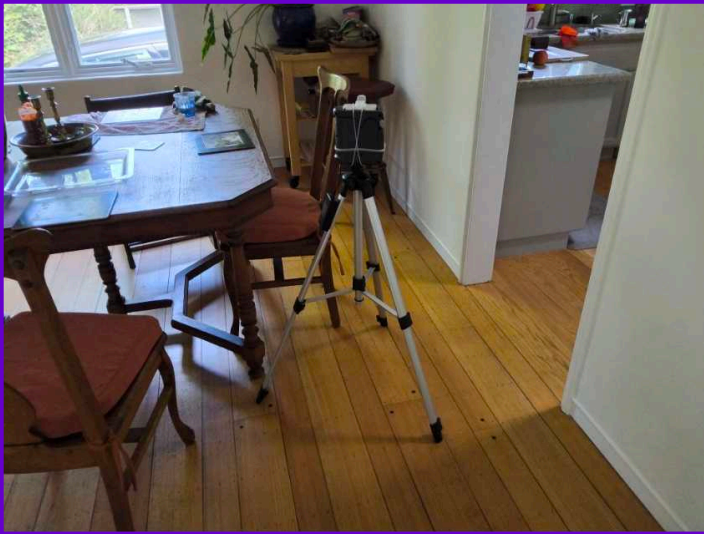
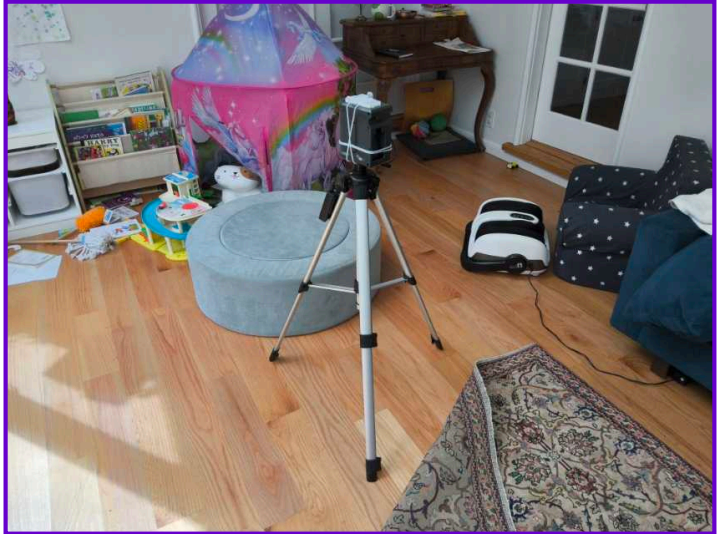
Your inspector took air samples with **Air Trap XL cassettes** inside.

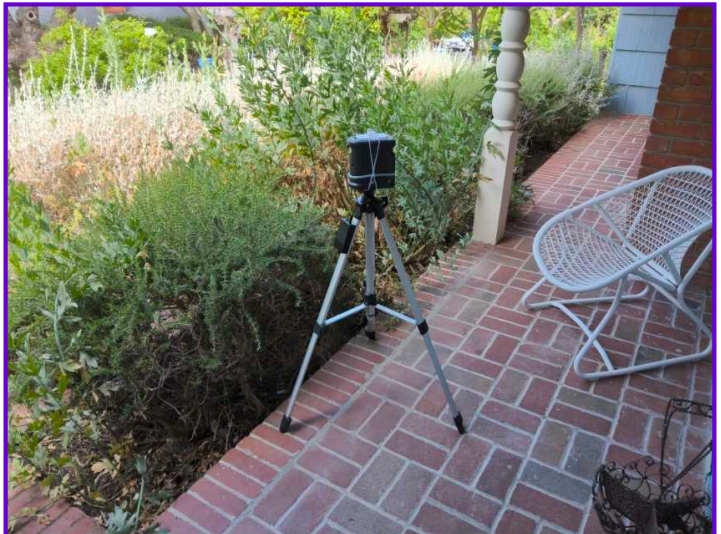
Your inspector took air samples with **Air Trap XL cassettes** outside.

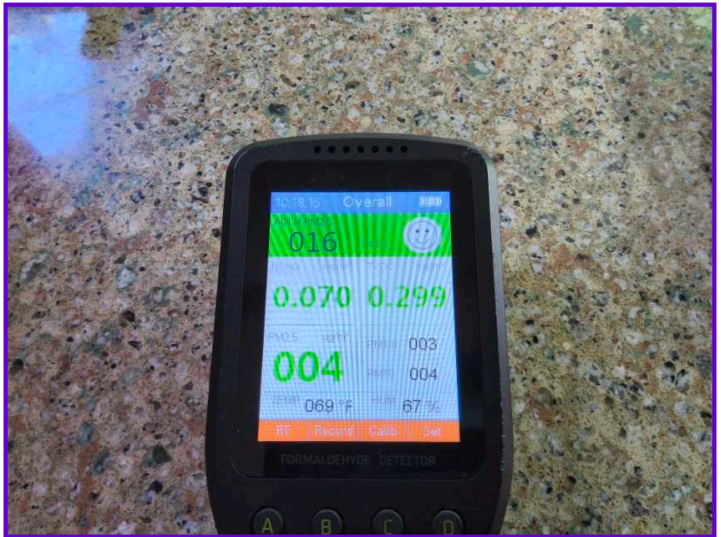
Health Parameter: The air quality was excellent and healthy.

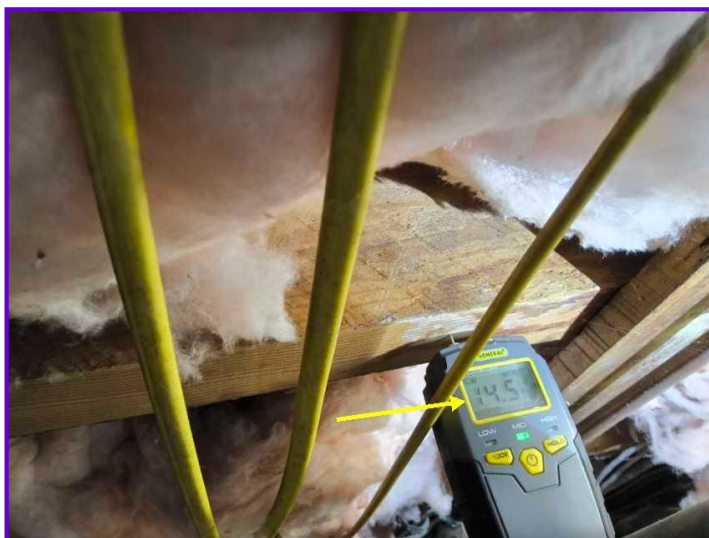
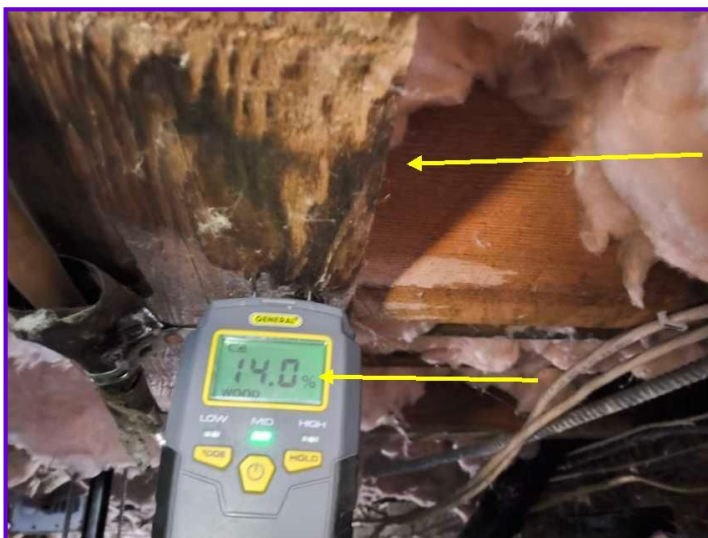
• Moisture meter readings indicated slightly elevated moisture levels consistent with the leak observed under the dishwasher. No visible biological growth was observed at the time of inspection; however, continued moisture conditions may contribute to mold growth if not properly addressed. Recommend correcting the source of moisture and monitoring the affected area for further changes.

Moisture meter readings indicated slightly elevated moisture levels consistent with the leak observed under the dishwasher.

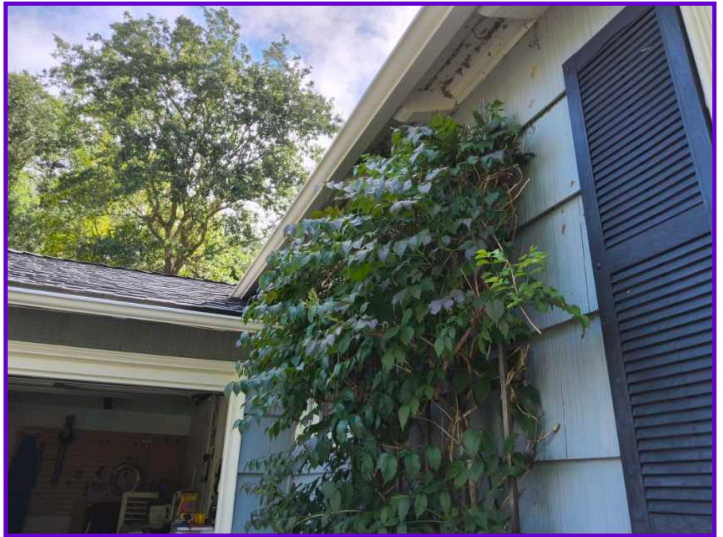
- Foliage was observed growing adjacent to the property. Recommend removal or trimming of vegetation to maintain clearance from the building exterior and help prevent potential damage to wall coverings, moisture accumulation, and deterioration of exterior components.

Foliage was observed growing adjacent to the property.

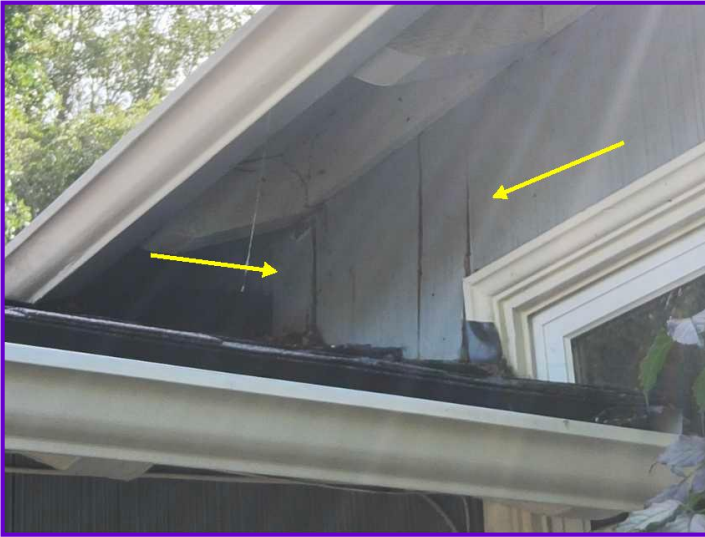
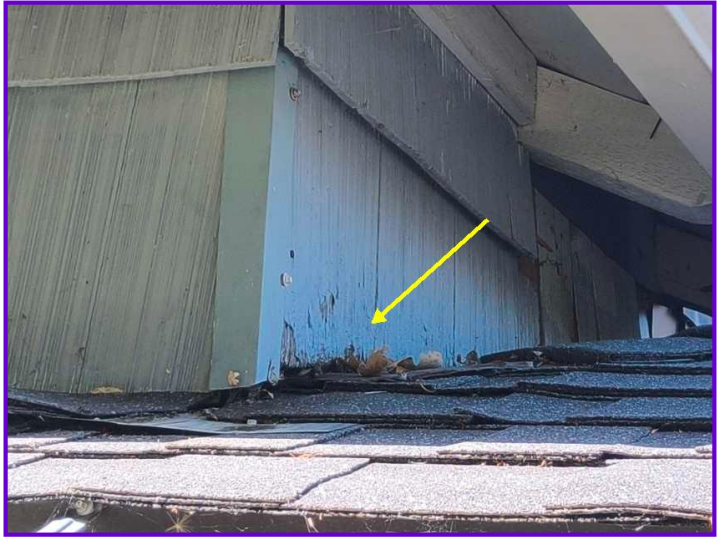
- Gaps or openings were observed in the wall coverings. Recommend repairing and sealing all openings to help maintain a watertight exterior, reduce the potential for moisture intrusion, and prevent possible pest entry.

Gaps or openings were observed in the wall coverings.

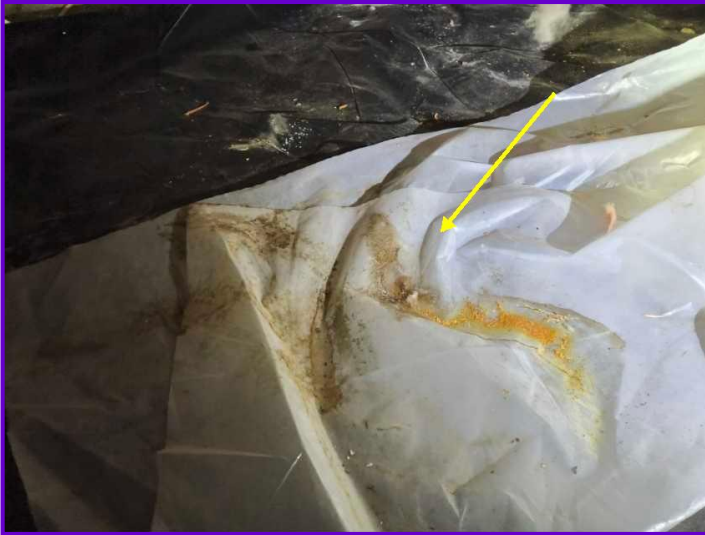
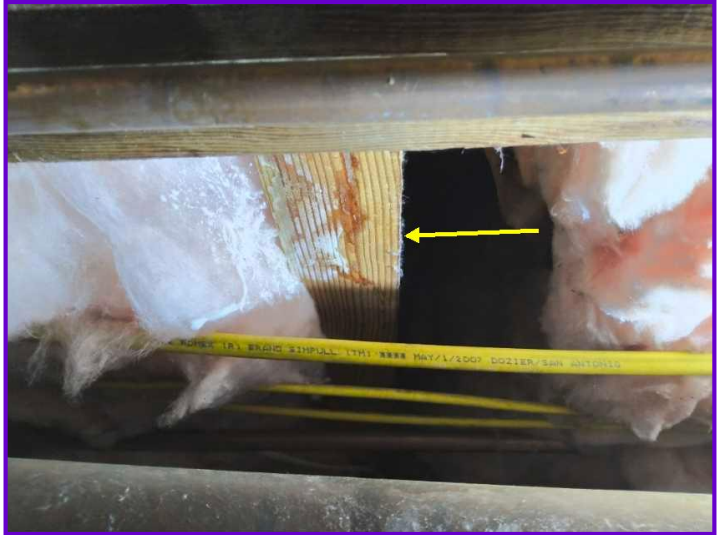
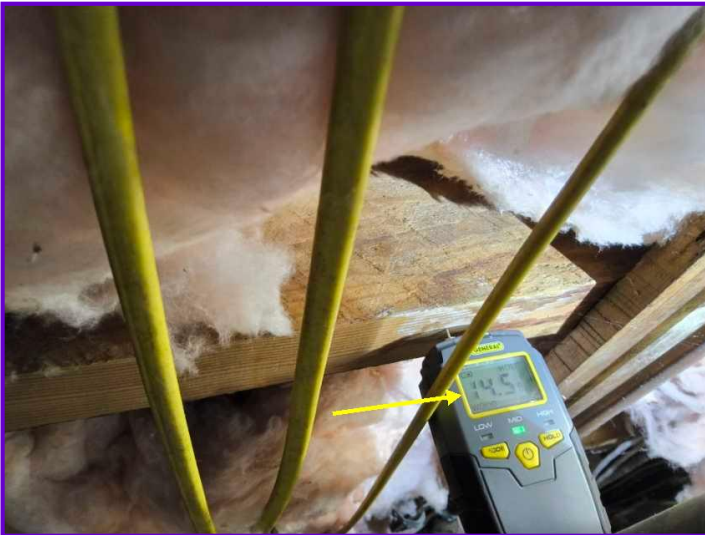
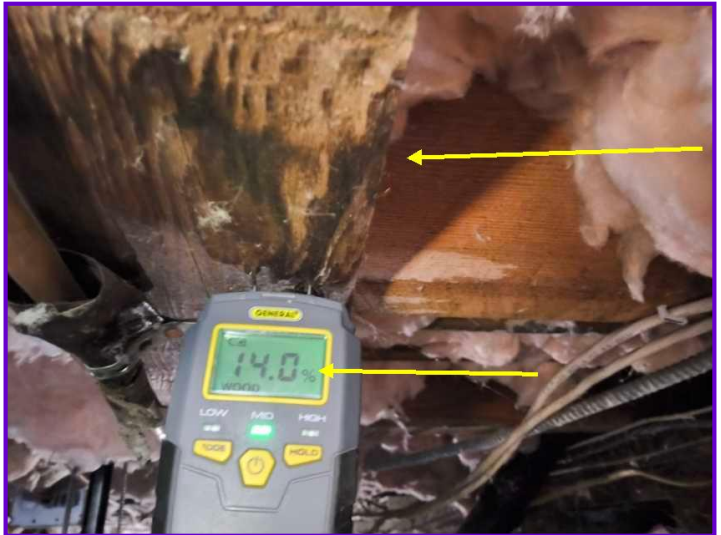
- Water staining was observed on the subfloor beneath the kitchen area, indicating possible past or ongoing moisture intrusion or leakage. Recommend identifying and correcting the source of moisture and evaluating the affected area for potential damage. Elevated moisture conditions can contribute to the growth of mold and fungi, which may affect indoor environmental conditions if not properly addressed.

Water staining was observed on the subfloor beneath the kitchen area.

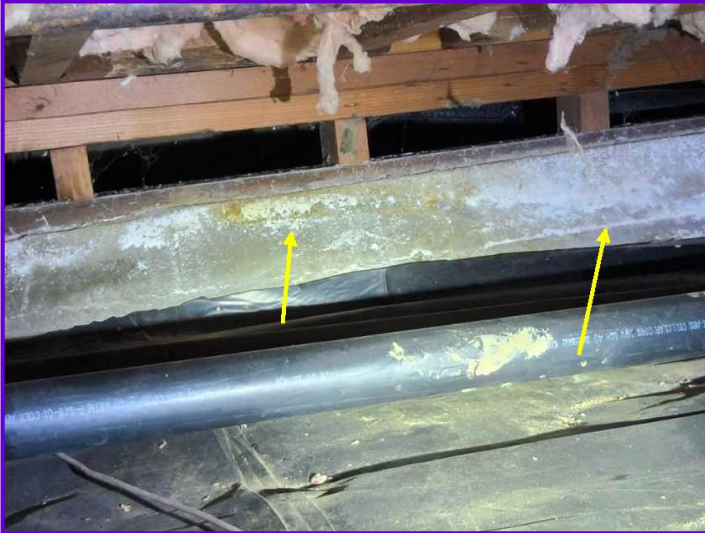
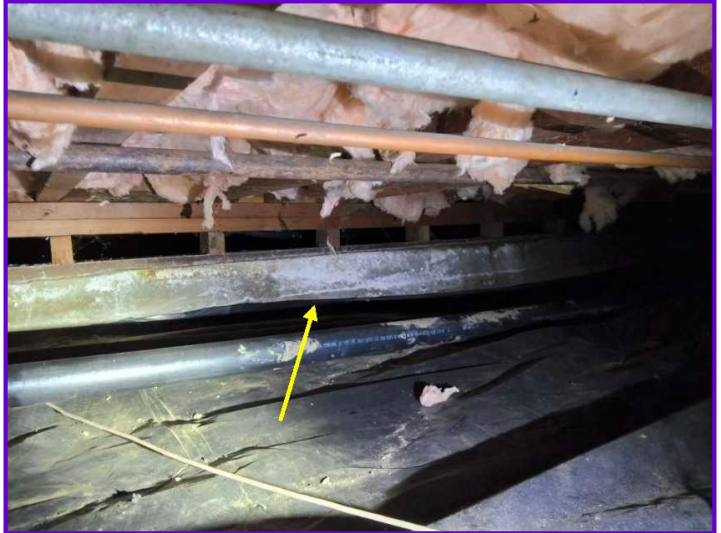
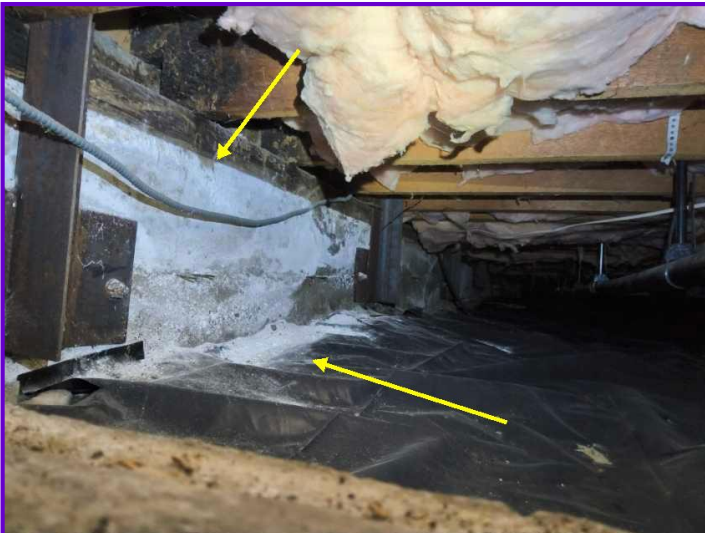
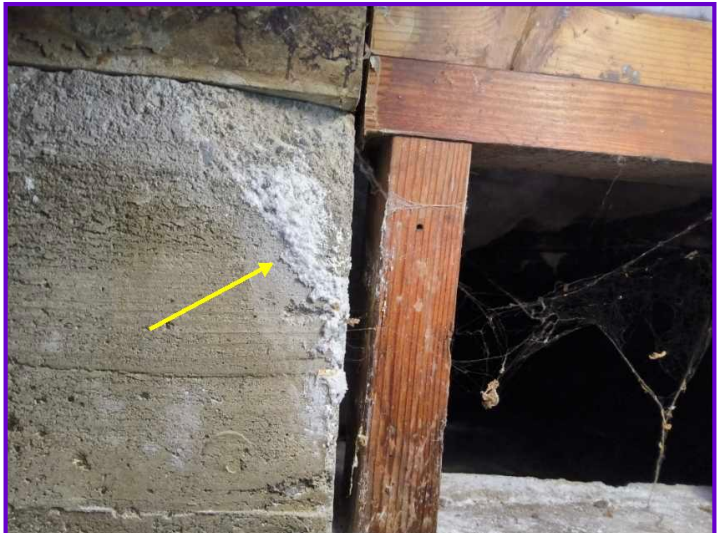
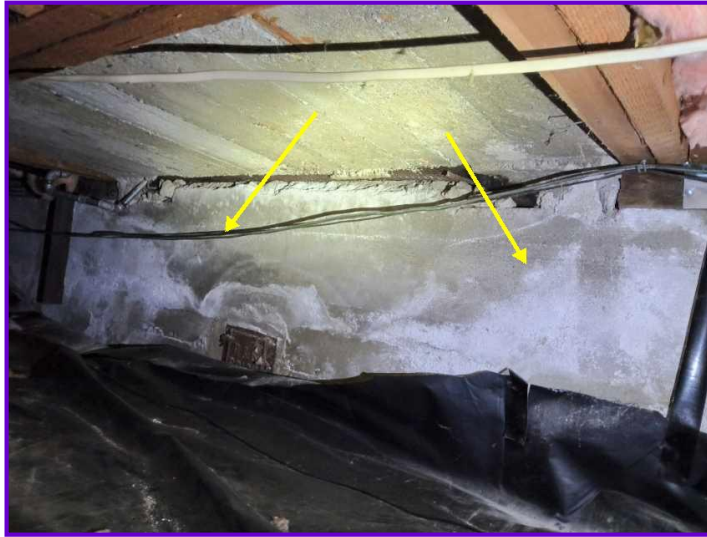
- Efflorescence was observed at the concrete raised foundation walls. This condition is typically associated with moisture movement through concrete materials and may indicate elevated moisture conditions or inadequate exterior water management. Recommend evaluation of potential contributing factors, including site grading, drainage, and surface water control. Excessive moisture exposure may contribute to deterioration of foundation materials and create conditions conducive to mold or fungal growth. Further evaluation by an appropriately qualified specialist is recommended to determine the source of moisture and appropriate corrective measures.

Efflorescence was observed at the concrete raised foundation walls.

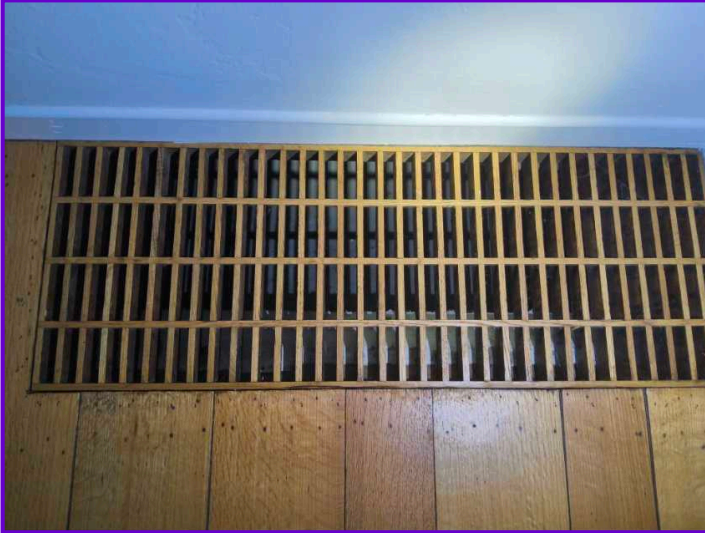
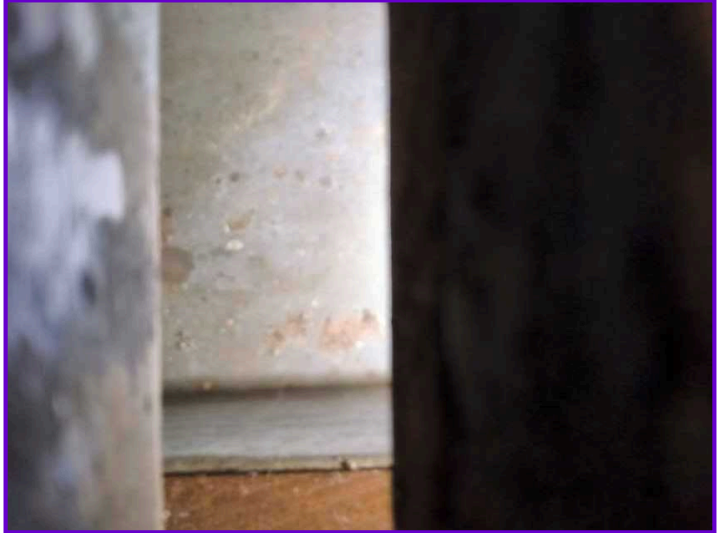
- The return air compartment in the living room was relatively clean at the time of inspection. Regular cleaning and maintenance are recommended to help maintain proper indoor air quality, support HVAC system performance, and reduce the accumulation of dust and debris.

The return air compartment in the living room was relatively clean at the time of inspection.

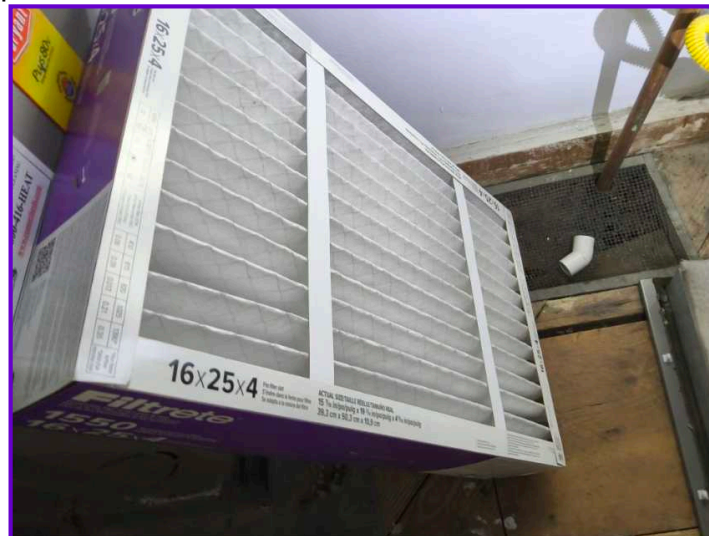
- The air filter was relatively clean. At the time of the inspection the filter did not need replacement.
- Depending on filter type, it is important to replace or clean the filter every two or three months. If filters are not changed or cleaned regularly, the ducts can become contaminated which can be expensive to clean or replace.

The air filter was relatively clean. At the time of the inspection the filter did not need replacement.

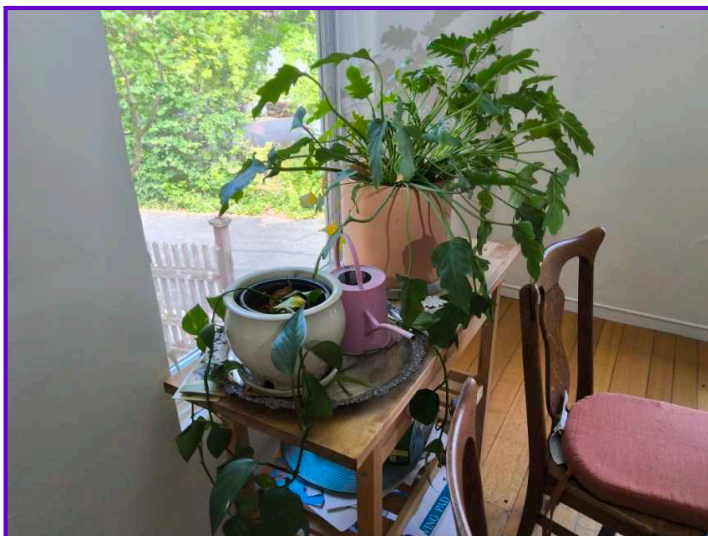
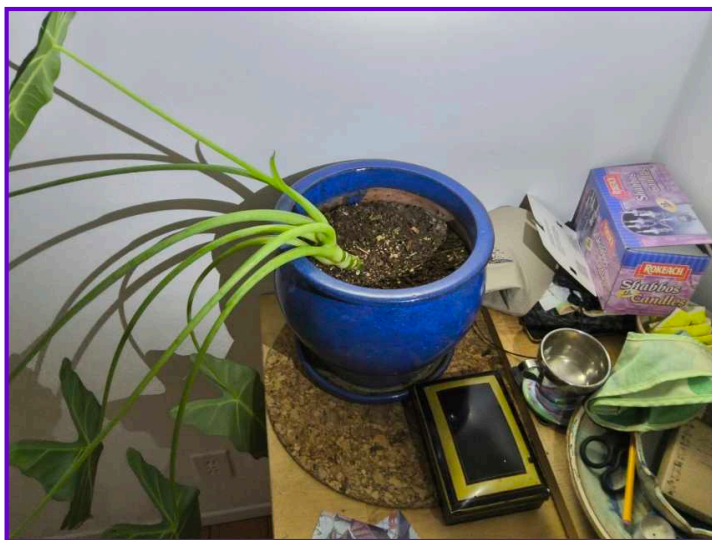
- Indoor plants were observed within the property. Soil and organic materials associated with indoor planters may naturally contain mold spores and can potentially influence indoor air sampling results. The presence of indoor plants should be considered as a possible contributing factor when interpreting mold test findings.

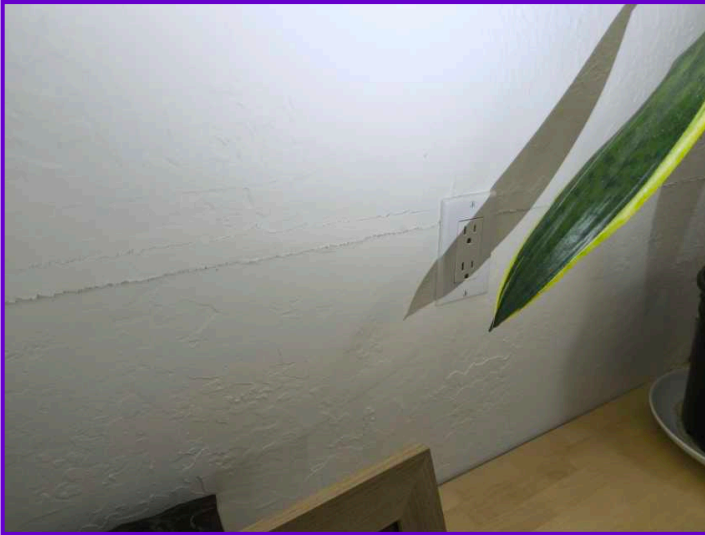
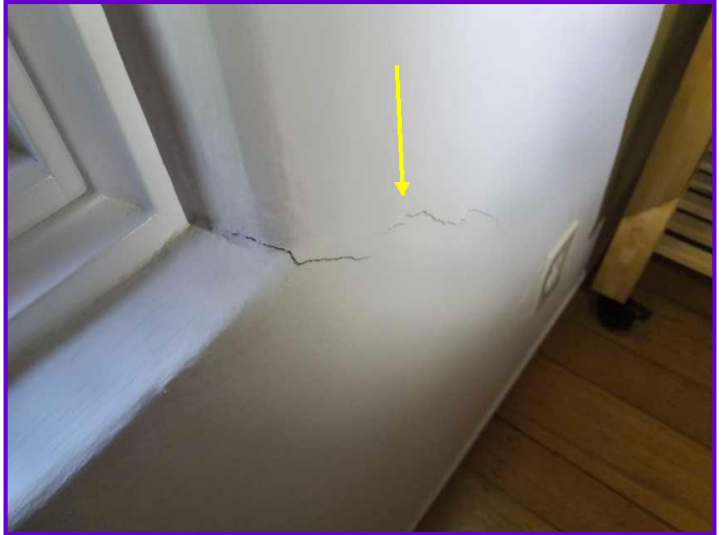
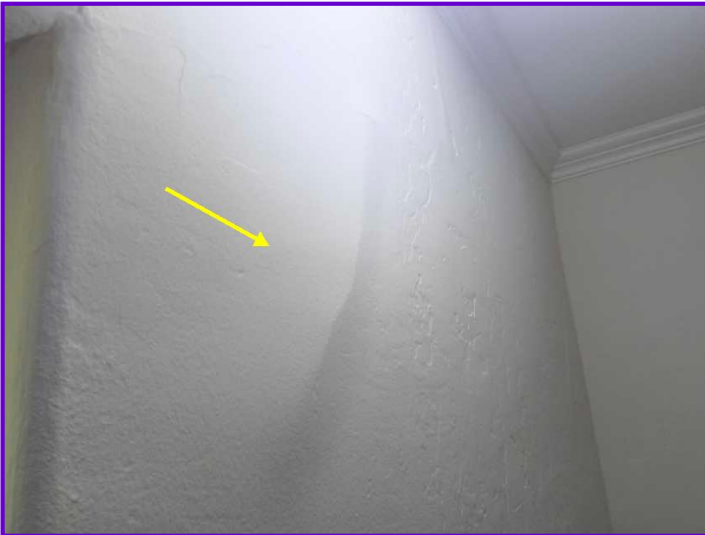
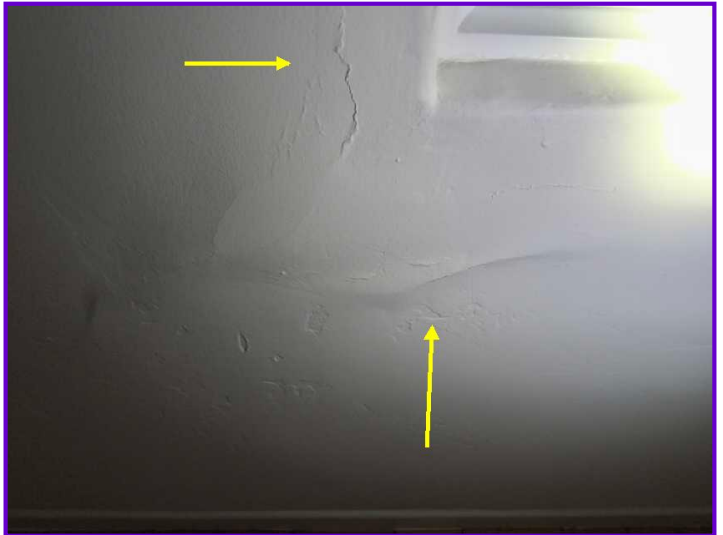
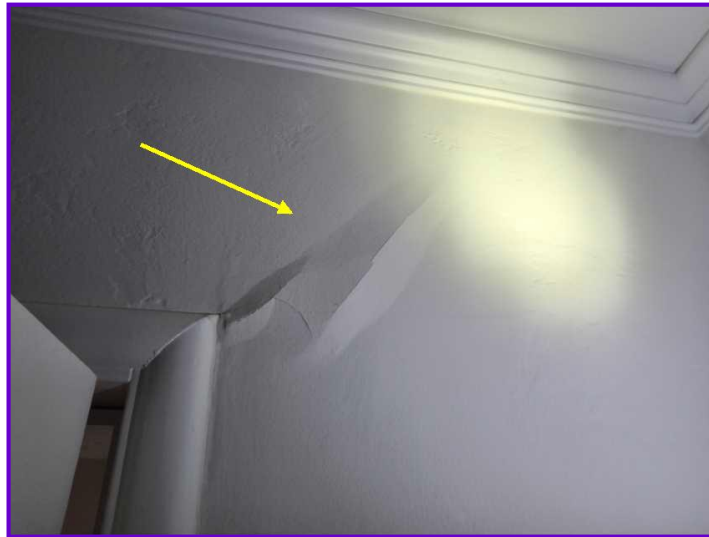
- Minor cracks and bubbling in the wall finish were observed; these conditions may or may not be associated with moisture intrusion. Due to the dry season conditions at the time of inspection and the absence of active weather conditions that could contribute to water intrusion, the presence of moisture-related damage could not be determined. Recommend monitoring the area and further evaluation if signs of moisture, staining, deterioration, or changes are observed.

Minor cracks and bubbling in the wall finish were observed.

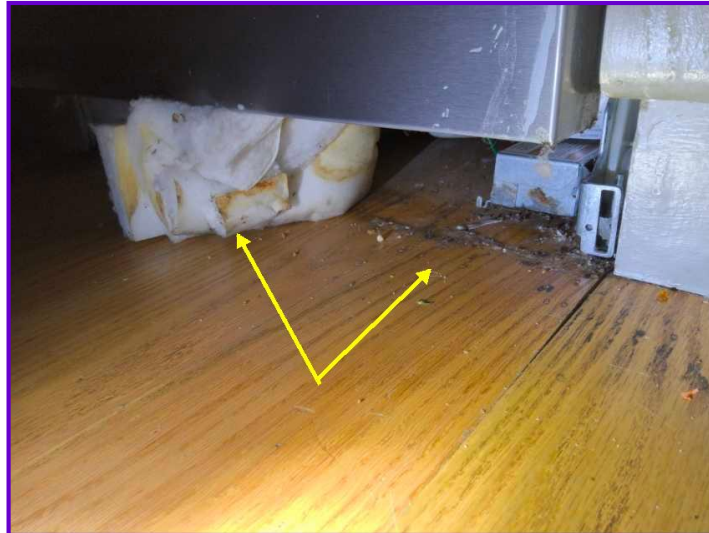
- A minor leak was observed beneath the dishwasher; recommend repair of the source and evaluation of the affected area for potential moisture damage or conditions conducive to mold growth.

A minor leak was observed beneath the dishwasher.
