# POOL & SPA INSPECTION REPORT

**0000 Near Me, Neverland 94000 CA**  
**Inspection Prepared For: Smith Sam**  
**Agent: Not Applicable -**

**Date of Inspection: 9/24/2026**  
**Age: 23 Size: 2274**  
**NACHI24041526 - CLSB #1158251**

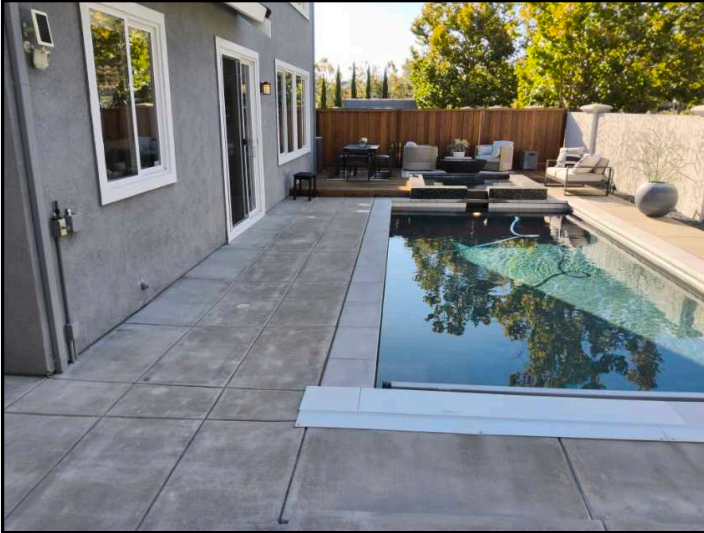
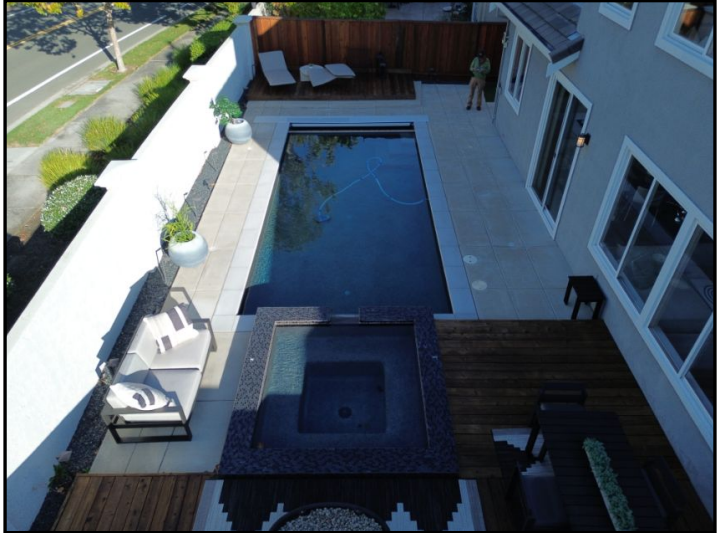
- **LOCATION:** The property has a pool at the rear of the property.

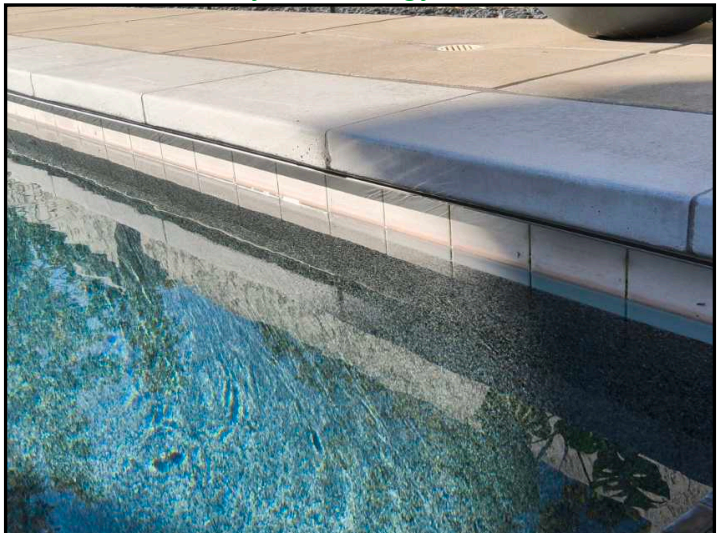
- The pool appeared to be reasonably level at the time of the inspection, as indicated by the generally consistent waterline along the perimeter tiles.
- **RECTANGULAR:** The pool is a rectangular-shaped pool type. This type is best shape for lap swimming and water games, as the straight lines create an uninterrupted swimming lane. A classic, timeless shape with clean, modern lines that fits well in most backyards, especially alongside contemporary architecture. Rectangular shape are the most efficient to maintain and are compatible with automatic pool covers, which are excellent for safety and energy conservation.

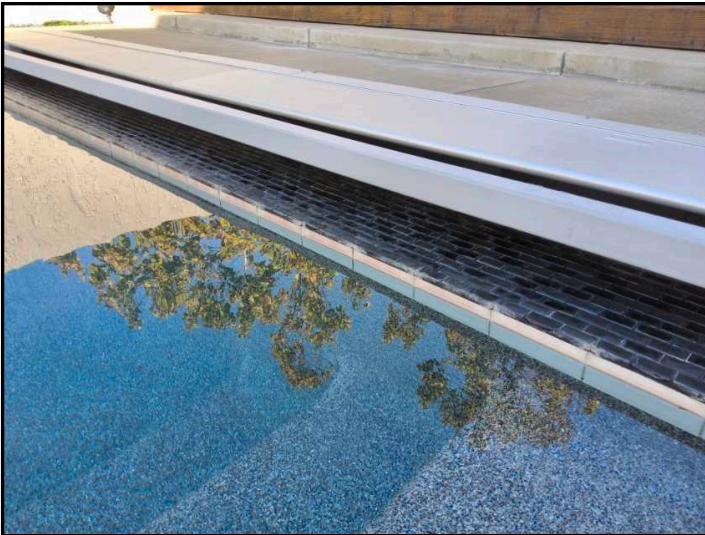
- The pool and spa waterline tiles appeared functional and in serviceable condition at the time of the inspection.

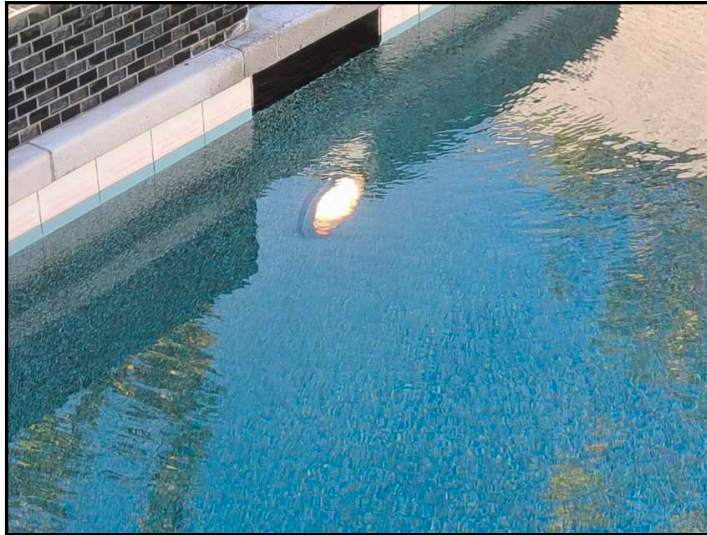
- The pool light operated when tested, and the circuit appeared to be **GFCI**-protected for safety.

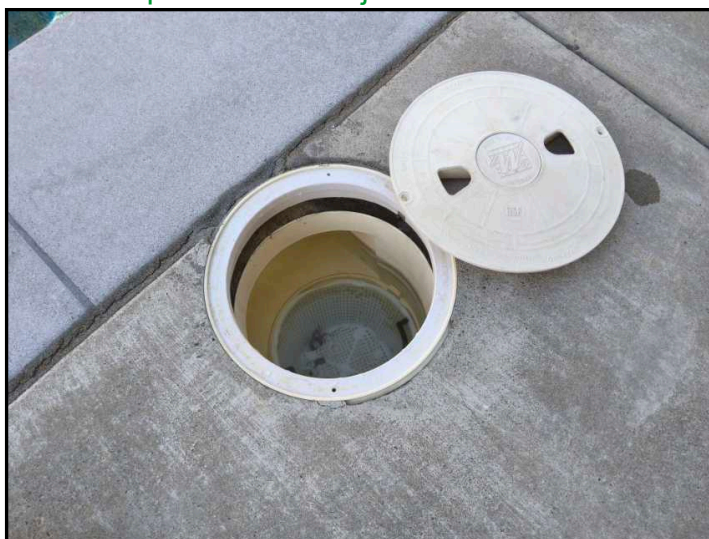
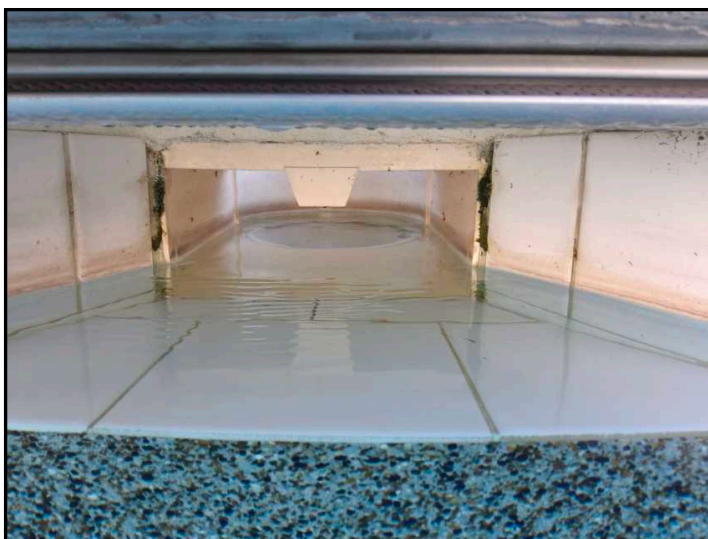
- The pool skimmers and covers appeared functional and in good, serviceable condition at the time of the inspection. No major defects were observed.

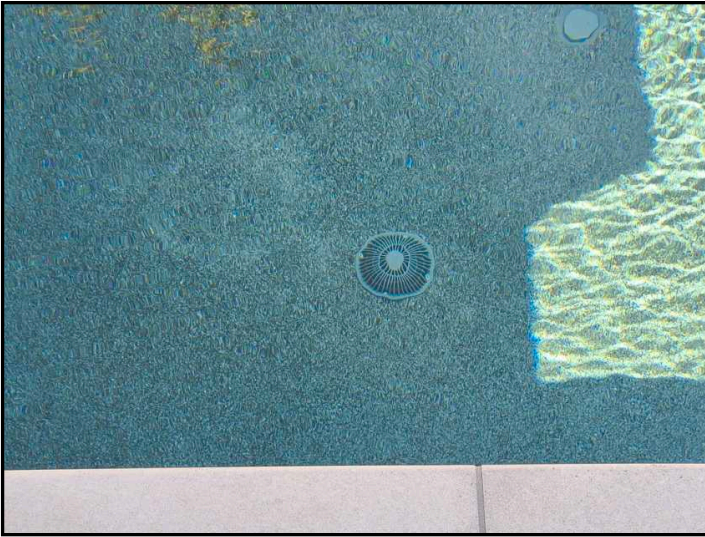
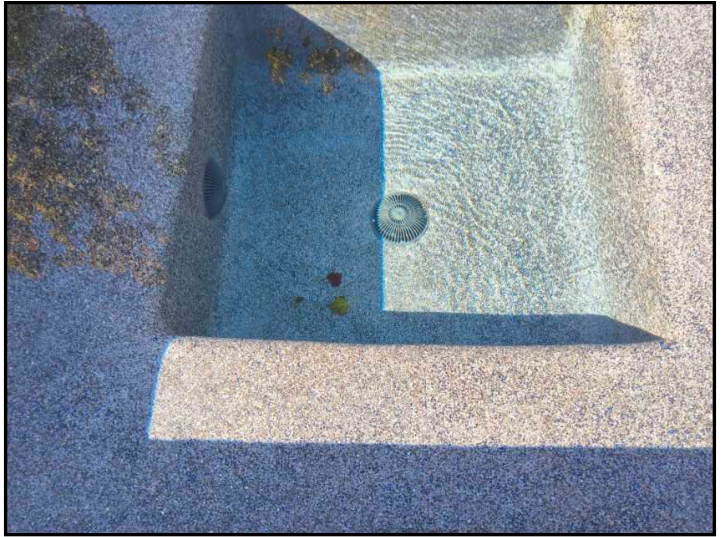
- The visible pool and spa drain covers appeared secure, functional, and consistent with anti-entrapment safety-type covers at the time of the inspection. No major defects were observed.

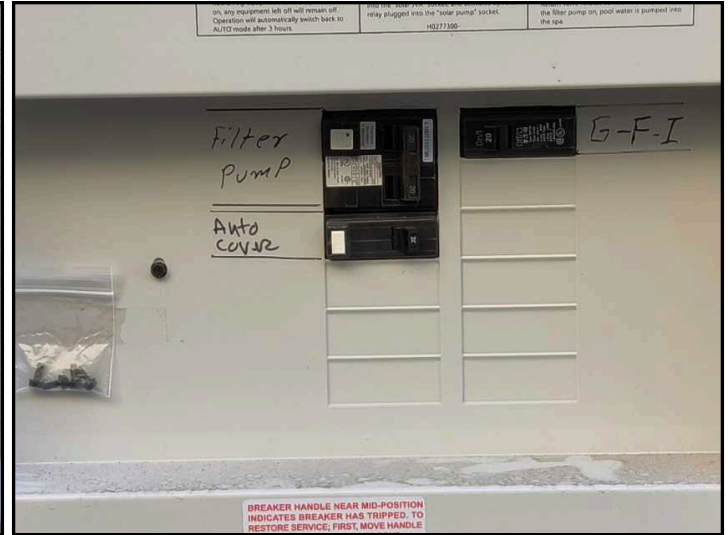
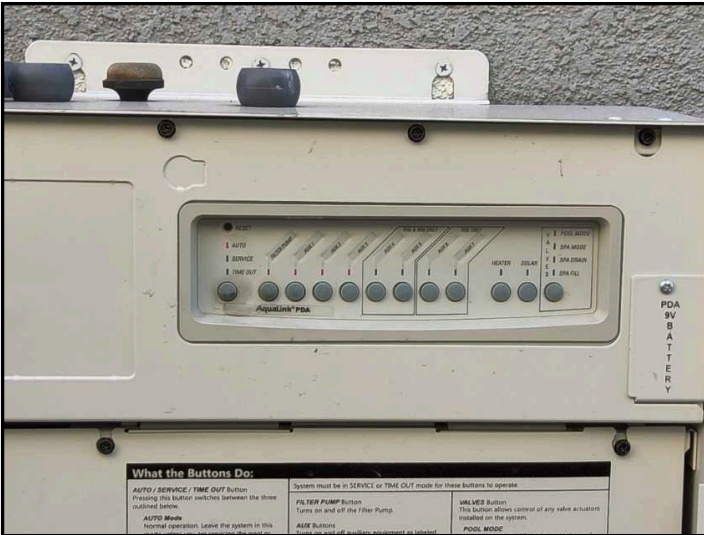
- The pool equipment subpanel appeared to be in satisfactory, serviceable condition at the time of the inspection. No major visible defects were observed.
- **SMART CONTROL:** The pool is operated by a smart control system accessible through an app for both the pool and spa. You may wish to obtain information about the system's operation and details about the app used to control it for ease of use and optimal functionality.

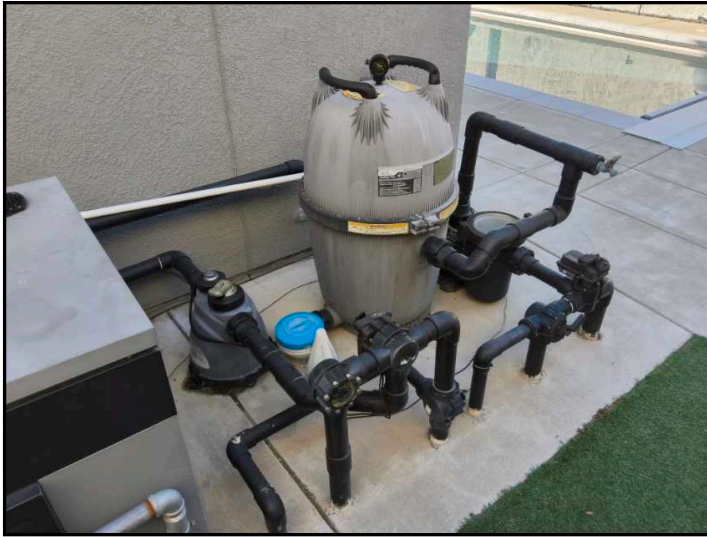
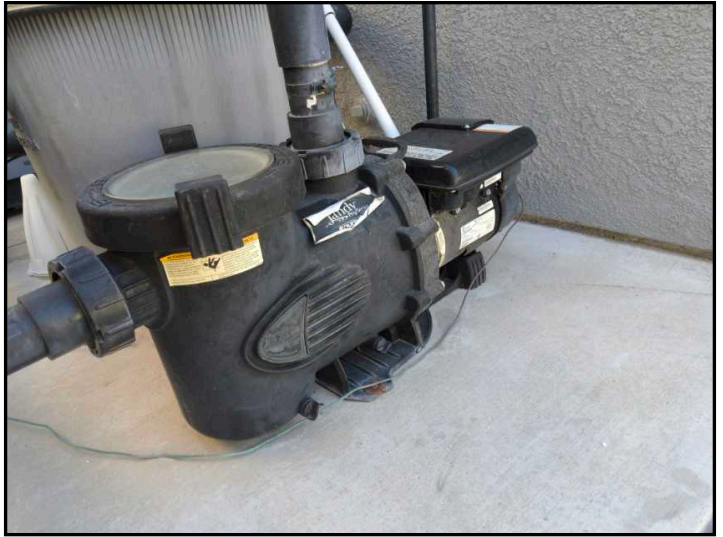
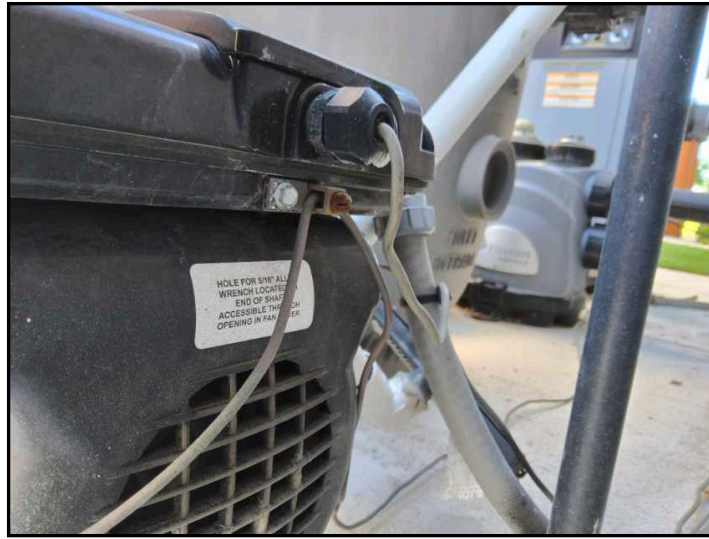
- The pool motors operated when tested and appeared properly bonded for safety. No major defects were observed.
- The pool is operated by a smart control system accessible through an app for both the pool and spa. You may wish to obtain information about the system's operation and details about the app used to control it for ease of use and optimal functionality.

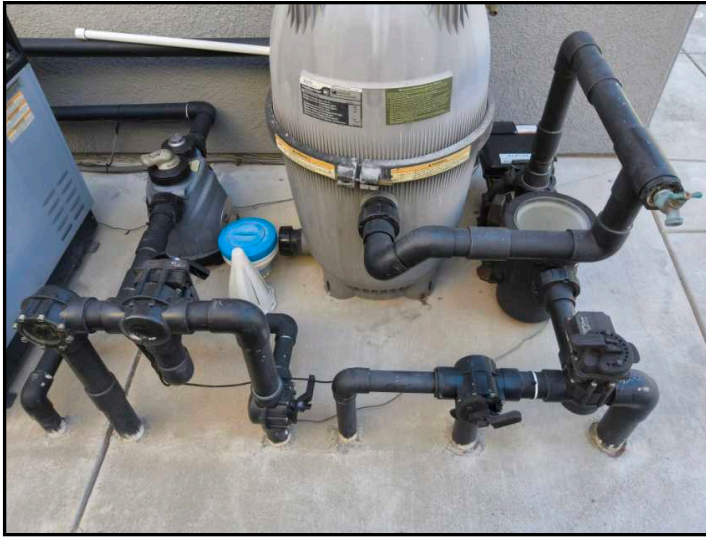
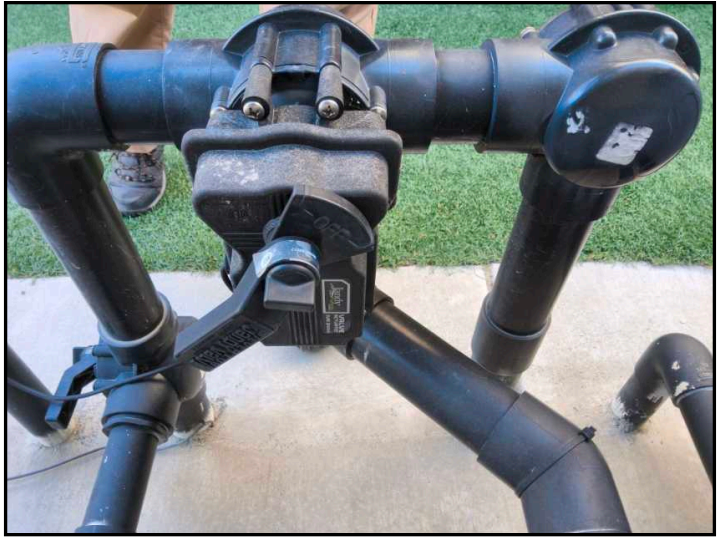
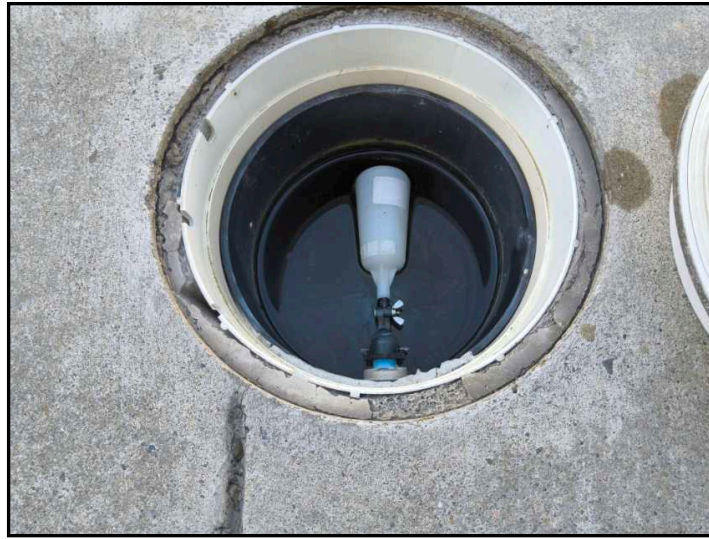
- The visible pool plumbing lines and valves appeared to be functional and reasonably leak free.
- The float activated automatic pool filler valve is functional.

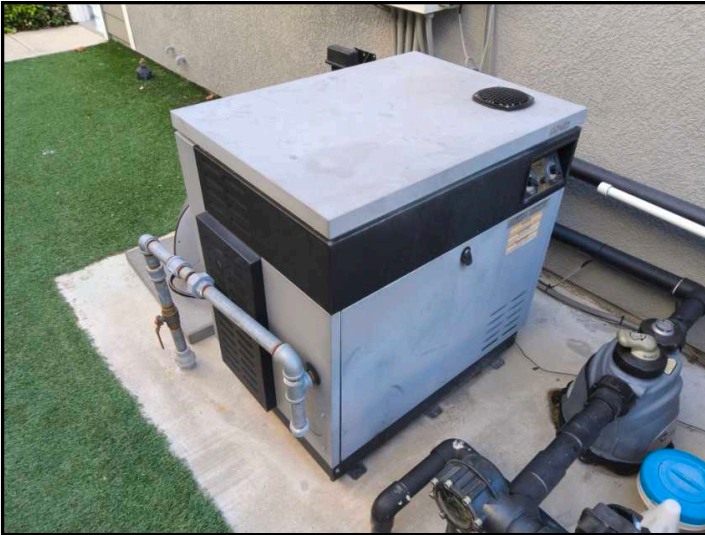
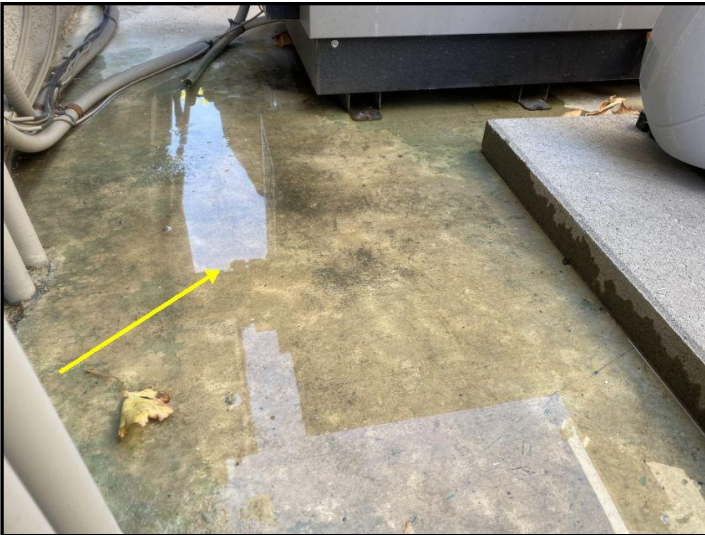
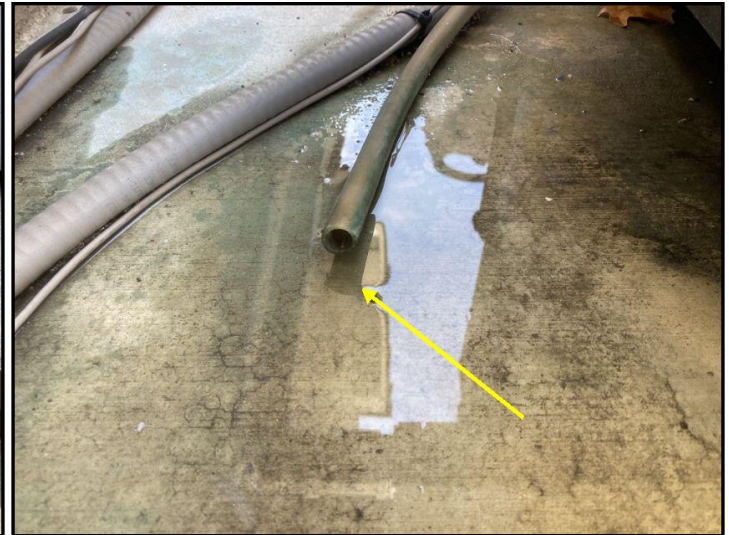
- The pool heater responded to normal user controls at the time of the inspection.
- **WATER DISCHARGE AT POOL HEATER – POSSIBLE CONDENSATION:** Substantial water discharge was observed at the pool heater drain/discharge piping during operation. This condition may be related to normal condensation; however, a plumbing or heater-related leak cannot be ruled out through visual inspection alone. Due to the large amount of water being discharged, redirecting or extending the discharge piping to an appropriate location farther away from the pool equipment and surrounding components may be considered. It is recommended that a qualified pool/heater professional evaluate the condition and provide appropriate recommendations for drainage and continued operation.

**WATER DISCHARGE AT POOL HEATER – POSSIBLE CONDENSATION:** Substantial water discharge was observed at the pool heater drain/discharge piping during operation.

| Page 16 Item: 5 | Heater | <ul style="list-style-type: none"><li>• <b>WATER DISCHARGE AT POOL HEATER – POSSIBLE CONDENSATION:</b> Substantial water discharge was observed at the pool heater drain/discharge piping during operation. This condition may be related to normal condensation; however, a plumbing or heater-related leak cannot be ruled out through visual inspection alone. Due to the large amount of water being discharged, redirecting or extending the discharge piping to an appropriate location farther away from the pool equipment and surrounding components may be considered. It is recommended that a qualified pool/heater professional evaluate the condition and provide appropriate recommendations for drainage and continued operation.</li></ul> |

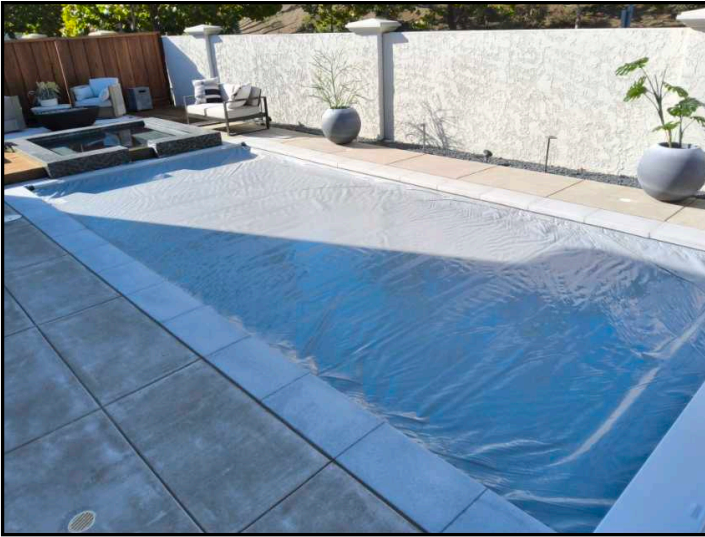
- The electric pool cover responded to normal user controls.

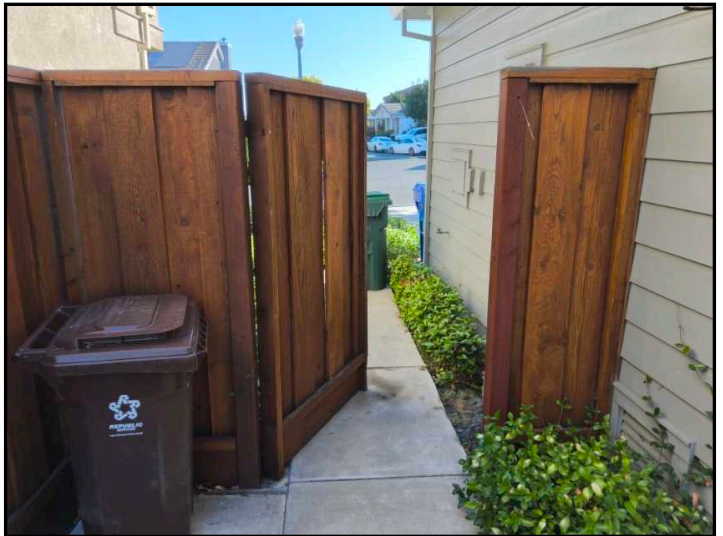
- **POOL GATE SAFETY:** Self-closing and self-latching hardware is present at the gate providing access to the swimming pool; however, the components require adjustment or servicing to operate properly. Have a qualified professional service and test the gate so that it closes and latches automatically and complies with applicable pool-safety requirements. Keep the gate secured and restrict unsupervised pool access until repairs are completed.

- **GARAGE SIDE DOOR – POOL SAFETY:** The garage side door provides direct access to the pool area and did not self-close and latch as intended. A door alarm was also not provided. Since an intervening compliant barrier or gate was not present between the door and the pool area, appropriate safeguards should be provided to help prevent unsupervised access, particularly by children. It is recommended that the door be equipped with self-closing and self-latching hardware, an appropriate door alarm, and a latch positioned at least 54 inches above the floor where applicable. A qualified pool safety professional should make the necessary corrections.

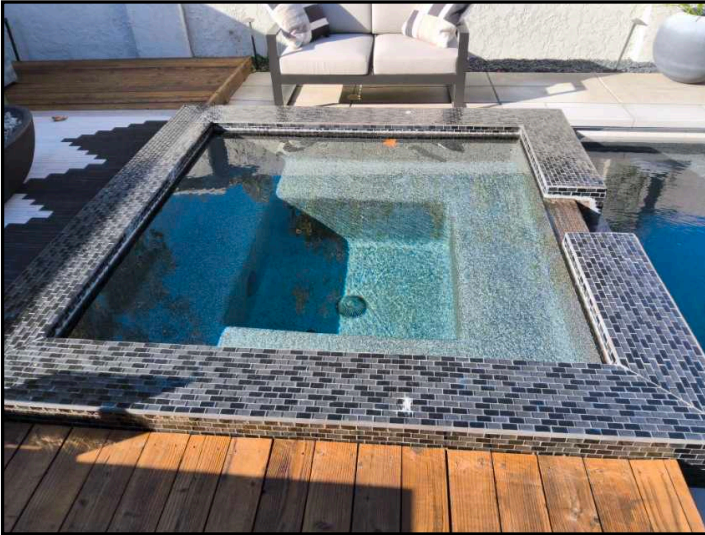
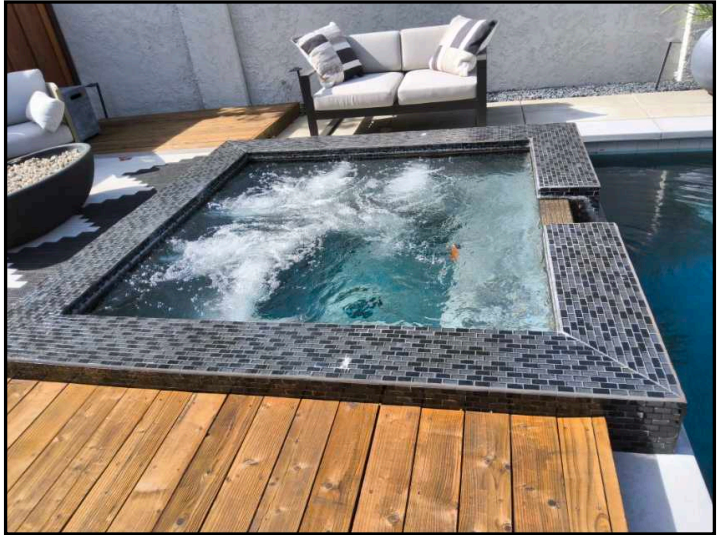
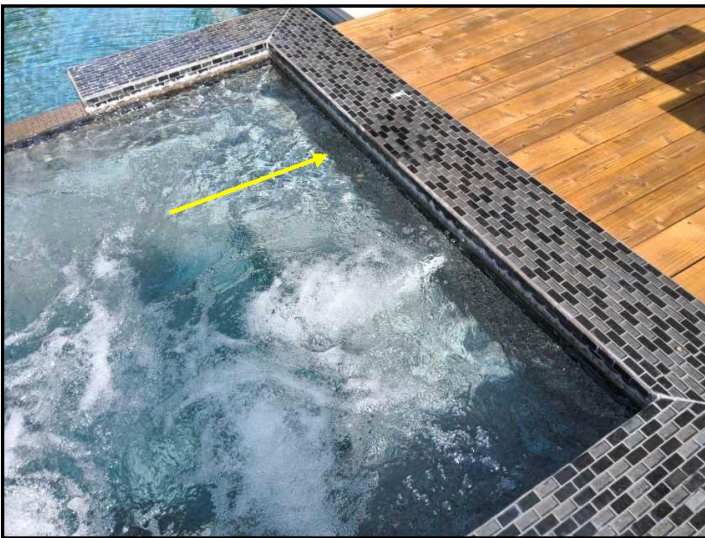
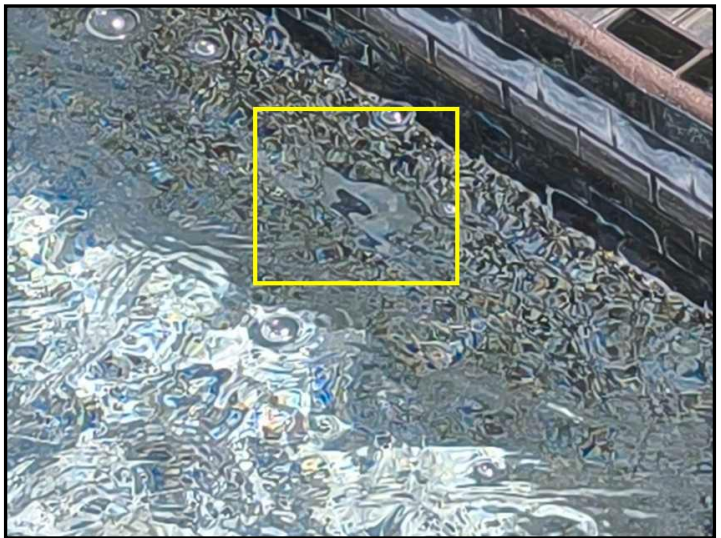
- **SPA JET NOT FUNCTIONING PROPERLY:** One of the spa jets did not operate properly during testing and did not produce the expected bubbling or aeration. This condition may be related to restricted flow, an air-line issue, or another component of the spa circulation system. It is recommended that a qualified pool/spa professional evaluate the affected jet and repair or service the system as necessary.

**SPA JET NOT FUNCTIONING PROPERLY:** One of the spa jets did not operate properly during testing and did not produce the expected bubbling or aeration.

| Safety/Item of Concern | | |
|---|---|---|
| Page 21 Item: 1 | General | <ul style="list-style-type: none"> <li>• <b>SPA JET NOT FUNCTIONING PROPERLY:</b> One of the spa jets did not operate properly during testing and did not produce the expected bubbling or aeration. This condition may be related to restricted flow, an air-line issue, or another component of the spa circulation system. It is recommended that a qualified pool/spa professional evaluate the affected jet and repair or service the system as necessary.</li> </ul> |
