# PROPERTY INSPECTION REPORT

**0000 Near me, Neverland CA 94000**  
**Inspection Prepared For: Smith Sam**  
**Agent: Not Applicable -**

**Date of Inspection: 9/24/2026**  
**Age: 23 - Size: 2274**  
**NACHI24041526 / CLSB #1158251**

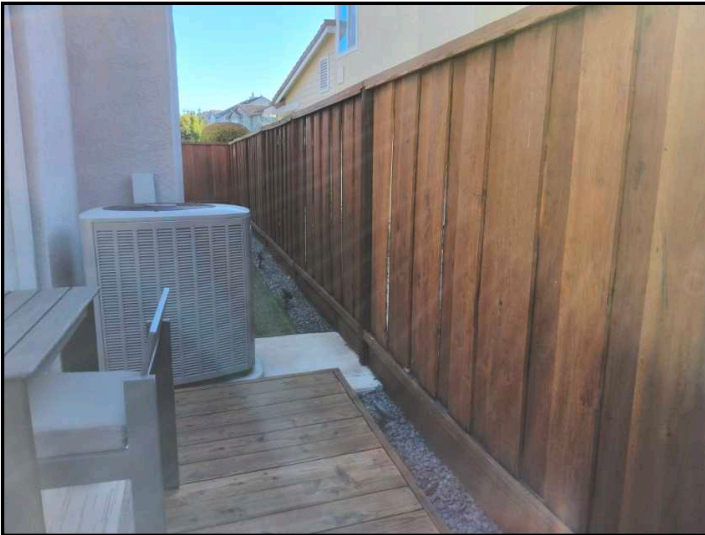
• **LOOSE FENCE COMPONENTS:** Fence posts, panels, boards, or other fencing components were observed to be loose. Continued movement may contribute to progressive deterioration or instability. It is recommended that the affected components be properly secured, repaired, or replaced as necessary.

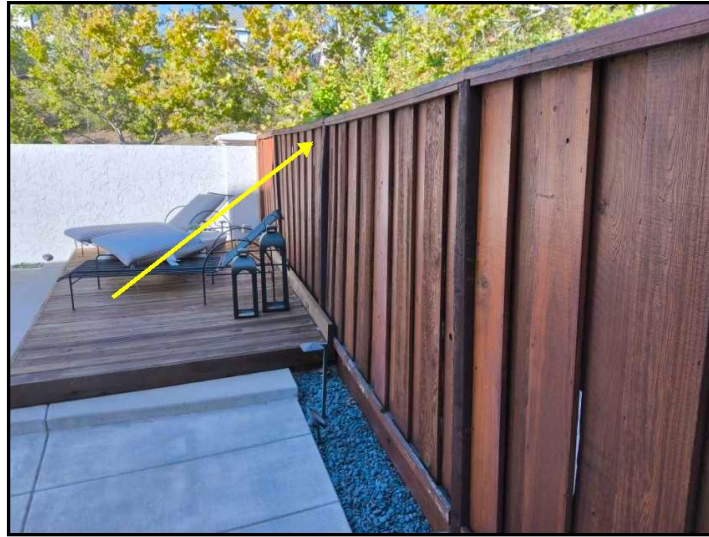
| Page 14 Item: 6 | Fence Condition | <ul style="list-style-type: none"> <li>• <b>LOOSE FENCE COMPONENTS:</b> Fence posts, panels, boards, or other fencing components were observed to be loose. Continued movement may contribute to progressive deterioration or instability. It is recommended that the affected components be properly secured, repaired, or replaced as necessary.</li> </ul> |

**LOOSE FENCE COMPONENTS:** Fence posts, panels, boards, or other fencing components were observed to be loose.

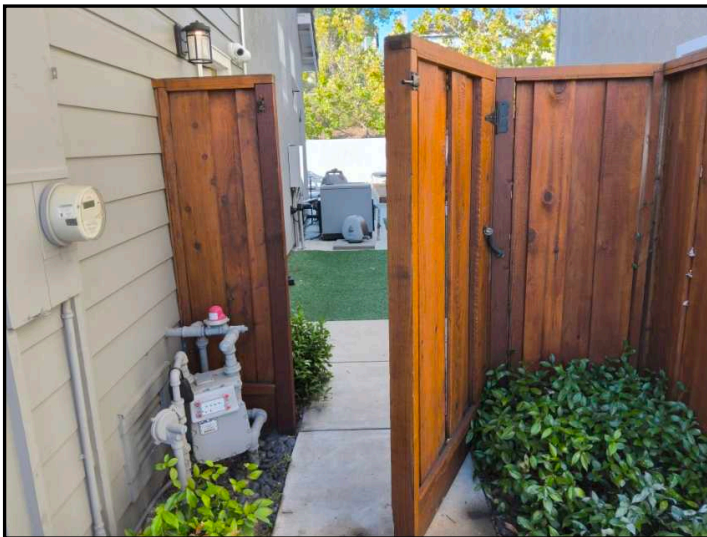
**MINOR SERVICE:** TThe gate at the side of the property exhibited minor operational or maintenance-related deficiencies.

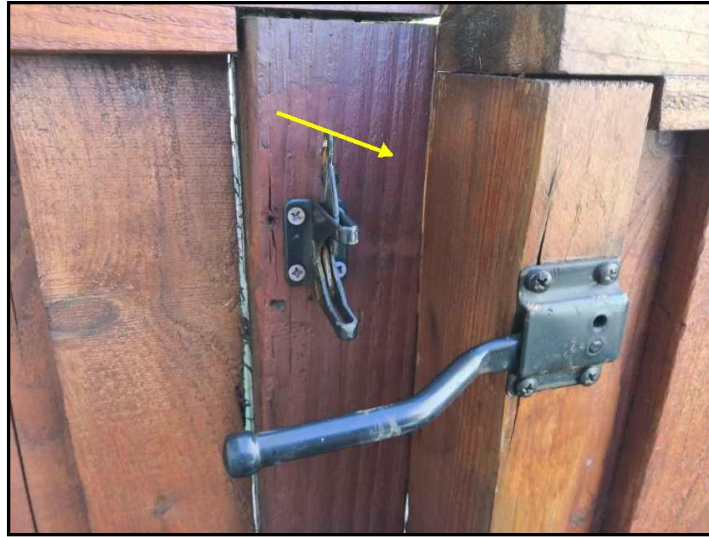
| Page 15 Item: 7 | Gate Condition | <ul style="list-style-type: none"> <li>• <b>MINOR SERVICE:</b> TThe gate at the side of the property exhibited minor operational or maintenance-related deficiencies. It is recommended that the gate be serviced or adjusted as necessary to maintain proper operation and help prevent further deterioration.</li> </ul> |

**MINOR SERVICE:** TThe gate at the side of the property exhibited minor operational or maintenance-related deficiencies.

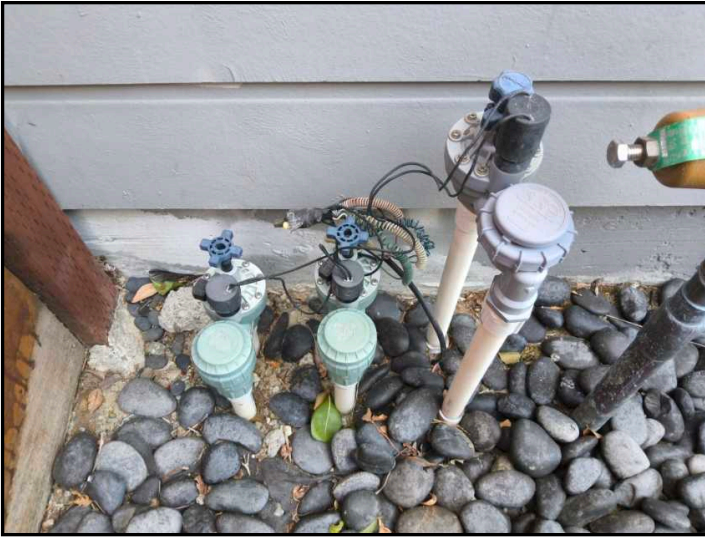
**SPRINKLER / IRRIGATION SYSTEM:** The property is equipped with a landscape sprinkler/irrigation system.

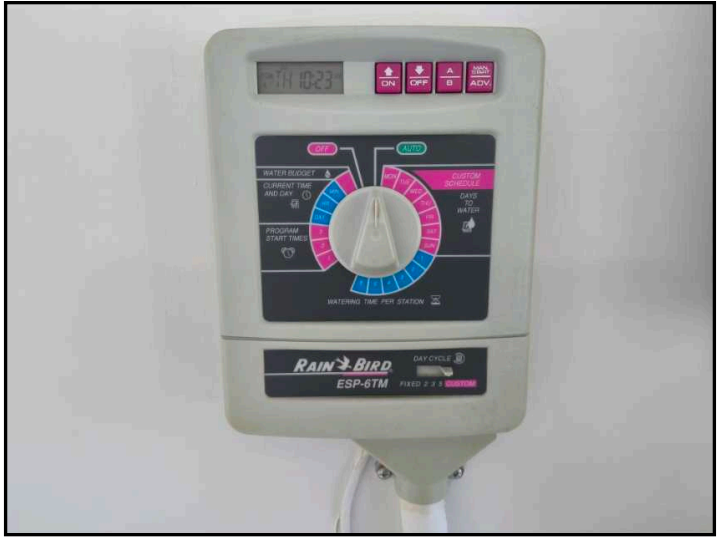
**SPRINKLER / IRRIGATION SYSTEM:** The property is equipped with a landscape sprinkler/irrigation system.

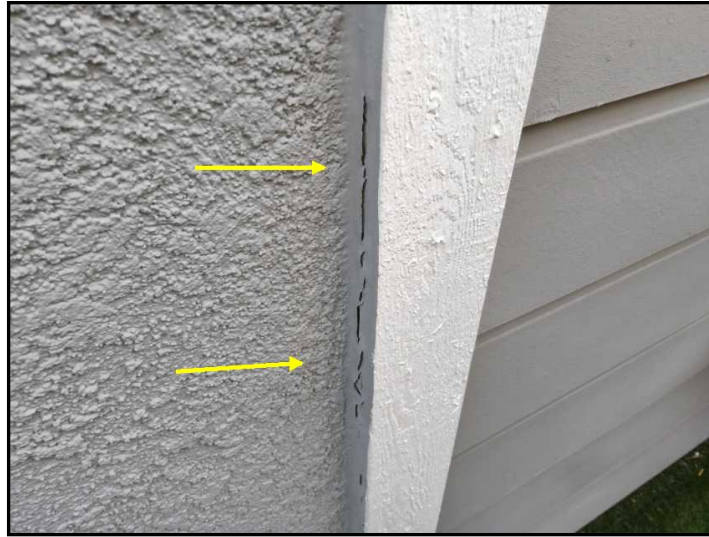
**EXTERIOR SEALANT / CAULKING – GUIDELINES:** Maintain exterior sealants and caulking at material transitions, penetrations, windows, doors, utility openings, and other appropriate joints.

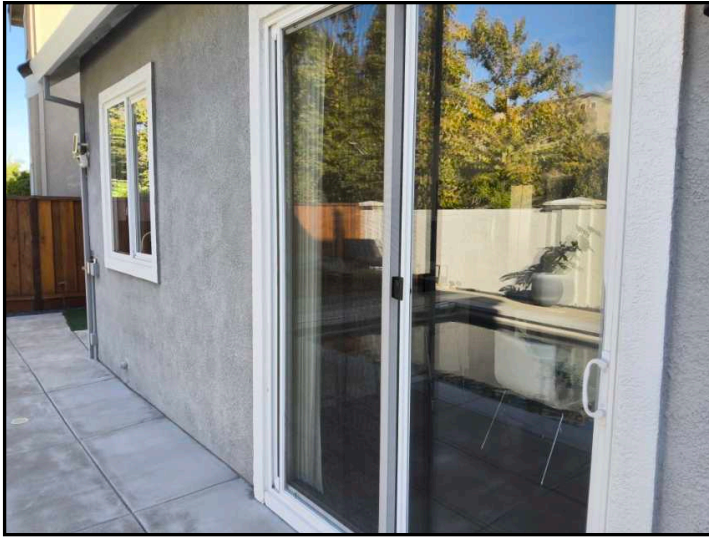
**SCREENS REMOVED FOR STAGING –**  
**INFORMATIONAL:** The window and/or door  
screens were removed for staging purposes and  
were not installed at the time of the inspection.

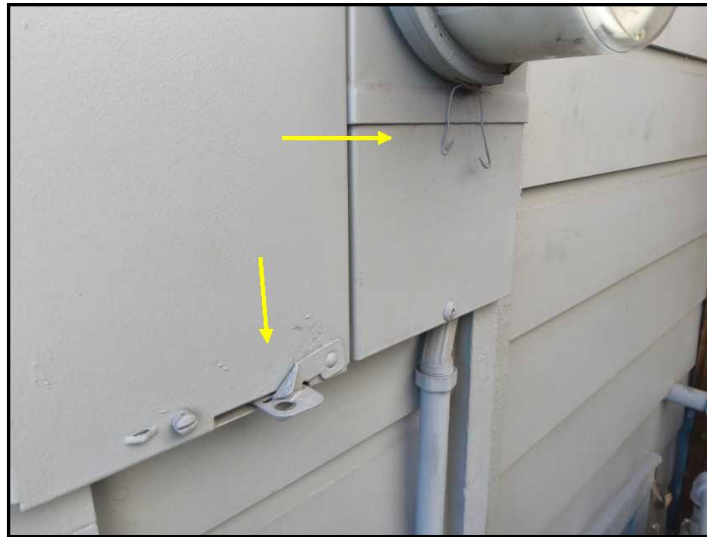
- **MISSING UTILITY METER SEAL - INFORMATIONAL:** The utility company seal was observed to be missing from the electrical meter. This condition does not typically affect electrical service; however, the seal is generally installed and maintained by the utility provider. A missing electric meter seal in California can lead to utility investigations, heavy fines, service disconnection, and criminal charges if the utility suspects tampering or theft of service. It is recommended that the serving utility company be notified to evaluate the meter and install a replacement seal as necessary.

**MISSING UTILITY METER SEAL - INFORMATIONAL:** The utility company seal was observed to be missing from the electrical meter.

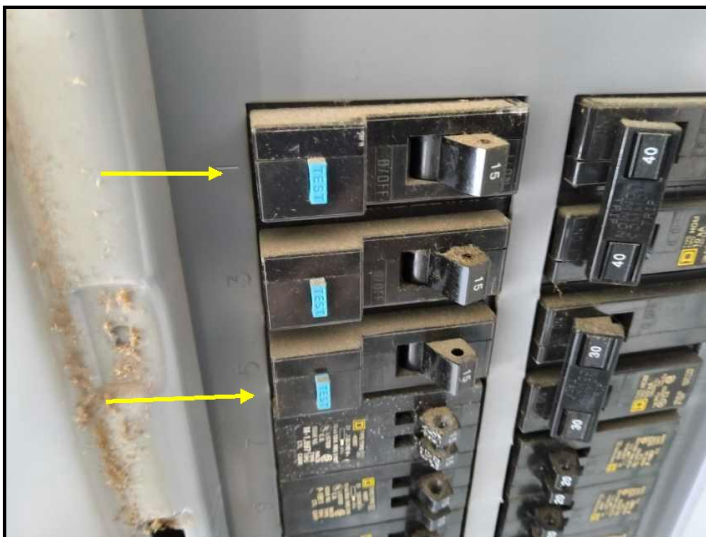
The majority of the AFCI protected circuit breakers at the sub panel responded correctly when tested using the built-in test buttons.

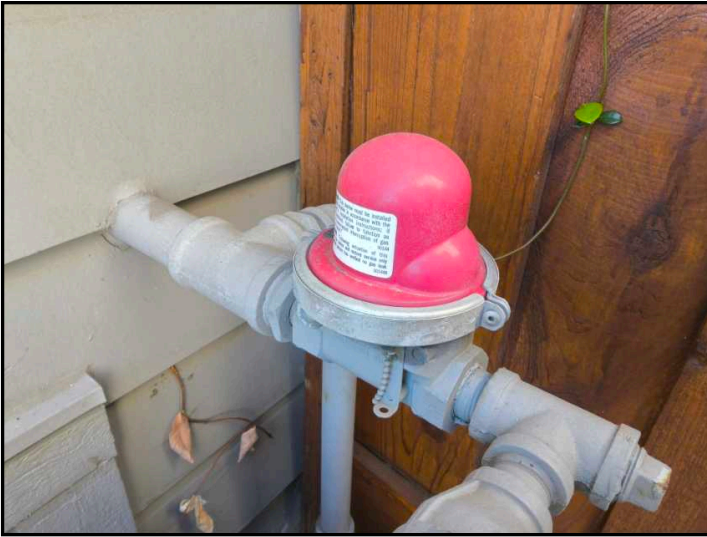
The gas main is equipped with a seismic shut-off valve.

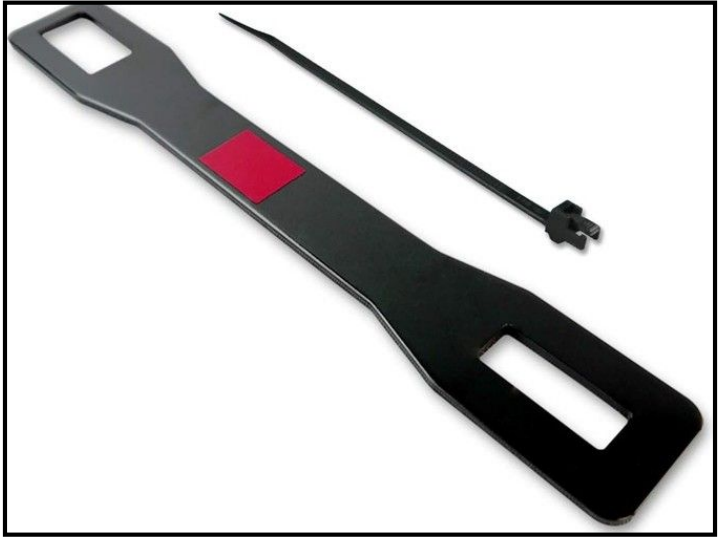
**GAS SHUT-OFF WRENCH**

- The gas main is equipped with a seismic shut-off valve. This type of valve is designed to automatically shut off gas in the event of an earthquake.
- **GAS SHUT-OFF WRENCH:** Having a wrench available near the gas main will facilitate a faster emergency shut down of the gas supply. These devices are inexpensive and can be zip tied to the gas line.

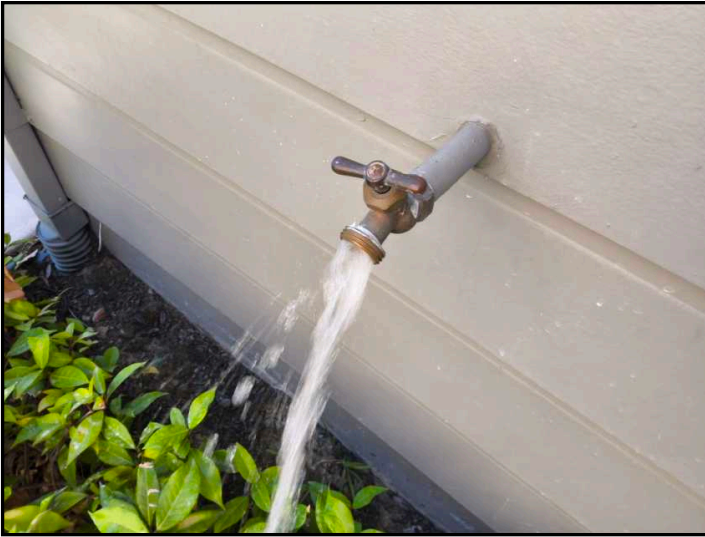
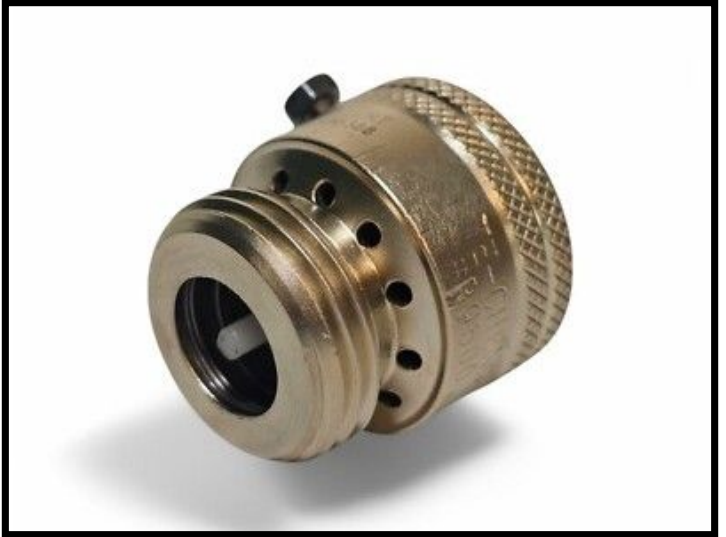
ANTI-BACKFLOW DEVICE

- The hose bibs appeared functional at the time of inspection. No adverse conditions were observed.
- **MISSING ANTI-BACKFLOW DEVICES:** Consider installing anti-backflow devices on all exterior hose bibs. These inexpensive and easily installed devices help protect the potable water supply by preventing the backflow of contaminated water, debris, or bacteria into the plumbing system.

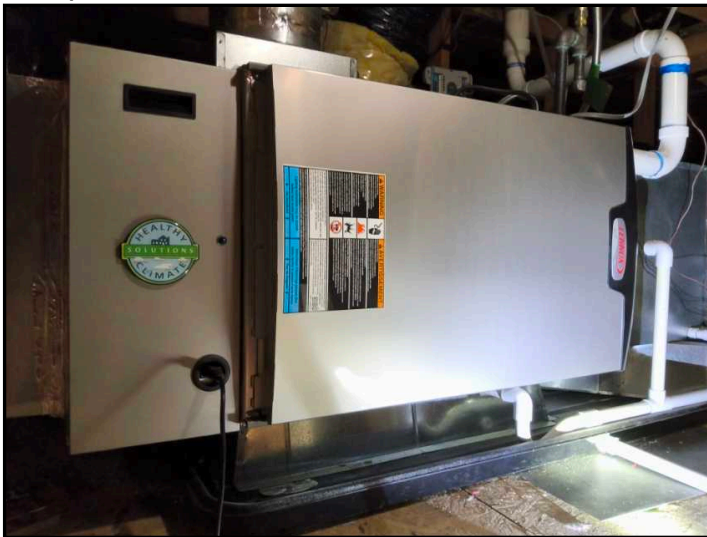
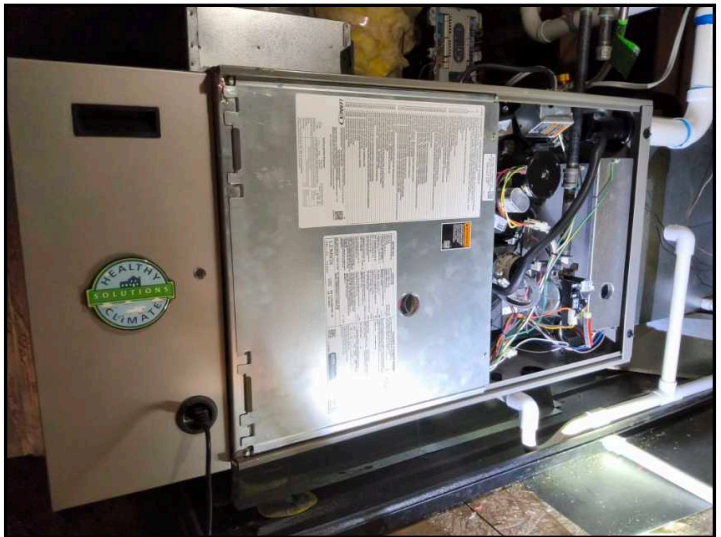
- **ZONED HVAC SYSTEM – INFORMATIONAL:** This home utilizes a zoned HVAC system. The system uses multiple thermostats and motorized dampers within the ductwork to independently control heating and cooling in different areas or zones of the home. The thermostats communicate with a central zone control panel, which operates the HVAC equipment and adjusts the dampers according to the temperature demand in each zone. This configuration can improve occupant comfort and energy efficiency by allowing different areas of the home to be maintained at different temperatures.

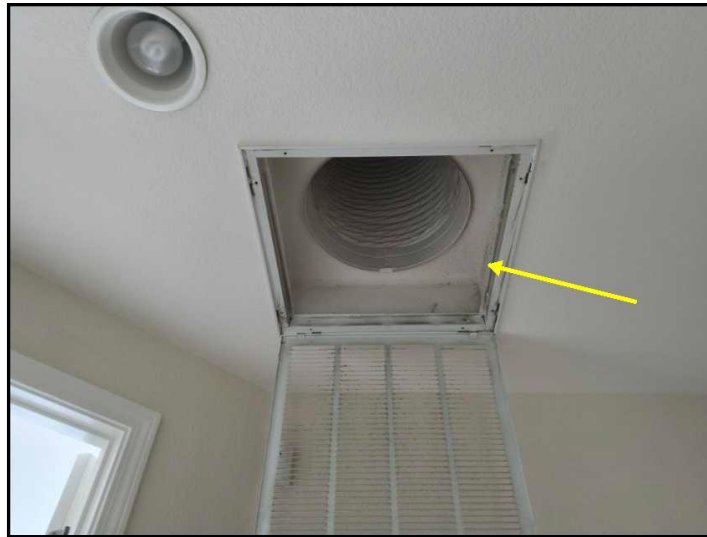
• **MISSING HVAC RETURN AIR FILTER:** The filter at the return air vent was missing. Operating the HVAC system without a filter can allow dust, debris, and other airborne particles to accumulate within the equipment and ductwork, potentially reducing system efficiency and contributing to premature equipment deterioration. It is recommended that a properly sized filter be installed before continued operation of the HVAC system.

**MISSING HVAC RETURN AIR FILTER:** The filter at the return air vent was missing.

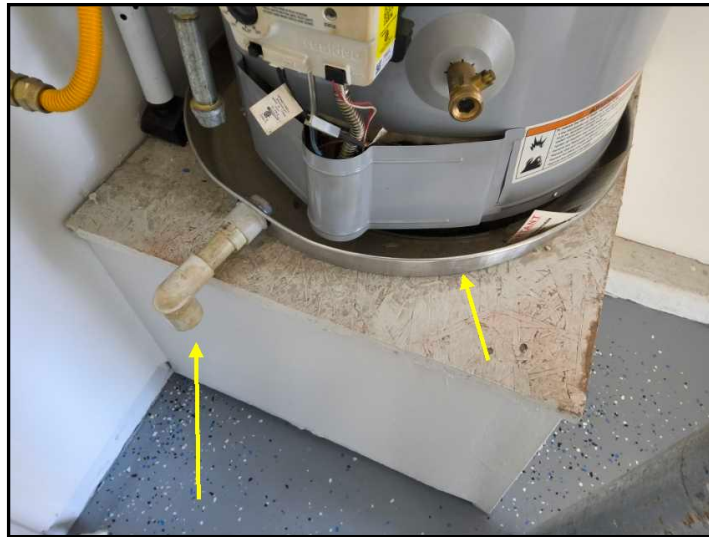
- **WATER HEATER DRIP PAN – MISSING DRAIN LINE:** The water heater was equipped with a drip pan; however, the pan did not have a drain line routed to an appropriate exterior or approved drainage location. A properly installed drain line helps direct water away from the interior if the water heater or associated connections leak, reducing the potential for water damage. It is recommended that a qualified plumbing contractor install an appropriate drain line as a preventive measure.

**WATER HEATER DRIP PAN – MISSING DRAIN LINE:** The water heater was equipped with a drip pan; however, the pan did not have a drain line routed to an appropriate exterior or approved drainage location.

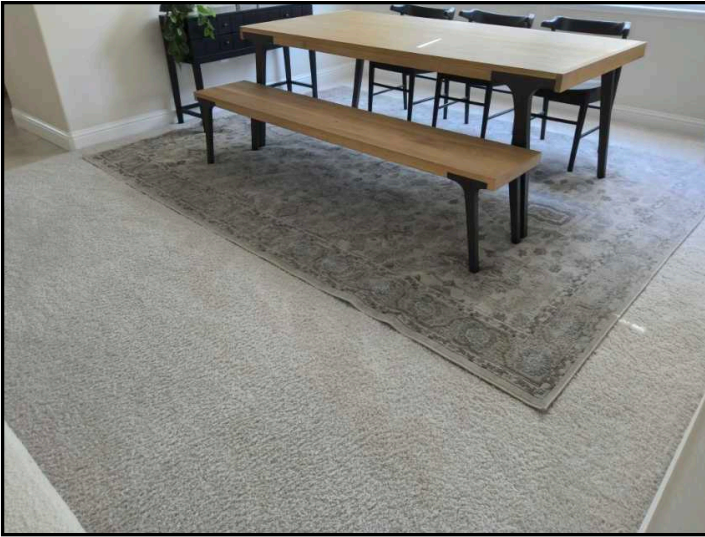
**CARPETING – NOT INSPECTED:** Evaluation of carpeting is outside the scope of this inspection.

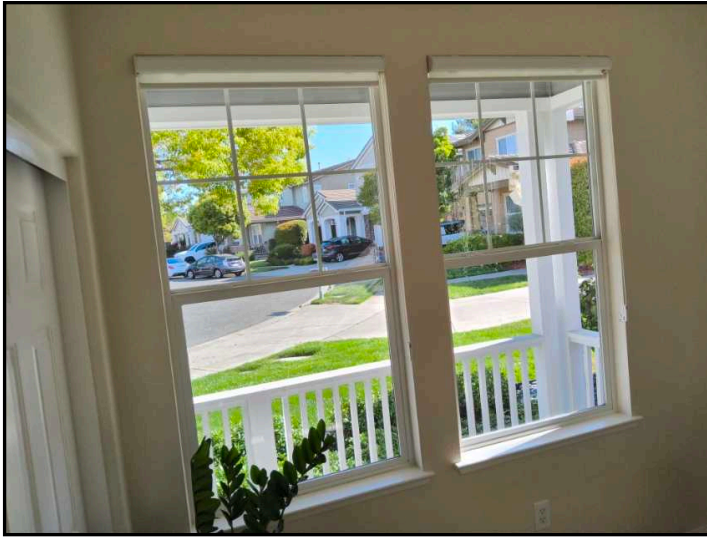
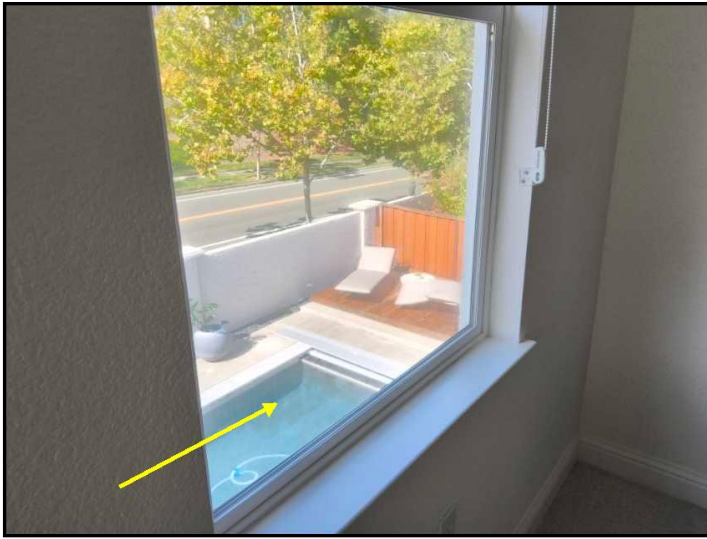
**FAILED THERMO-PANE SEAL:** Fogging or condensation was observed between the panes of one or more insulated windows.

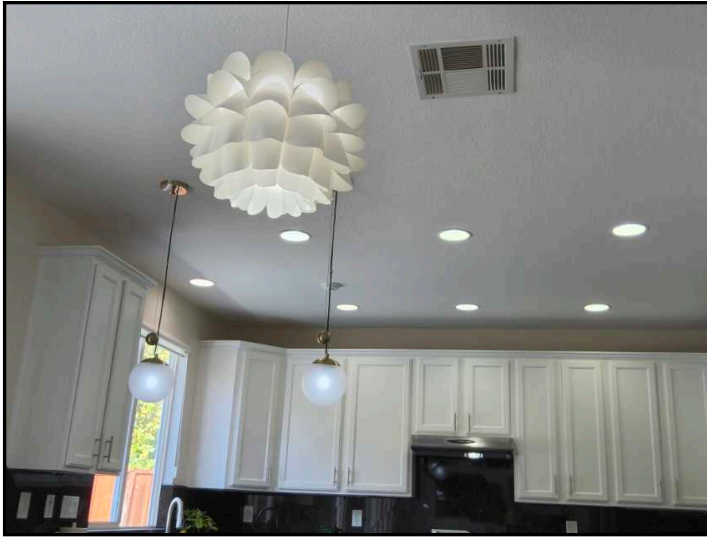
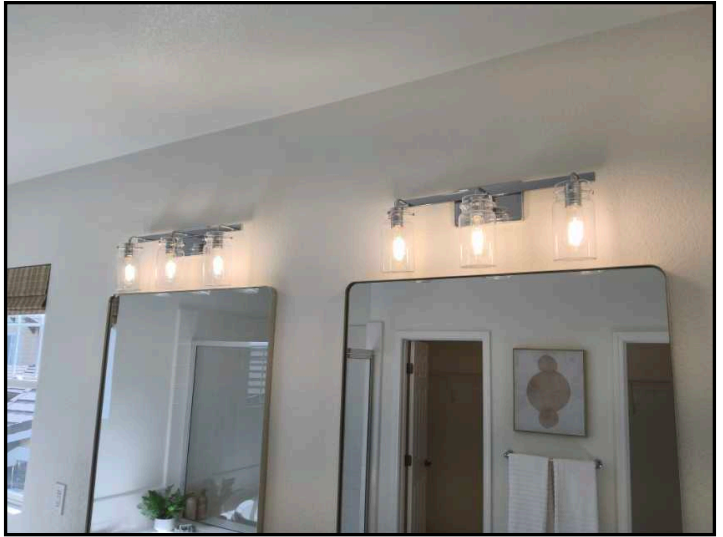
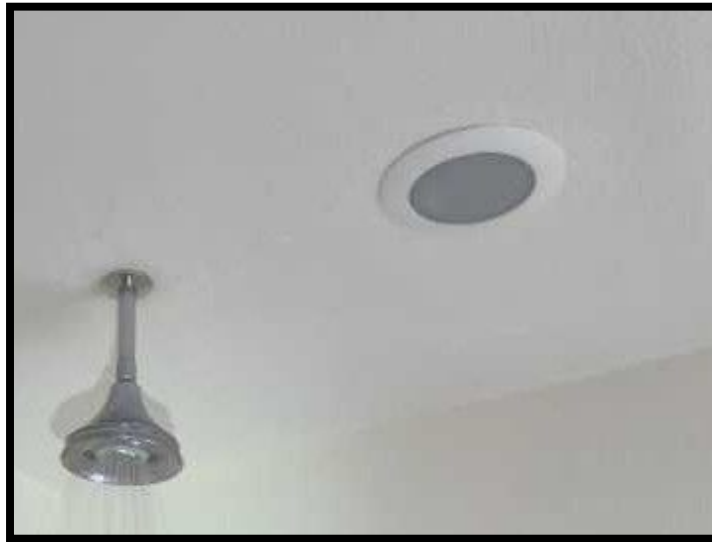
- The tested interior light fixtures appeared functional and operated satisfactorily at the time of the inspection, unless otherwise noted in this report. No significant operational deficiencies were observed during the limited testing performed.
- **LIGHT FIXTURE NOT FUNCTIONAL:** A light fixture did not respond when tested in the primary bathroom. The condition may be due to a burned-out or missing bulb or another electrical deficiency. It is recommended that the bulb be replaced and the fixture retested. If the fixture remains inoperable, evaluation and repair by a qualified electrician is recommended.

**LIGHT FIXTURE NOT FUNCTIONAL:** A light fixture did not respond when tested.

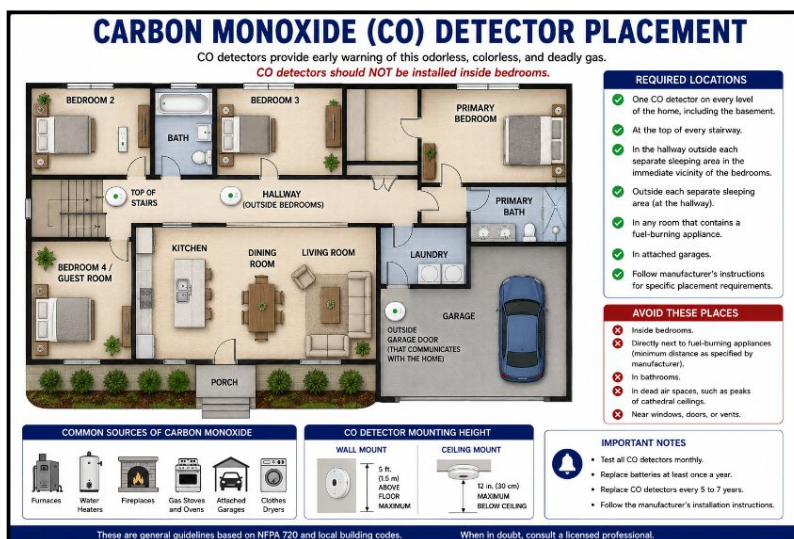
- **MISSING CARBON MONOXIDE DETECTOR – TOP OF STAIRS:** A carbon monoxide detector was not observed at the top of the stairway. A properly located carbon monoxide detector should be installed in this area for improved occupant safety and in accordance with applicable requirements.

- **MISSING CARBON MONOXIDE DETECTOR – BEDROOM HALLWAY:** A carbon monoxide detector was not observed in the hallway serving the bedrooms. It is recommended that an appropriate carbon monoxide detector be installed in the hallway outside the sleeping areas for improved occupant safety.

- **MISSING CARBON MONOXIDE DETECTOR – HALLWAY OFF GARAGE:** A carbon monoxide detector was not observed in the hallway adjacent to the door communicating with the garage. It is recommended that an appropriate carbon monoxide detector be installed in this area for improved occupant safety.

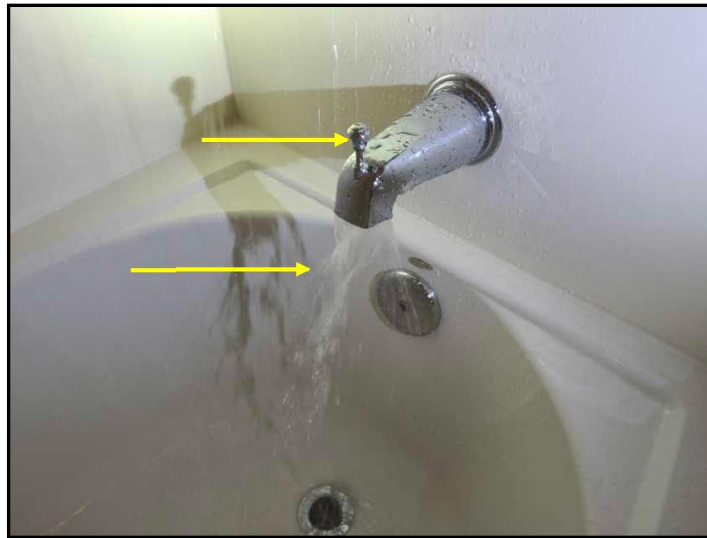
- The tub-shower and its visible and accessible components were functional and appeared to be in satisfactory condition at the time of the inspection. No significant deficiencies were observed unless otherwise noted in this report.
- **SHOWER DIVERTER VALVE NOT SEALING PROPERLY:** The shower diverter valve did not seal properly when operated, allowing water to continue flowing from the unintended outlet. This condition may reduce shower performance and waste water. It is recommended that the diverter valve be serviced, repaired, or replaced as necessary for proper operation.

**SHOWER DIVERTER VALVE NOT SEALING PROPERLY:** The shower diverter valve did not seal properly when operated.

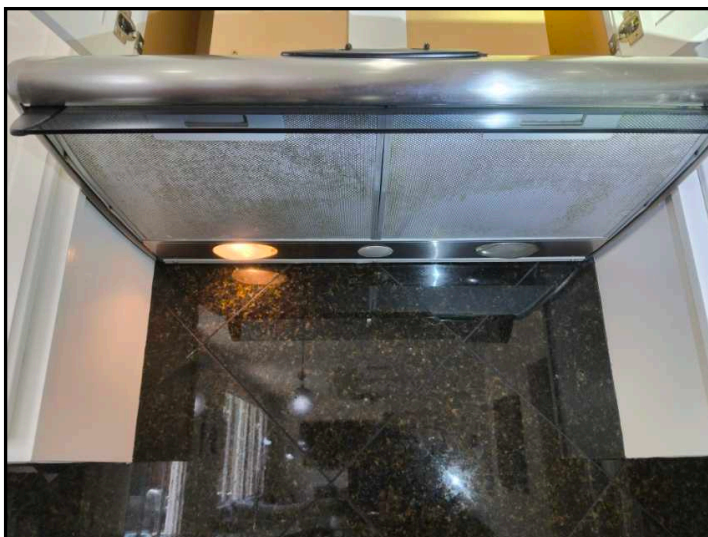
- The built-in vent hood responded to normal user controls.
- **NOISY KITCHEN EXHAUST FAN:** The kitchen exhaust fan was functional but produced excessive or unusual noise during operation, which may indicate wear or deterioration of the motor or other components. The unit may have a limited remaining service life. It is recommended that the fan be monitored and serviced or replaced as necessary.
- **VENT HOOD LIGHT NOT FUNCTIONAL:** A light at the kitchen vent hood did not respond during testing. It is recommended that the bulb be replaced and the light retested. If the light remains nonfunctional, the fixture or associated components should be serviced or repaired as necessary.

**VENT HOOD LIGHT NOT FUNCTIONAL:** A light at the kitchen vent hood did not respond during testing.

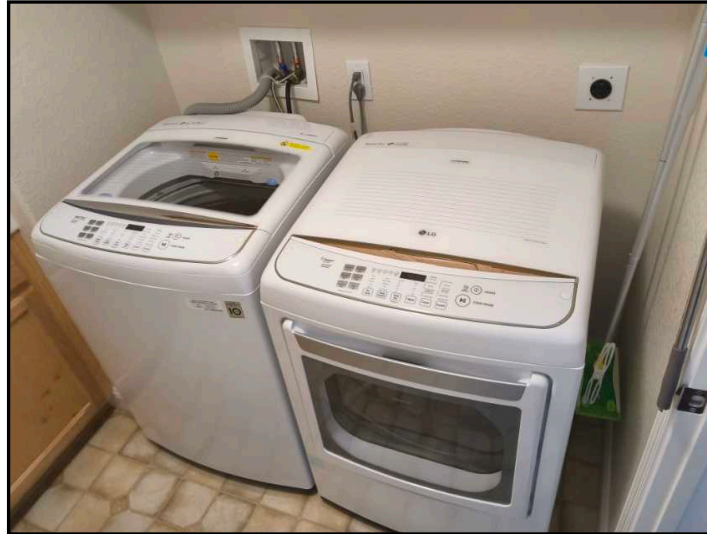
- The laundry provisions are located in the room outside the garage.

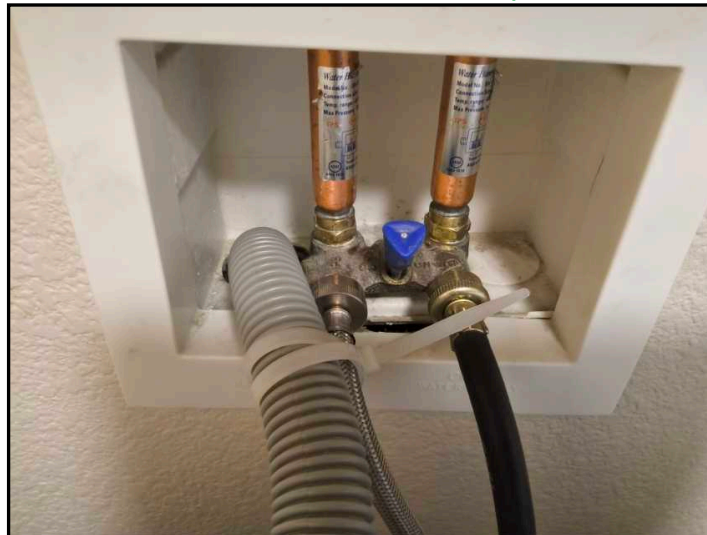
- The washer water supply valves and drainage system were functional and satisfactory at the time of the inspection. The valves were not turned or tested at the time of inspection. No significant deficiencies were observed unless otherwise noted in this report.

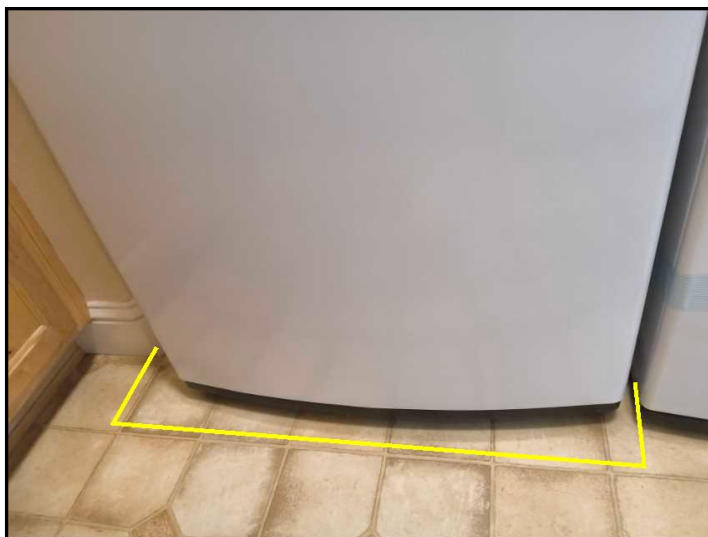
- **DISCRETIONARY UPGRADE:** No drain pan was installed beneath the washing machine. Because the laundry area is located on the first floor over a concrete slab, the potential for damage to structural components below is limited; however, a washer leak or overflow could still damage the surrounding wood flooring and finishes. As a discretionary upgrade, consider installing a properly sized drain pan with a drain line routed to an approved drain or suitable exterior discharge location, where permitted, to help minimize water damage in the event of leakage.

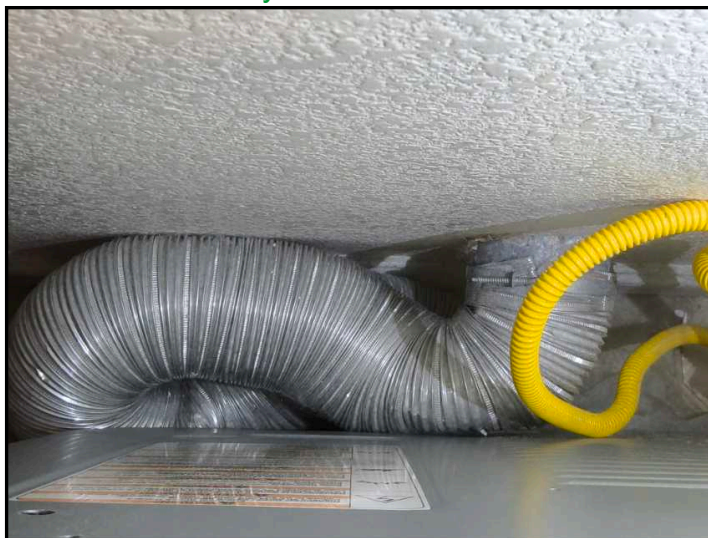
- Dryer exhaust provisions were satisfactory.

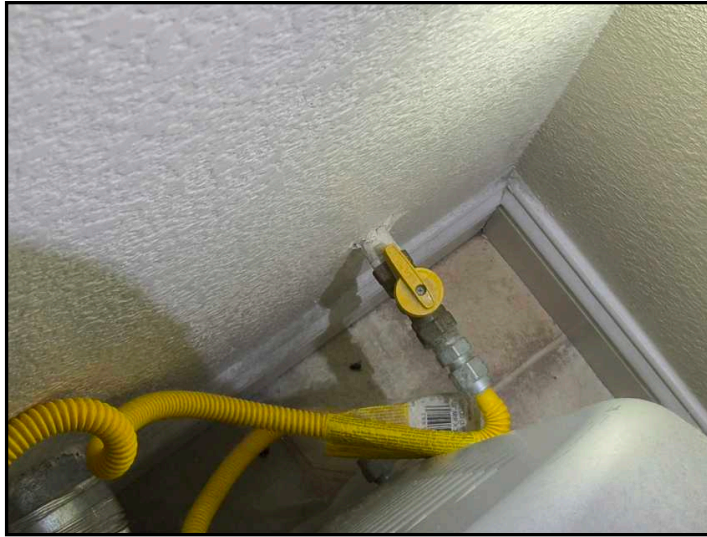
- The gas line and valve for the clothes dryer appeared to be in satisfactory condition. The valve was not turned or tested.

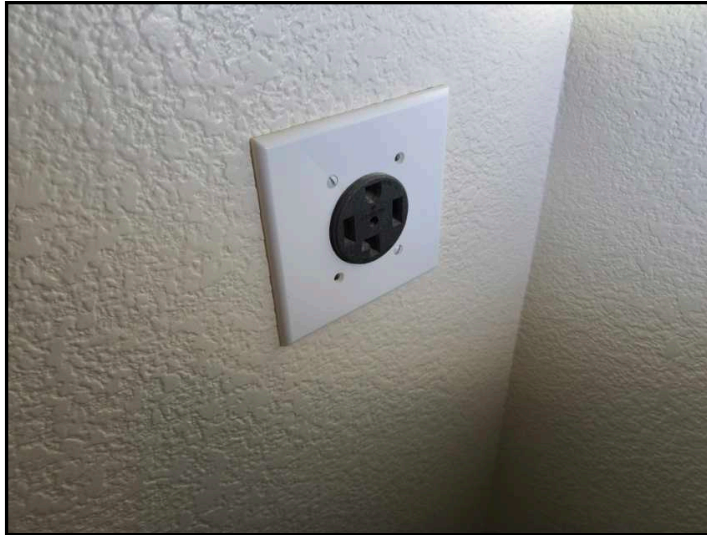
- A 220-volt electrical receptacle was provided for an electric clothes dryer.

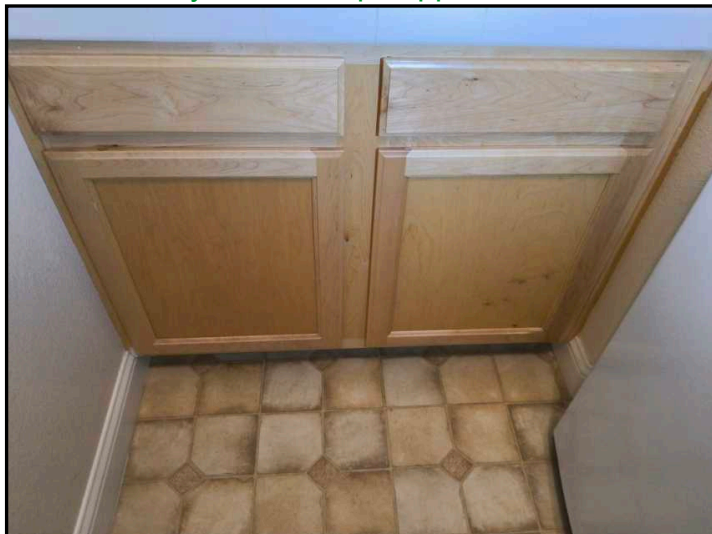
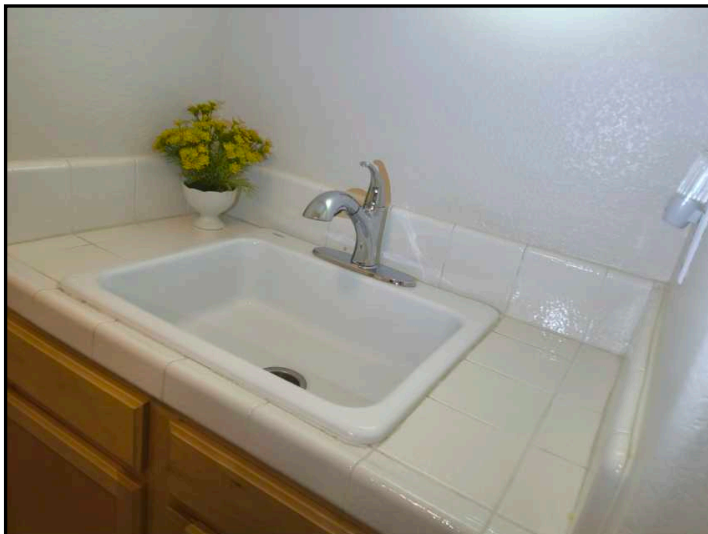
- The laundry cabinets appeared to be in excellent condition.
- The laundry counter tops appeared newer and in excellent condition.

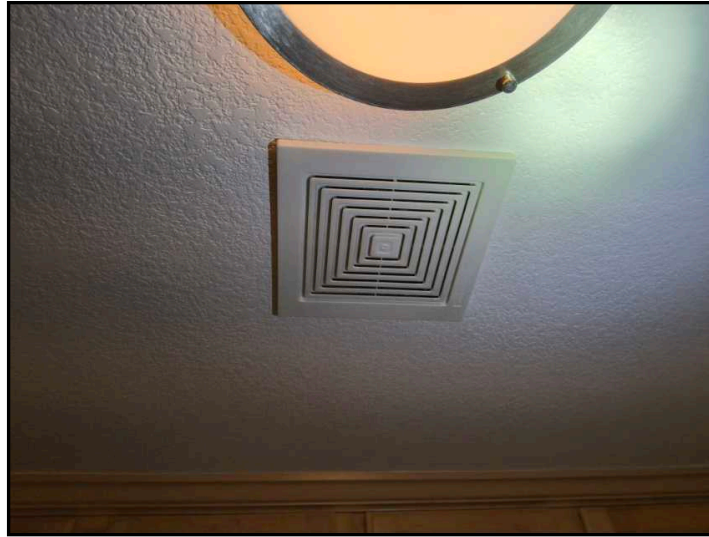
- The laundry room exhaust fan is functional.

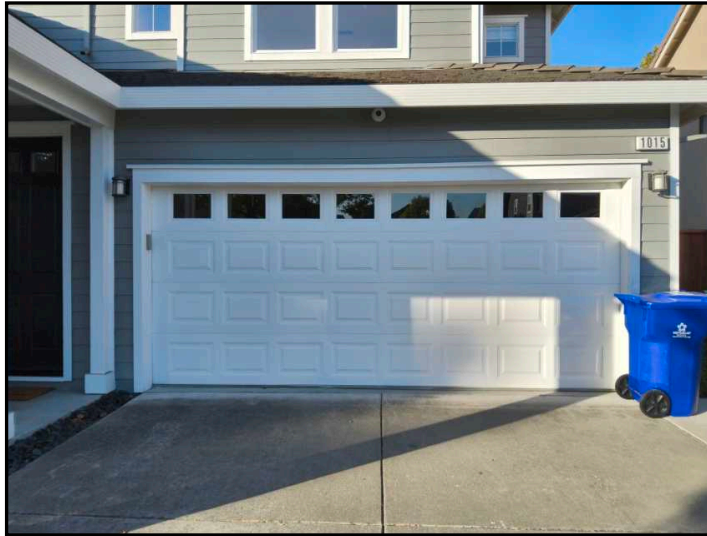
- The sectional garage vehicle door appeared functional and operated satisfactorily when tested using the **automatic opener**. No significant operational deficiencies were observed unless otherwise noted in this report.

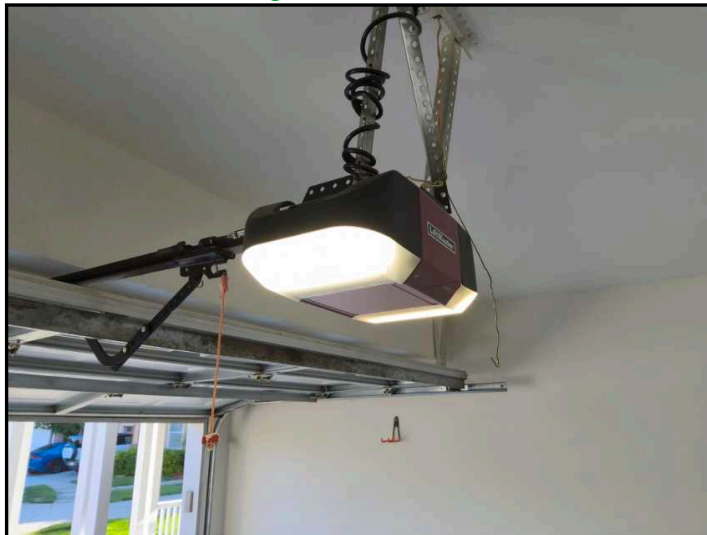
- The garage door opener is functional using normal controls, at time of inspection.

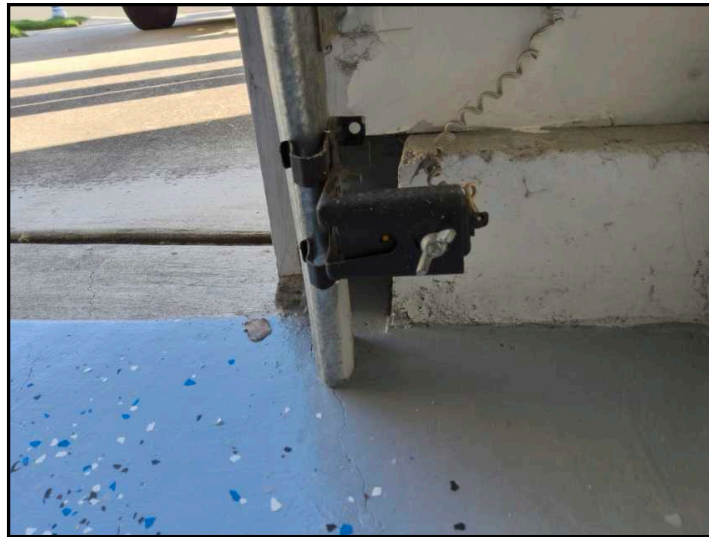
- The automatic garage door opener's photoelectric safety sensors and downward-force reversal system functioned satisfactorily when tested at the time of the inspection.

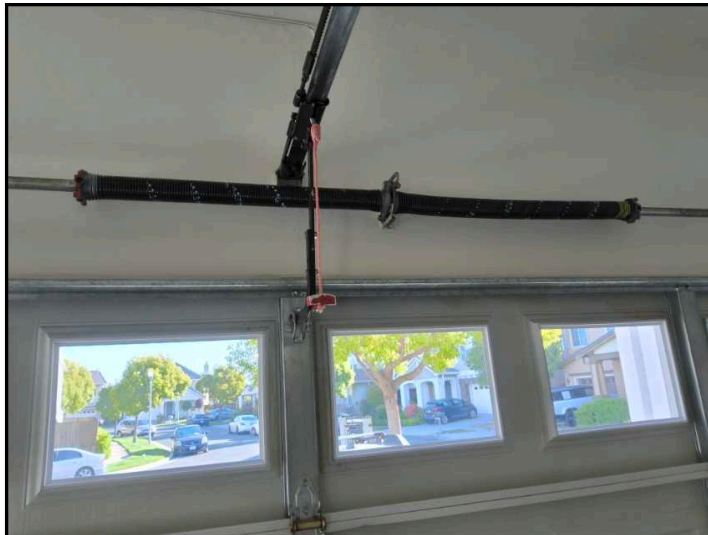
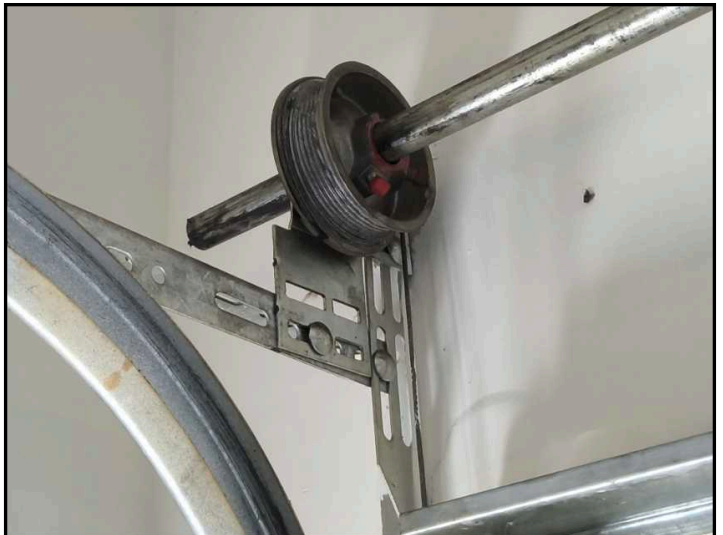
- The vehicle door spring and torsion bar are functional.

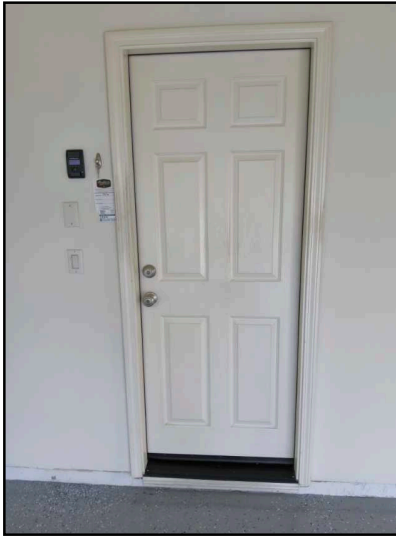
- The interior door leading to the garage appears to be a fire-rated door.

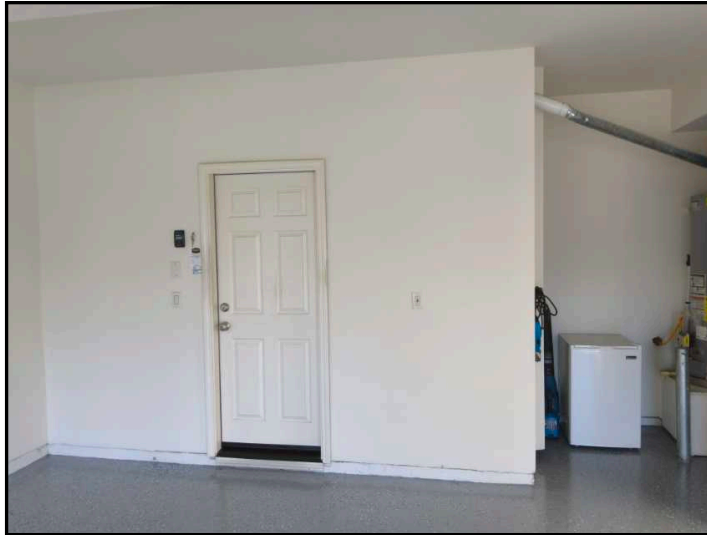
- The fire wall coverings were functional and in satisfactory condition.

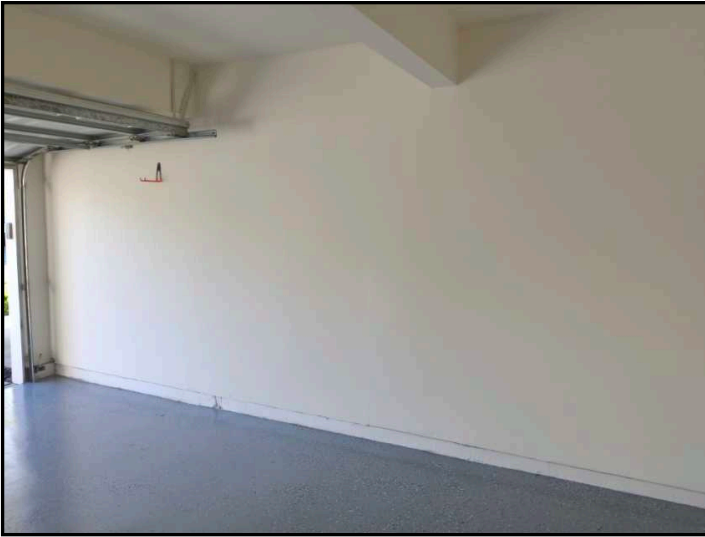
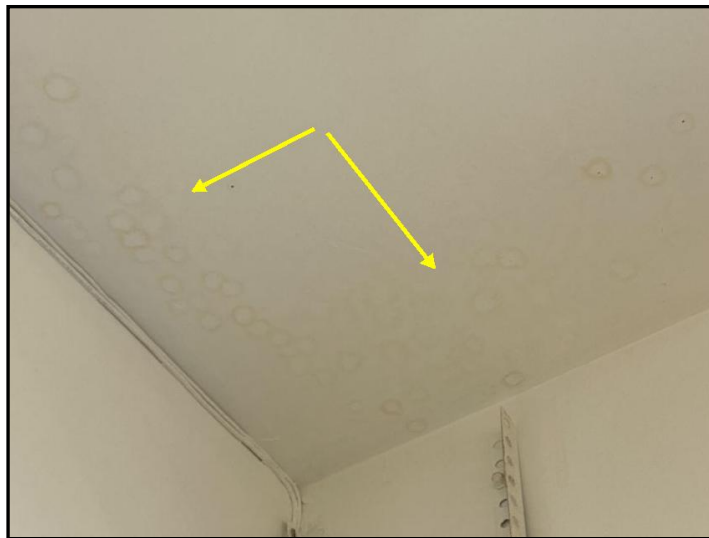
- The visible garage wall and ceiling coverings appeared functional and well maintained at the time of the inspection. No significant visible deficiencies were observed unless otherwise noted in this report.
- **WATER STAINS AT GARAGE CEILING:** Water stains or other evidence of moisture intrusion were observed at portions of the garage ceiling. The staining appeared older or inactive at the time of the inspection; however, the source and current activity could not be conclusively determined. Monitor the affected areas during and after rainfall or plumbing use for evidence of recurring moisture. If moisture reappears, identify and correct the source and repair damaged materials as necessary.

**WATER STAINS AT GARAGE CEILING:** Water stains or other evidence of moisture intrusion were observed at portions of the garage ceiling.

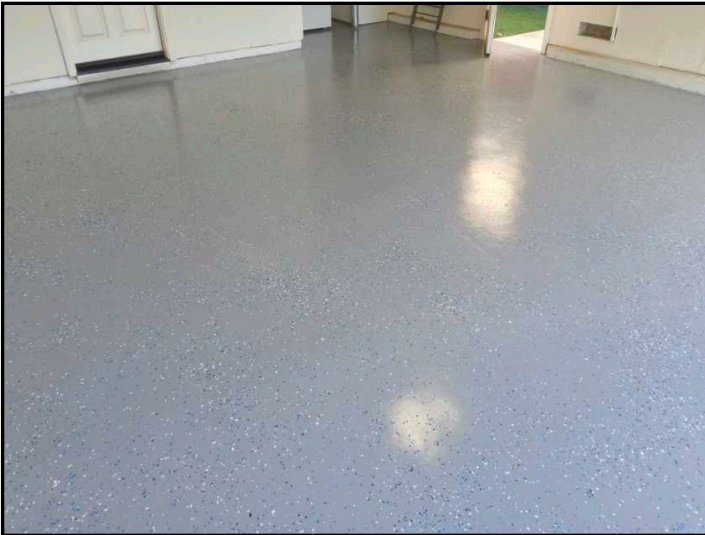
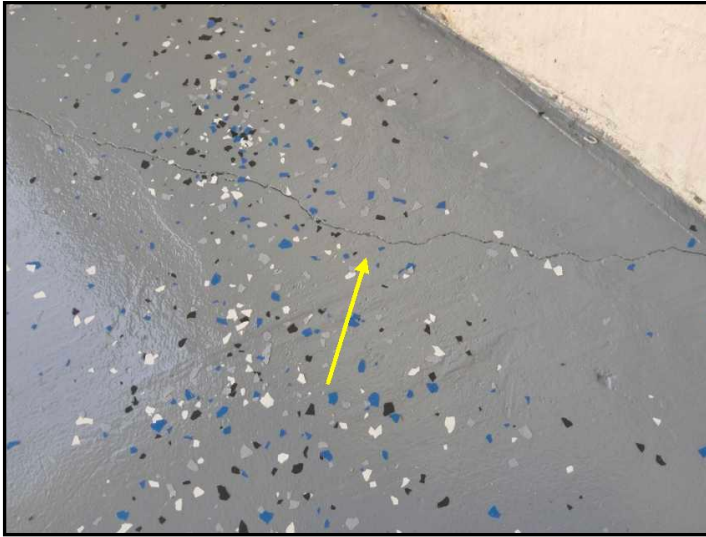
- No significant visible abnormalities were observed at the accessible portions of the garage concrete slab foundation at the time of the inspection. The visible floor appeared functional and serviceable unless otherwise noted in this report.
- **COMMON CONCRETE CRACKS:** Common cracks were observed in the garage slab. This type of cracking is frequently associated with normal concrete shrinkage, settlement, expansion, or minor movement. Monitor the cracks for widening, displacement, or additional movement and seal or repair them as necessary.

**COMMON CONCRETE CRACKS:** Common cracks were observed in the garage slab.

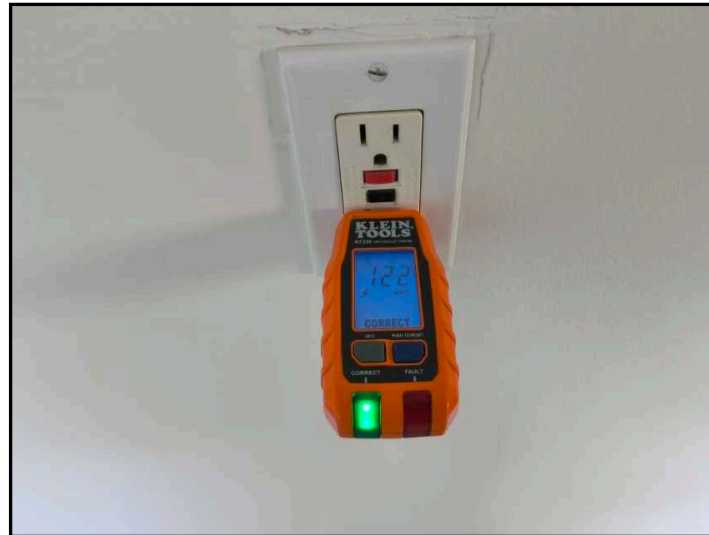
- The grounded receptacle outlets, were tested and found to be wired correctly.

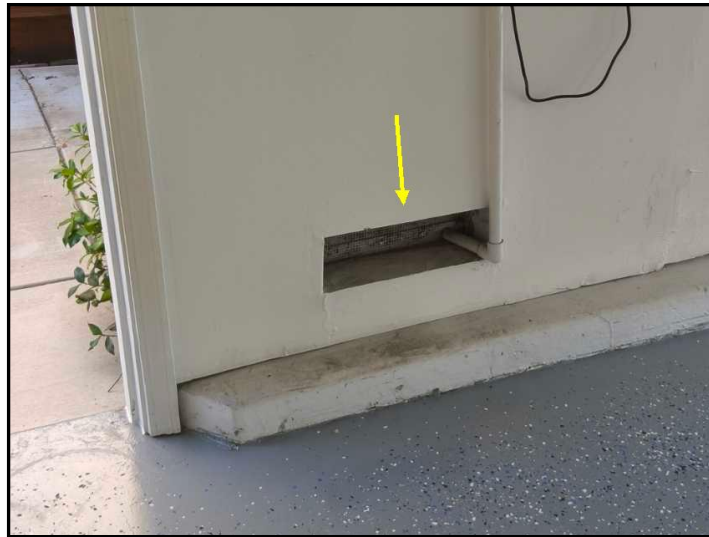
- **LIMITED GARAGE VENTILATION:** Limited ventilation provisions were observed within the garage for dispersing vehicle exhaust fumes. Vehicle engines should never be left running inside an enclosed or inadequately ventilated garage, as exhaust gases can accumulate and create a serious carbon monoxide poisoning hazard. Always open the garage vehicle door before starting a vehicle and move the vehicle outdoors promptly.

**LIMITED GARAGE VENTILATION:** Limited ventilation provisions were observed within the garage for dispersing vehicle exhaust fumes.

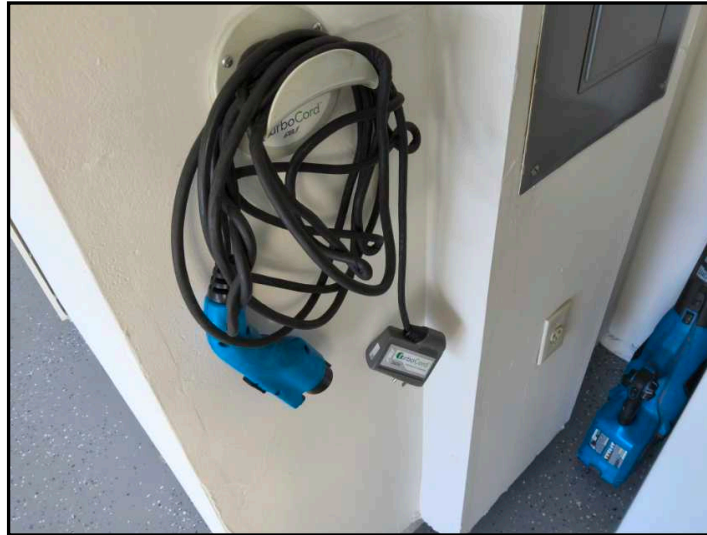
• **ELECTRIC VEHICLE CHARGER:** The electrical system includes an electric vehicle charger (EVC) located in the garage. The EVC appears to be functional but falls outside the scope of our inspection and this report. We recommend an appropriately qualified specialist evaluate the EVC and its components for safe and proper function.

**ELECTRIC VEHICLE CHARGER:** The electrical system includes an electric vehicle charger (EVC) located in the garage.
