# PROPERTY INSPECTION REPORT

**0000 Near me, Neverland CA 94000**  
**Inspection Prepared For: Smith Sam**  
**Agent: Not Applicable -**

**Date of Inspection: 9/24/2026**  
**Age: 23 - Size: 2274**  
**NACHI24041526 / CLSB #1158251**

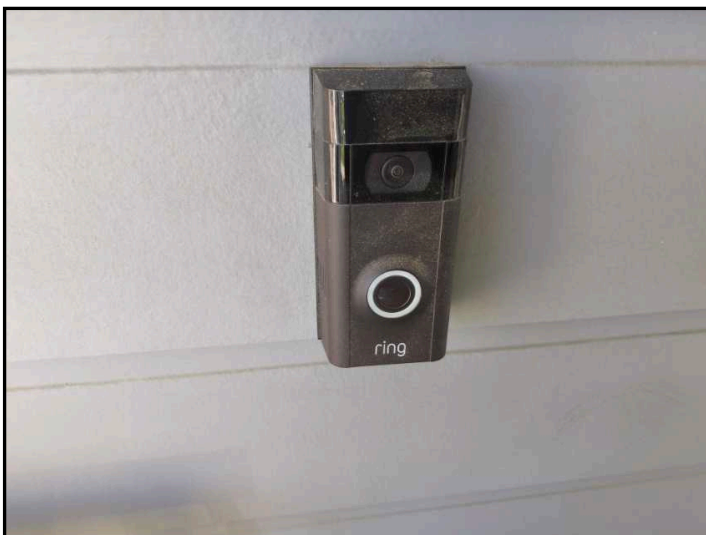
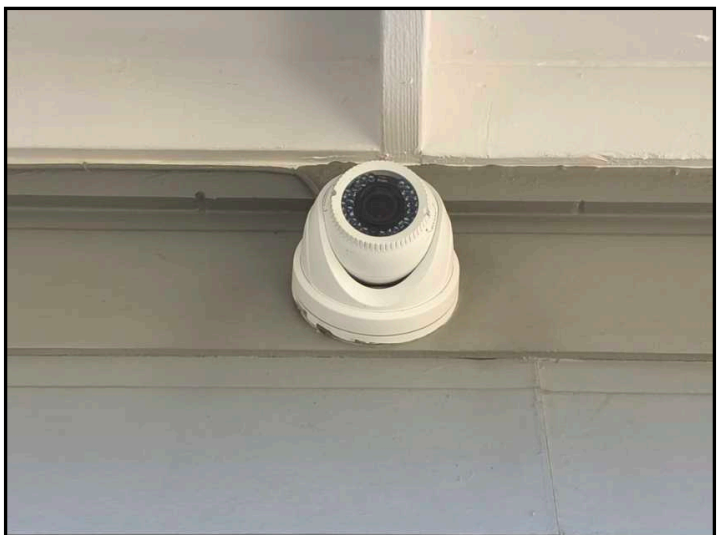
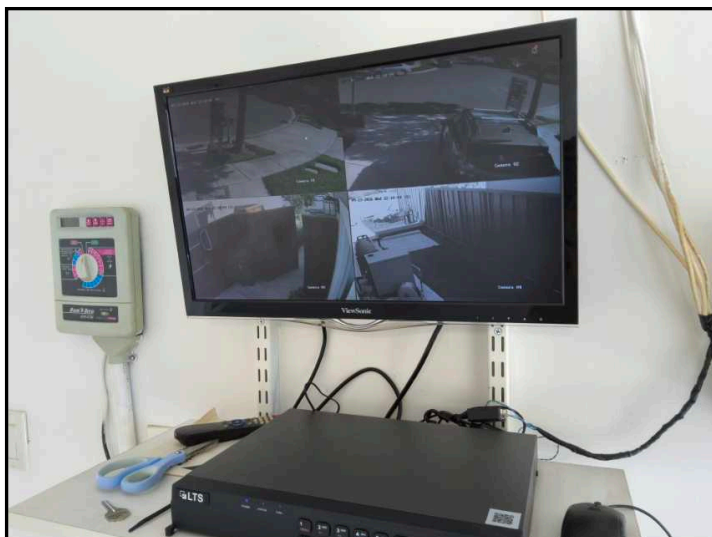
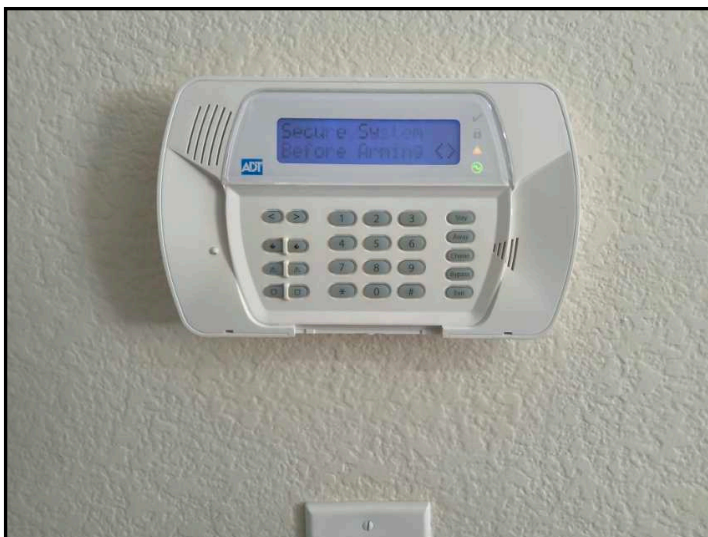
• **WI-FI SECURITY SYSTEM – NOT INSPECTED:** The property is equipped with a removable Wi-Fi camera/security system. Evaluation and functional testing of security systems are outside the scope of a home inspection and were not performed. It is recommended that the seller be consulted to determine whether the system will remain with the property and, if so, to provide information regarding its operation, functionality, account transfer, and associated equipment.

**WI-FI SECURITY SYSTEM – NOT INSPECTED:** The property is equipped with a removable Wi-Fi camera/security system.
