# ROOF INSPECTION REPORT

Inspector: Tina Kirkpatrick  
**TK Contracting & Consulting Inc.**

**xxx Near me St, Neverland CA 94xxx**  
**Inspection Prepared For: Sam Super**  
**Agent: Not Applicable -**

**Date of Inspection: 7/22/2026**  
**Year Built: 1930 Size: 1500**  
**NACHI24041526 / CLSB #1158251**

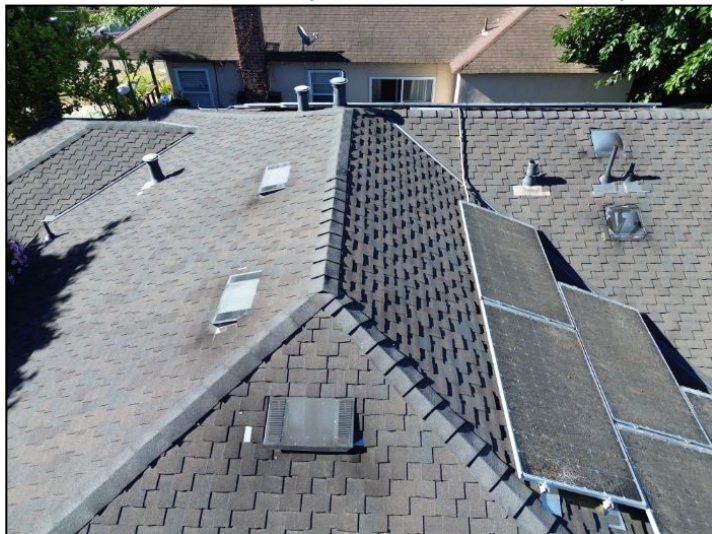
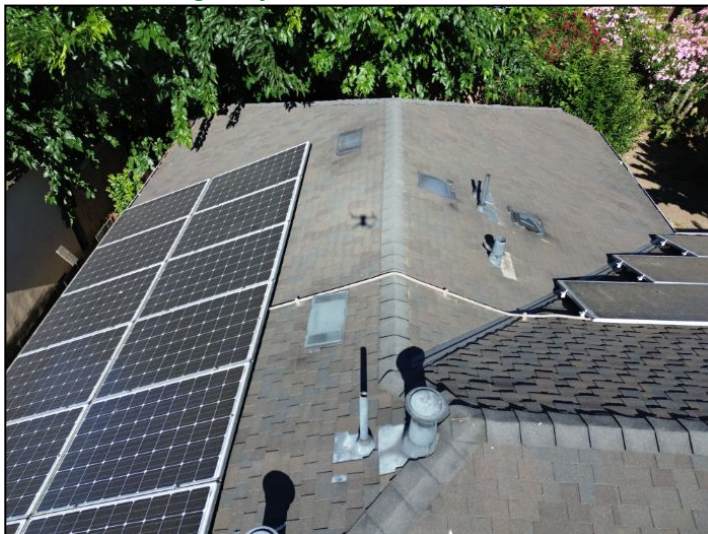
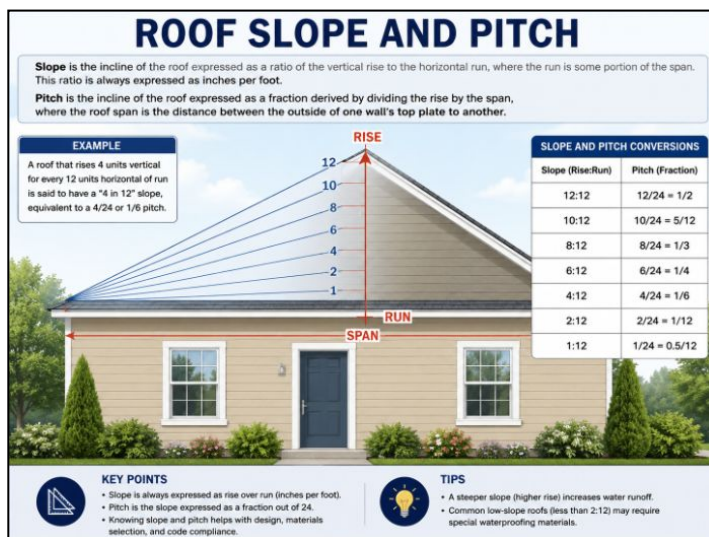
• **SLOPED ROOF:** The property features a sloped (pitched) roof designed to shed water efficiently and protect the structure from weather-related moisture intrusion. The service life of a roofing system is influenced by several factors, including the roof's pitch, the type and quality of the roofing material, installation methods, maintenance practices, exposure to sunlight, and environmental conditions such as wind, rain, snow, ice, and overhanging tree branches. Common roofing materials used on sloped roofs include asphalt shingles, concrete or clay tiles, wood shakes, slate, metal roofing systems, and various composite products. Regular inspections and maintenance are recommended to help maximize the roof's performance and longevity.

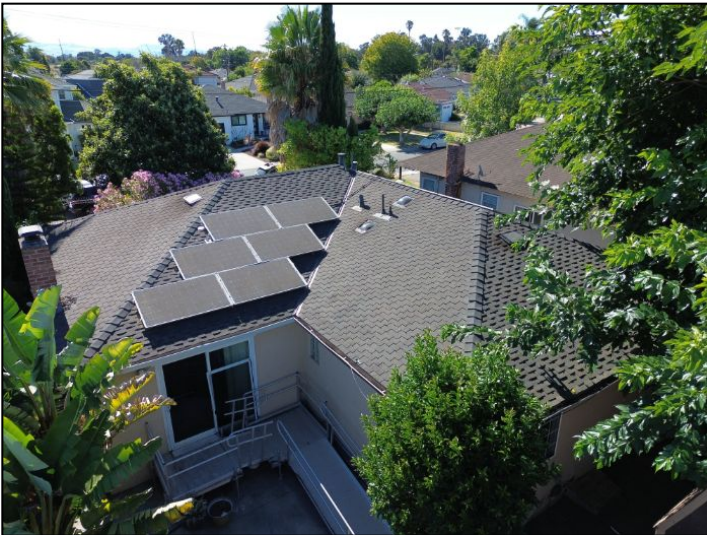
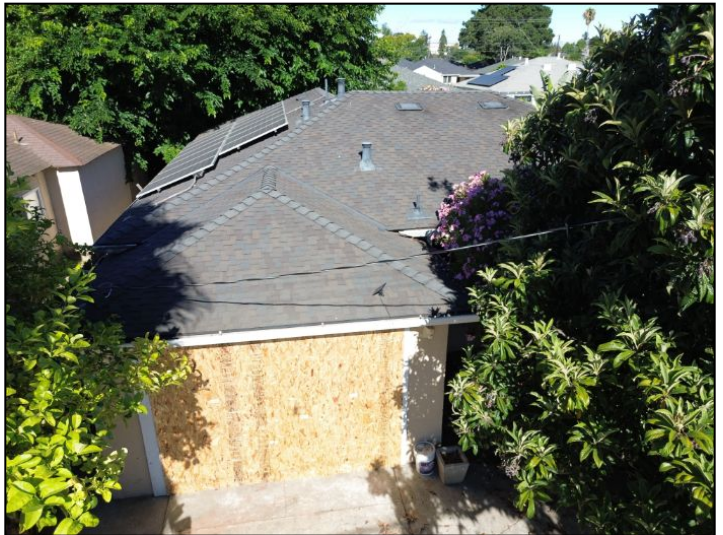
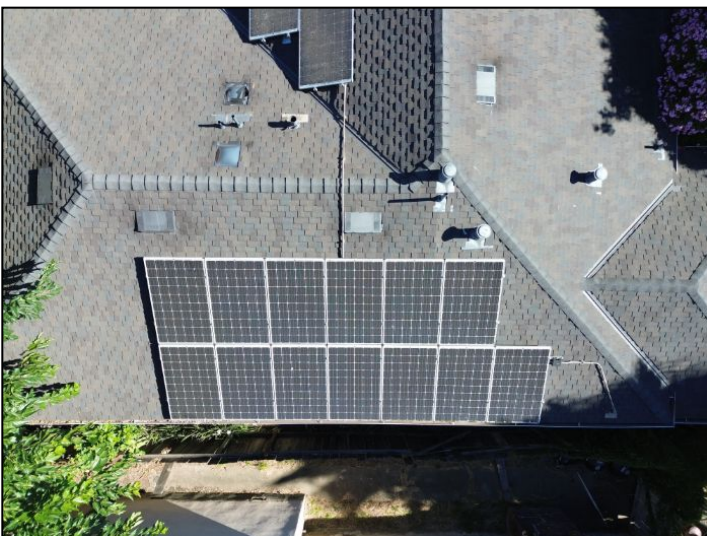
- The roof is equipped with photovoltaic (solar) panels, which limit visibility and access to portions of the roof covering beneath and adjacent to the panels. As a result, certain areas of the roofing system could not be fully inspected. This limitation should be considered when evaluating the overall condition of the roof, as concealed deficiencies may exist in areas obstructed by the solar equipment.

The roof is equipped with photovoltaic (solar) panels.

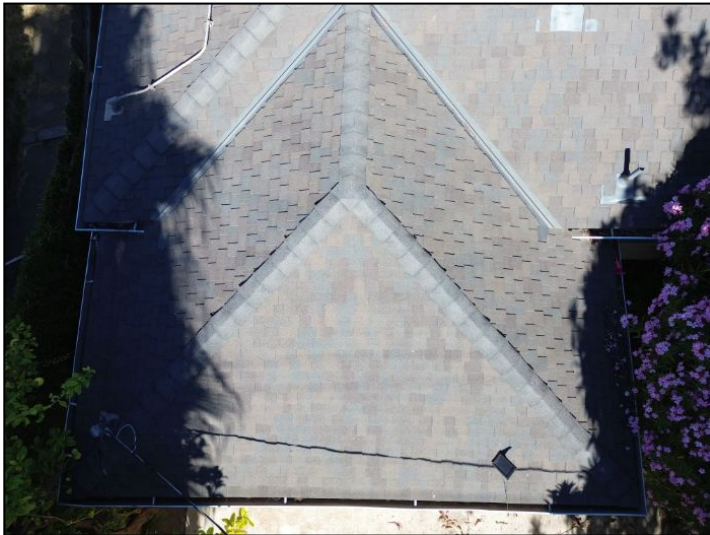
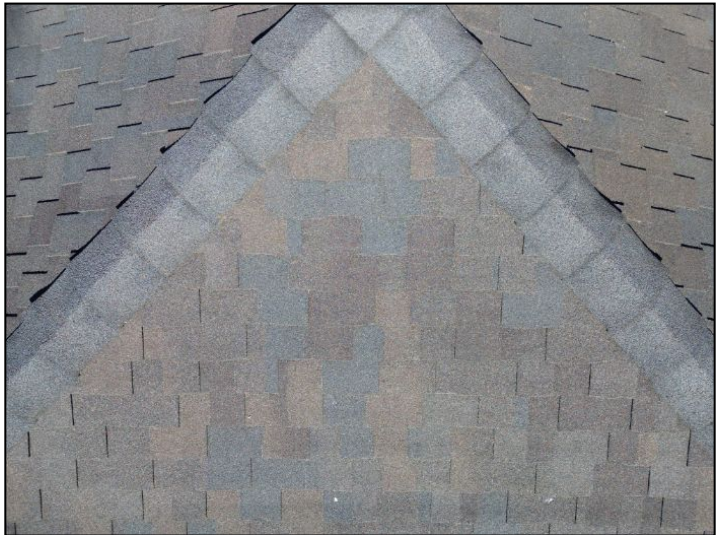
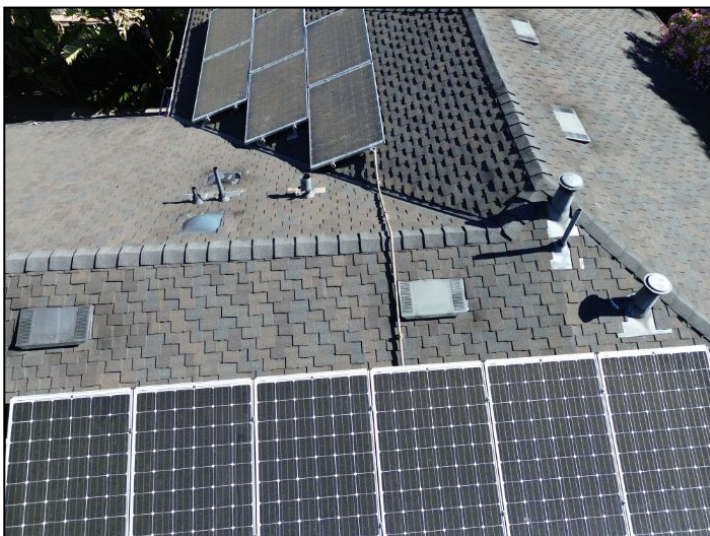
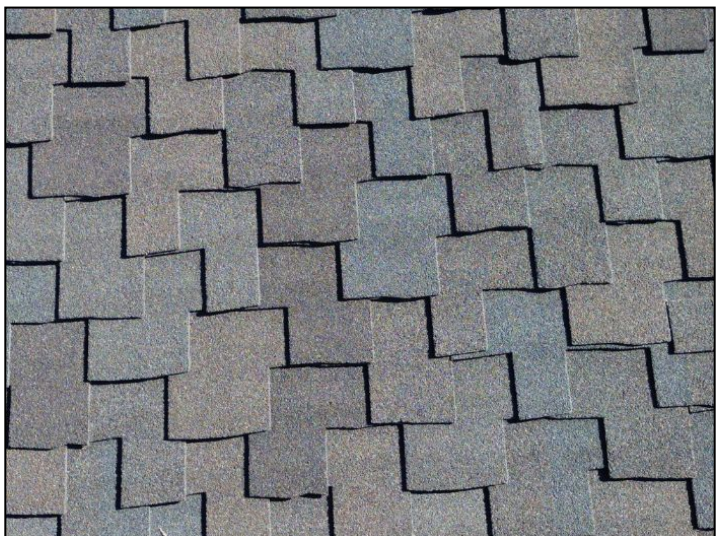
- The premium composition shingle roofing material appeared to be in satisfactory condition relative to its age.
- FOLIAGE NOTED: Foliage was observed growing over or in proximity to the roof. Overhanging vegetation can accelerate roof wear, trap moisture, obstruct drainage, and provide access for pests. Recommend trimming back vegetation to maintain adequate clearance from the roof and help prolong the life of the roofing system.
- DEBRIS ON THE ROOF: Leaves and debris were observed in portions of the roof near the chimney. Accumulated debris can impede proper drainage, trap moisture, and accelerate deterioration of roofing materials. Recommend cleaning the affected areas and maintaining the roof free of debris to help ensure proper roof drainage and prolong the life of the roofing system.

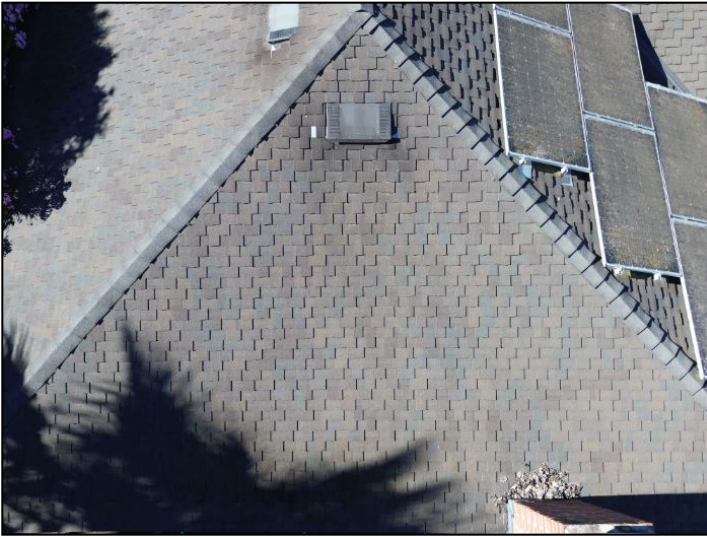
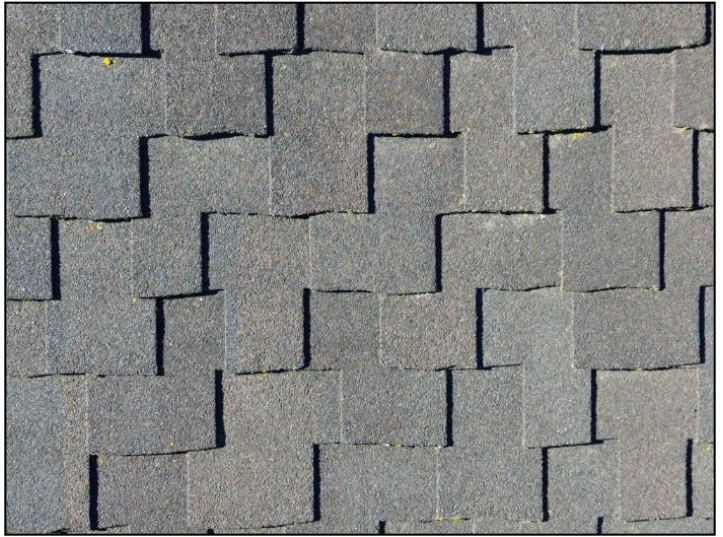
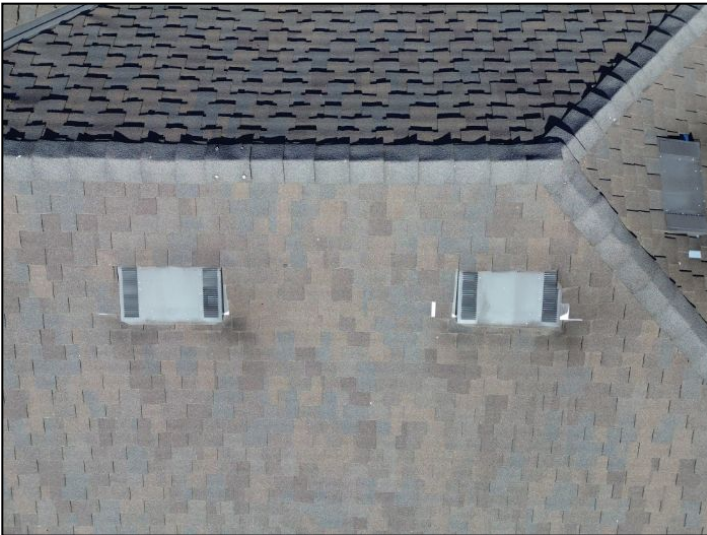
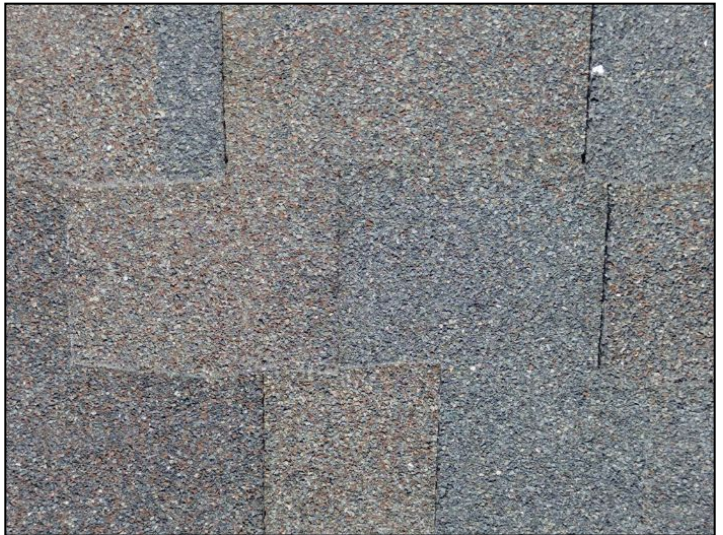
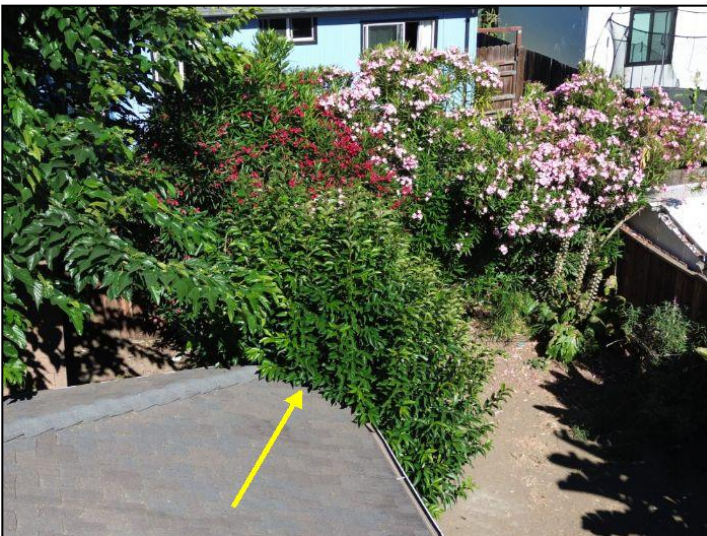
FOLIAGE NOTED: Foliage was observed growing over or in proximity to the roof.

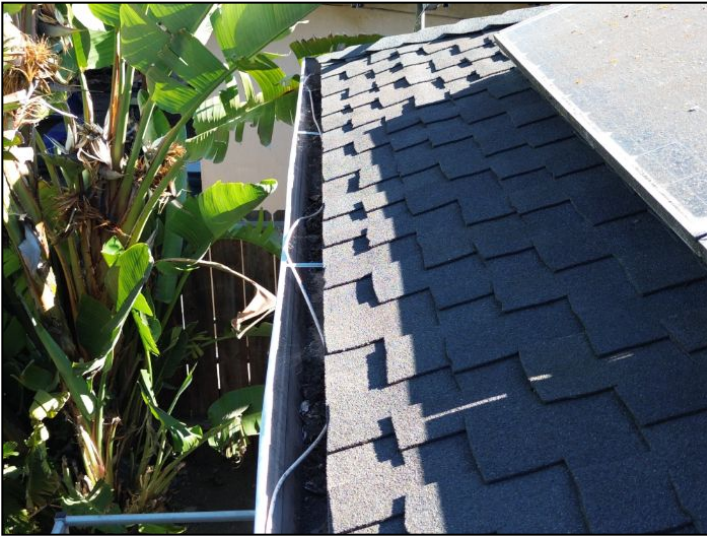
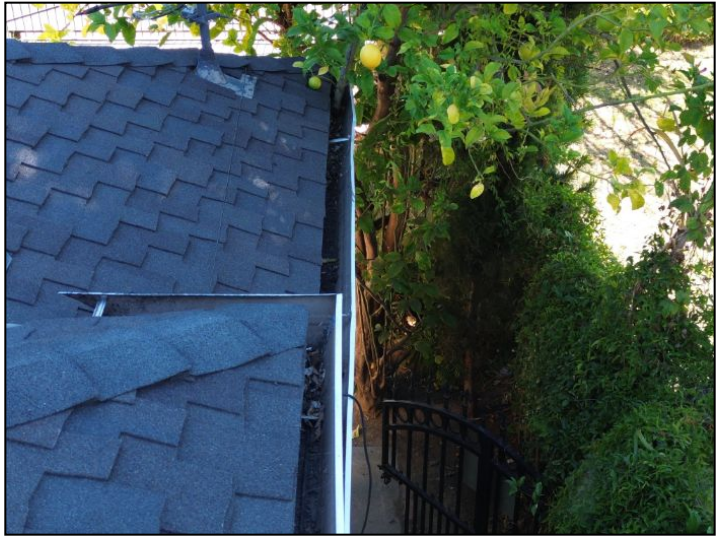
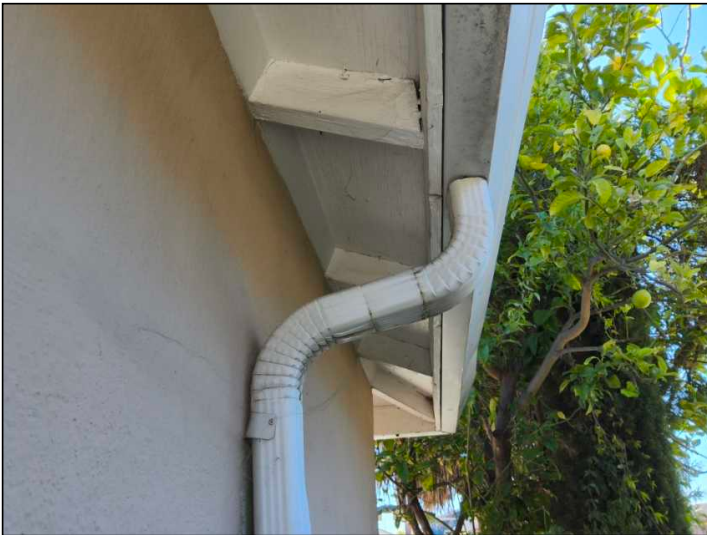
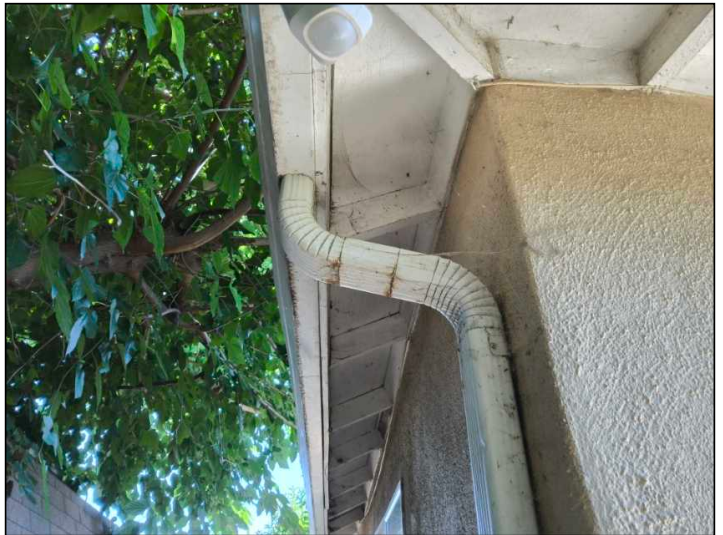
- The majority of the gutters and downspouts appeared to be clear and in satisfactory condition.
- The roof gutters require cleaning to function effectively. Regular maintenance will help ensure proper drainage and prevent water damage to the property.
- Some downspouts are missing or need to be reconnected or serviced. This will divert water away from the residence and its foundation to prevent moisture under the home and reduce the chance of the foundation settling.
- We recommend you have diverters or splash blocks installed at the bottom of all downspouts or have downspouts connect to underground drain lines. This will divert water away from the residence and its foundation to prevent moisture under the home and reduce the chance of the foundation settling.

Some downspouts are missing or need to be reconnected or serviced.

We recommend you have diverters or splash blocks installed at the bottom of all downspouts.

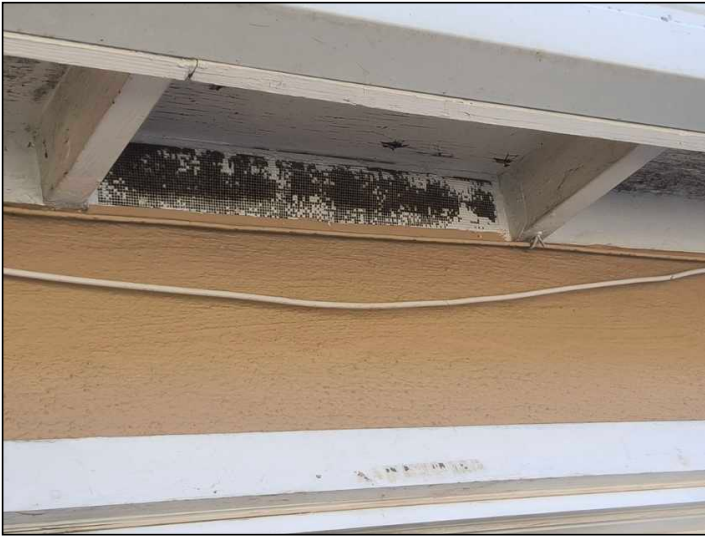
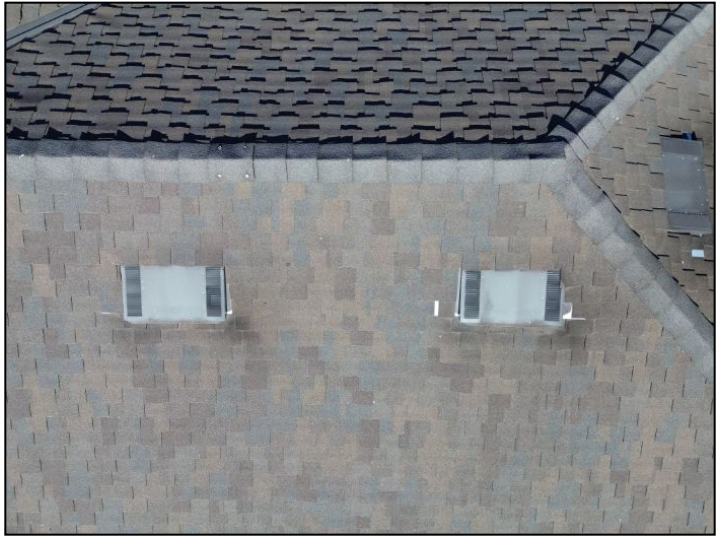
- Vent screens noted as functional.
- Vent screens noted painted over. The screens covering the vent openings were painted over in some areas, which reduces the amount of air flow/circulation through the attic. You may therefore wish to have the screens cleaned or replaced.

Vent screens noted painted over.

| Materials and Condition | | |
|---|---|---|
| Page 20 Item: 4 | Vent Screens | <ul style="list-style-type: none"> <li>• Vent screens noted painted over. The screens covering the vent openings were painted over in some areas, which reduces the amount of air flow/circulation through the attic. You may therefore wish to have the screens cleaned or replaced.</li> </ul> |
