# FOUNDATION INSPECTION REPORT

**TK Contracting & Consulting Inc.**

**xxx Near me St. Neverland CA 94xxx,  
Inspection Prepared For: Sam Super  
Agent: Not Applicable -**

**Date of Inspection: 7/29/2026**

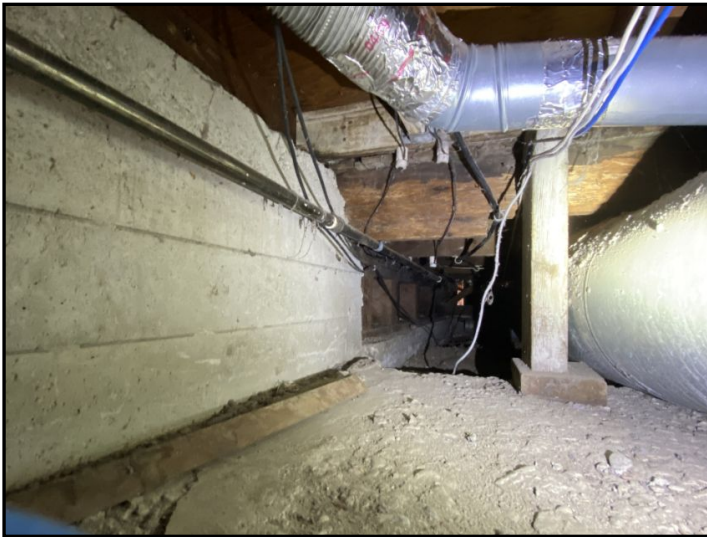
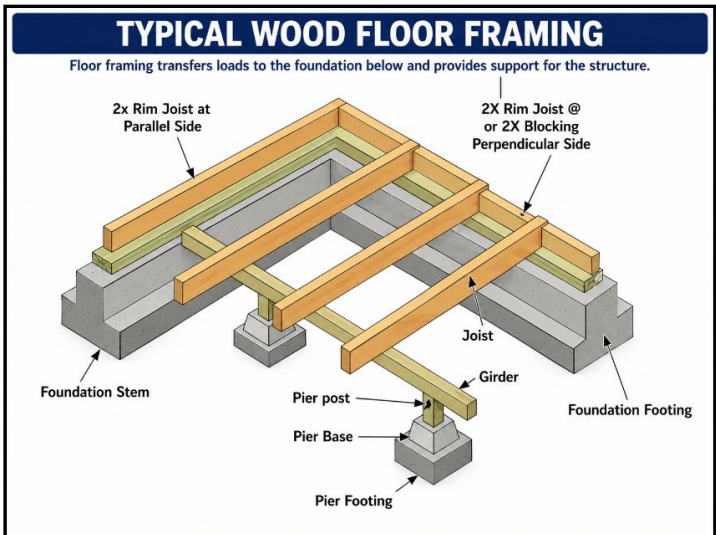
- The floor within the newly added section was observed to be out of level, with a slight slope toward the exterior. This condition appears to be related to differential settlement of the supporting foundation system. The addition was constructed partially over an existing concrete slab, with some supplemental supports bearing on the slab and others bearing directly on the soil. The concrete foundation appears to have settled approximately 1"1/2 inches from its original position. Although some settlement is common as supporting soils consolidate over time, the supplemental supports bearing on the existing slab did not settle at the same rate. This uneven movement has created different support elevations, resulting in the sloping floor observed inside the addition. This type of condition is relatively common in older homes and is often primarily an aesthetic concern. However, it is important to monitor the area over time for evidence of additional movement. If the slope increases or new cracking, separation, or other signs of movement develop, a structural engineer should evaluate the foundation to determine whether movement is ongoing and whether leveling, stabilization, or modification of the support system is necessary.

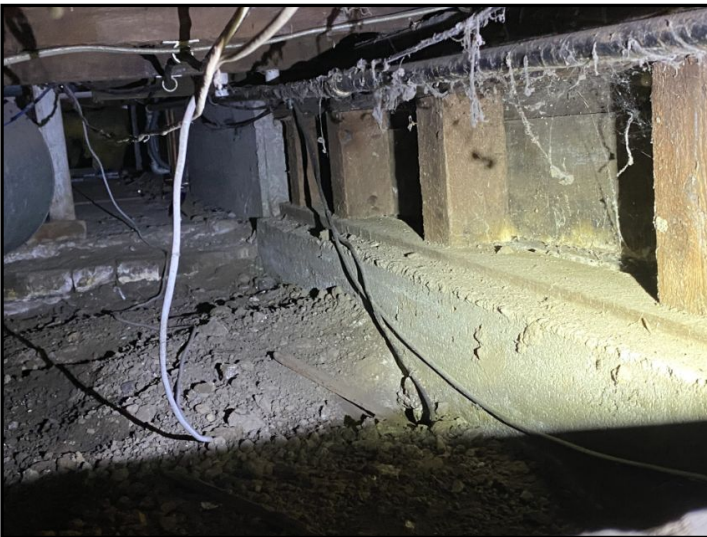
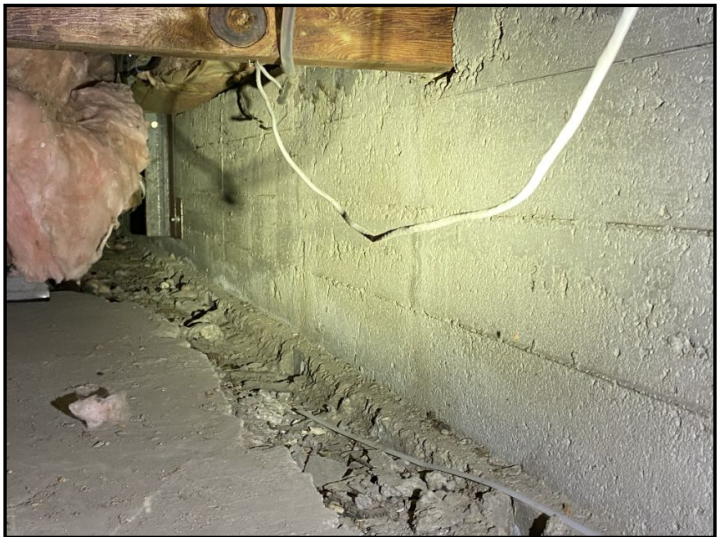
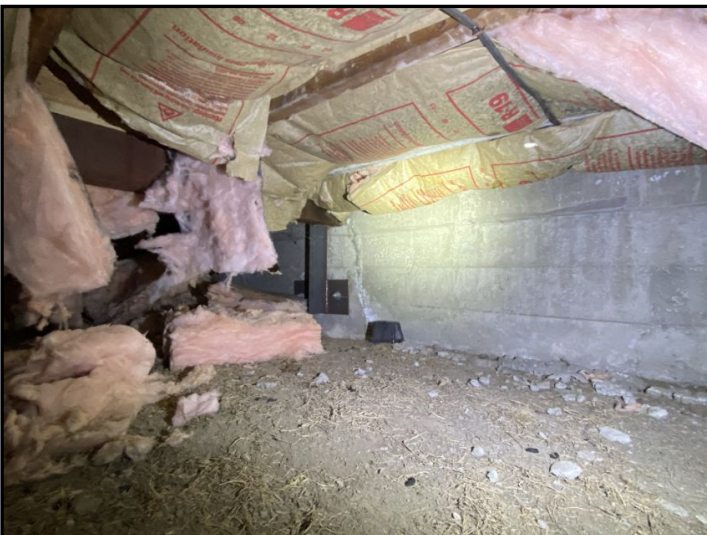
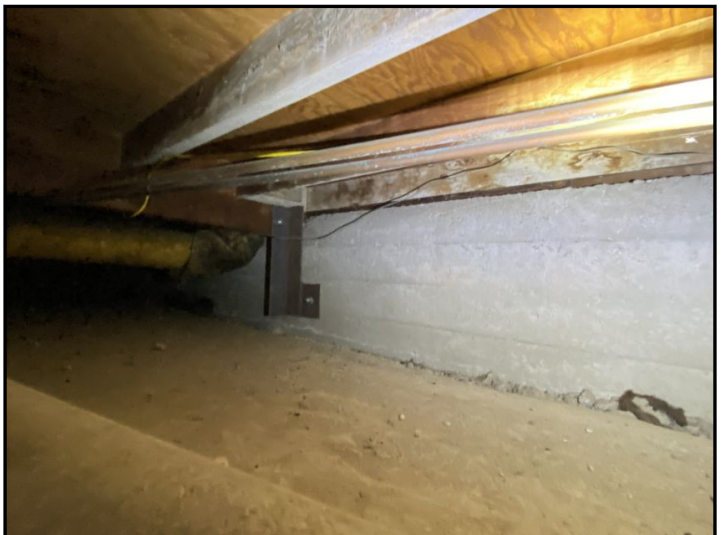
The poured concrete foundation walls appear to be functional.

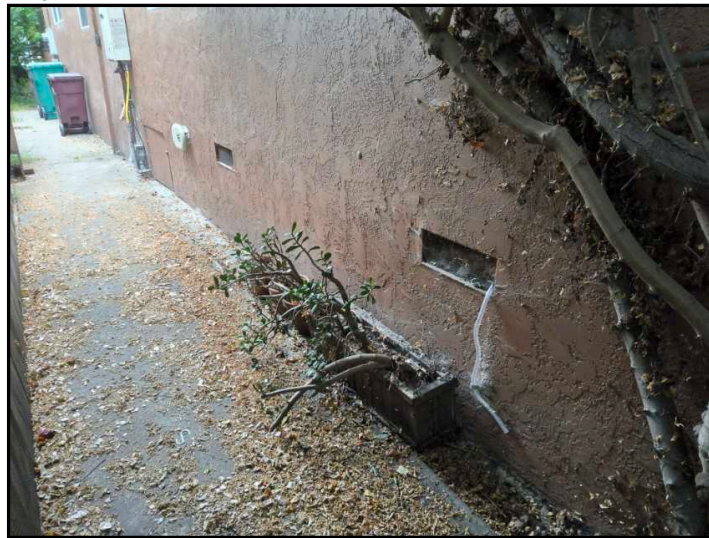
- Ventilation of the foundation crawlspace appears to be conventional. This type of ventilation should be adequate for proper airflow.

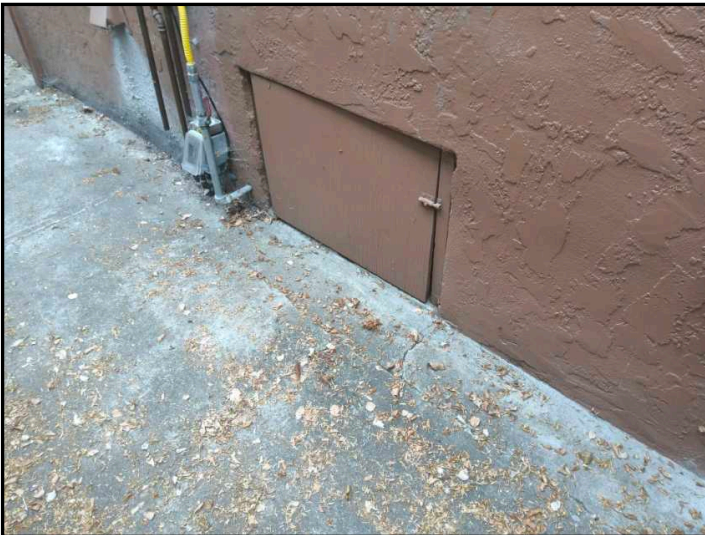
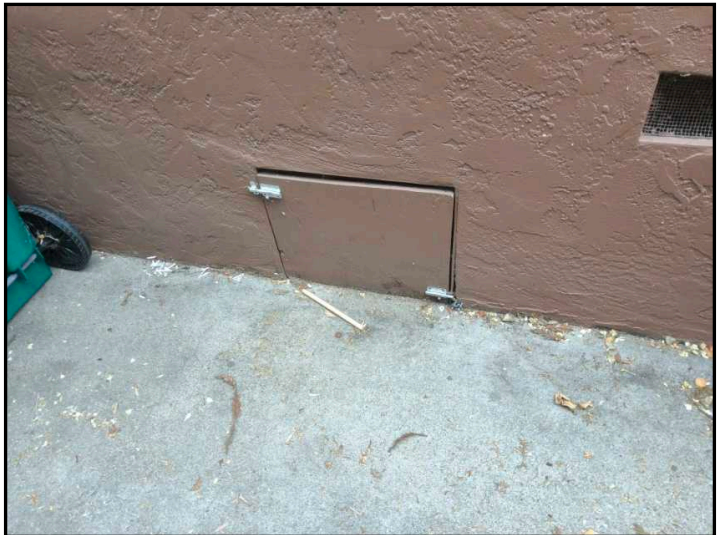
- The crawlspace access is located at the exterior of the property. The crawlspace and underfloor areas were easy and convenient to access.
