# ROOF INSPECTION REPORT

**TK Contracting & Consulting Inc.**

**0000 Near Me, Neverland 94000 CA**  
**Inspection Prepared For: Smith Sam**  
**Agent: Not Applicable -**

**Date of Inspection: 9/24/2026**

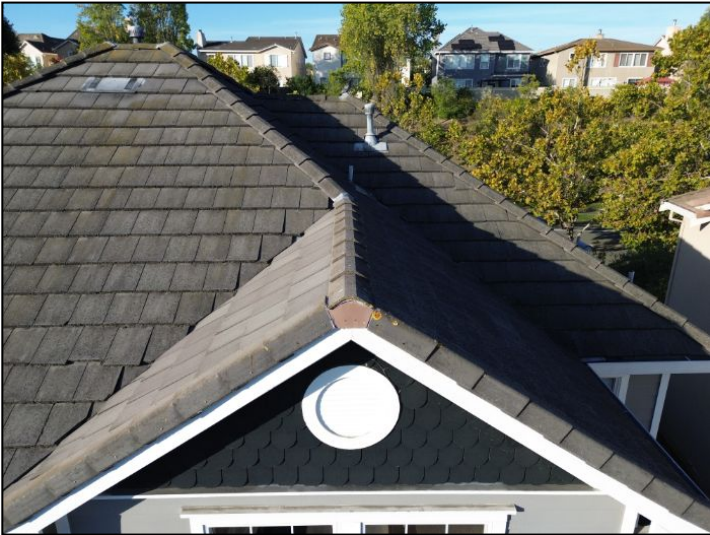
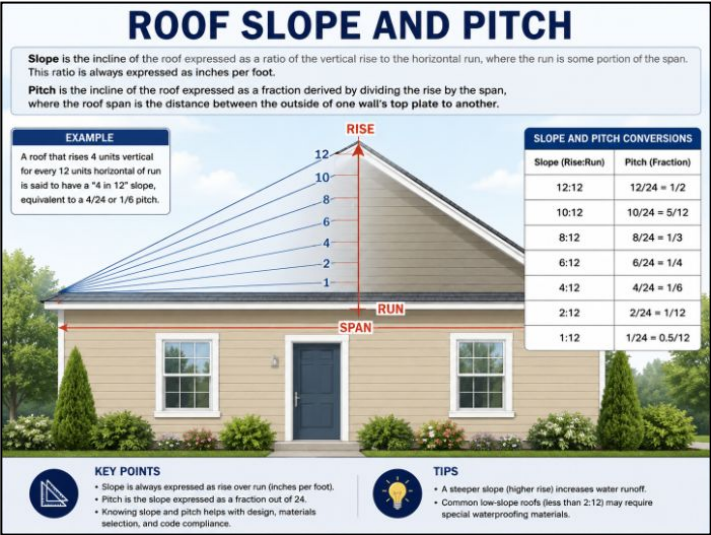
• **SLOPED ROOF:** The property features a sloped (pitched) roof designed to shed water efficiently and protect the structure from weather-related moisture intrusion. The service life of a roofing system is influenced by several factors, including the roof's pitch, the type and quality of the roofing material, installation methods, maintenance practices, exposure to sunlight, and environmental conditions such as wind, rain, snow, ice, and overhanging tree branches. Common roofing materials used on sloped roofs include asphalt shingles, concrete or clay tiles, wood shakes, slate, metal roofing systems, and various composite products. Regular inspections and maintenance are recommended to help maximize the roof's performance and longevity.

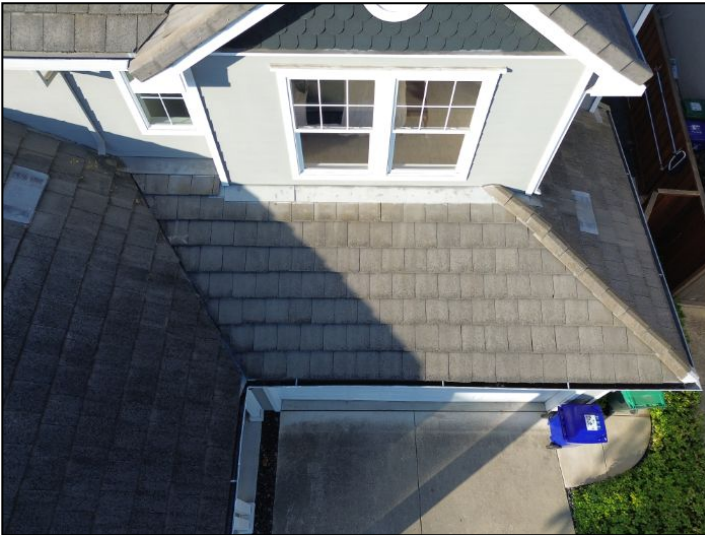
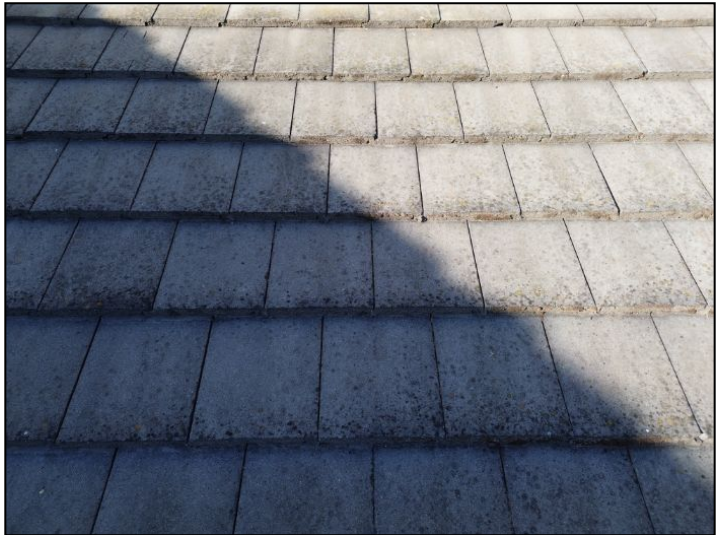
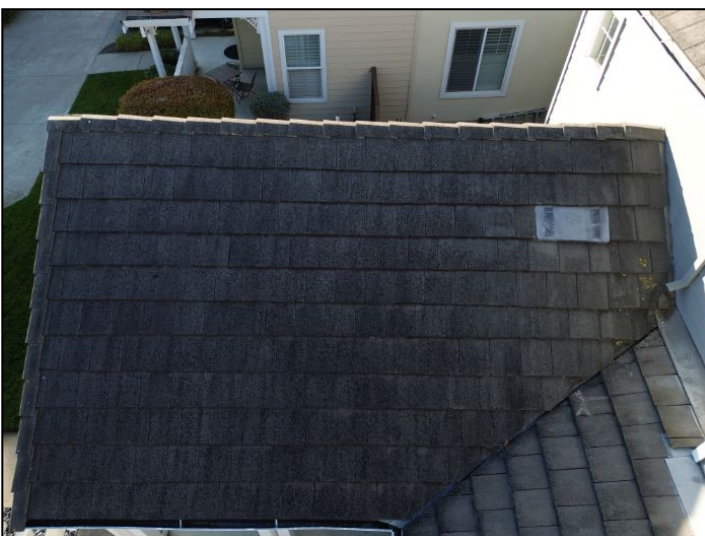
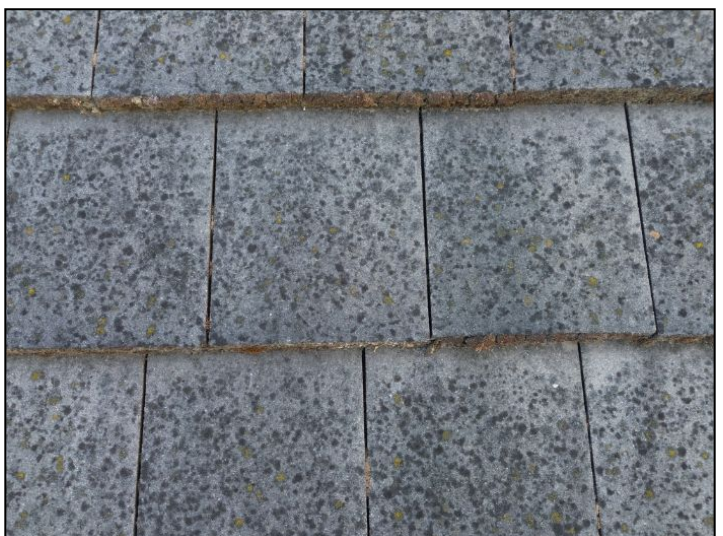
- **SLIPPED TILES:** Some roof tiles, particularly near the **valley flashing**, were loose, displaced, or had slipped from their intended positions. Although this condition is not uncommon near roof **valley**s, it may expose the underlayment and other roofing components, increasing the potential for moisture intrusion and premature deterioration. Have a qualified roofing contractor properly reposition and secure the affected tiles before the rainy season and evaluate the surrounding roof areas for additional deficiencies.

- **CRACKED TILES:** One or more cracked roof tiles were observed. Damaged tiles may expose the underlayment to accelerated weathering and increase the potential for moisture intrusion and deterioration of the underlying roofing components. Have a qualified roofing contractor repair or replace the affected tiles and evaluate the surrounding area for additional damage.

- **ROOF-TILE CLEANING:** Moss growth was observed on the roof tiles. This condition is not uncommon and routine cleaning is part of regular roof maintenance. Have the roof professionally cleaned and treated using methods appropriate for tile roofing to improve drainage and help prevent moss from spreading beneath or displacing the tiles. Avoid pressure washing, which may damage the tiles or underlying roofing components.

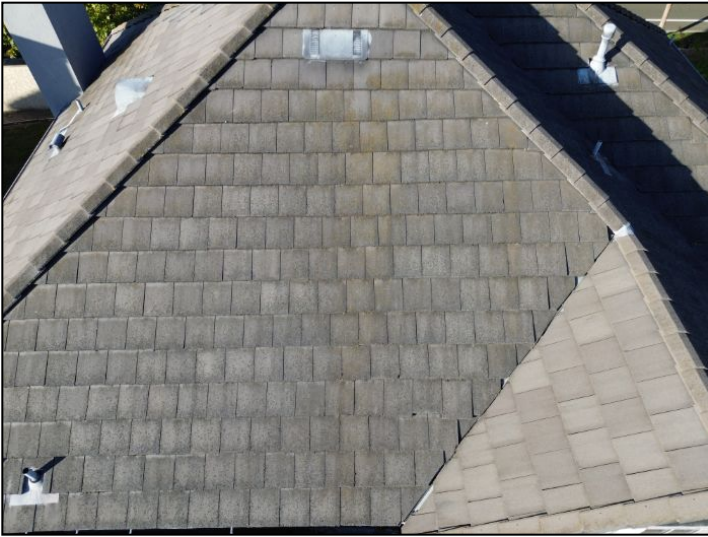
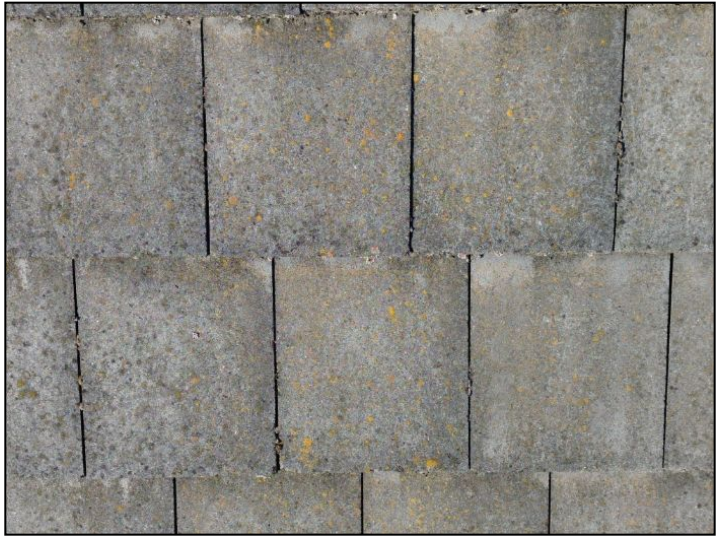
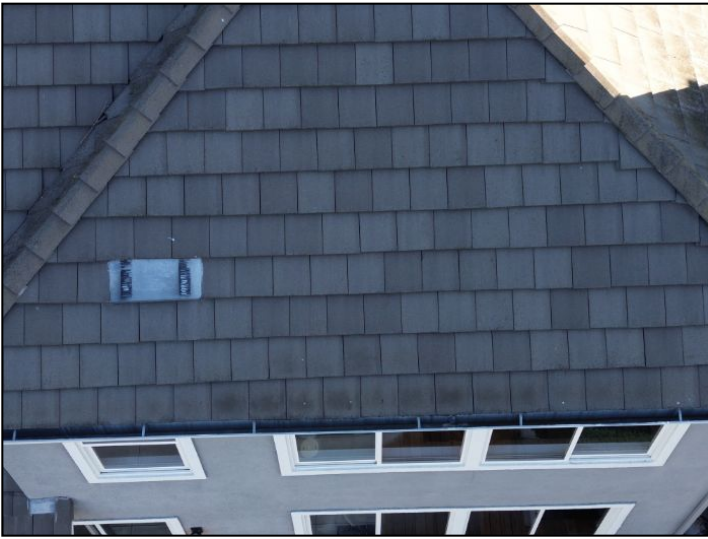
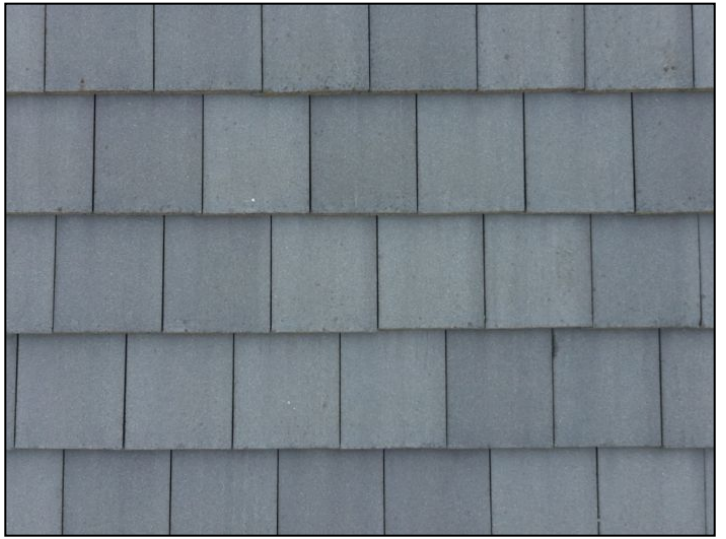
- The composite tile roofing material appears to be in satisfactory condition relative to its age.
- There may be the occasional cracked or chipped tiles, but none that would appear to warrant replacement of the tiles. This is common on tile roofs and is normally not a concern.

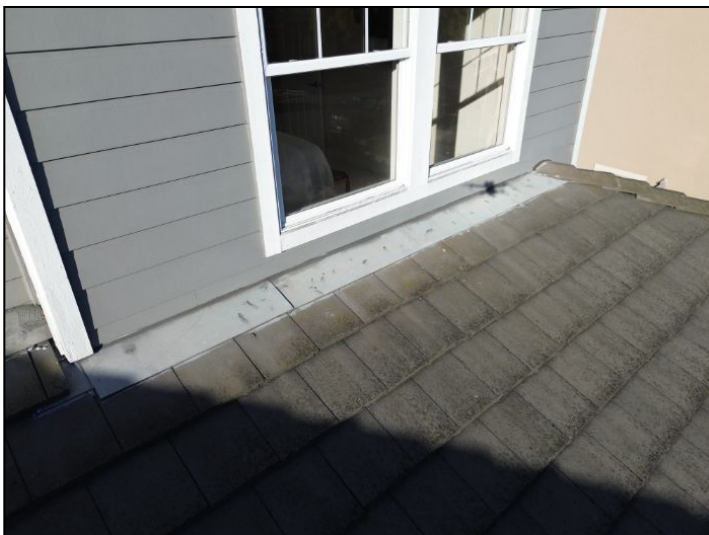
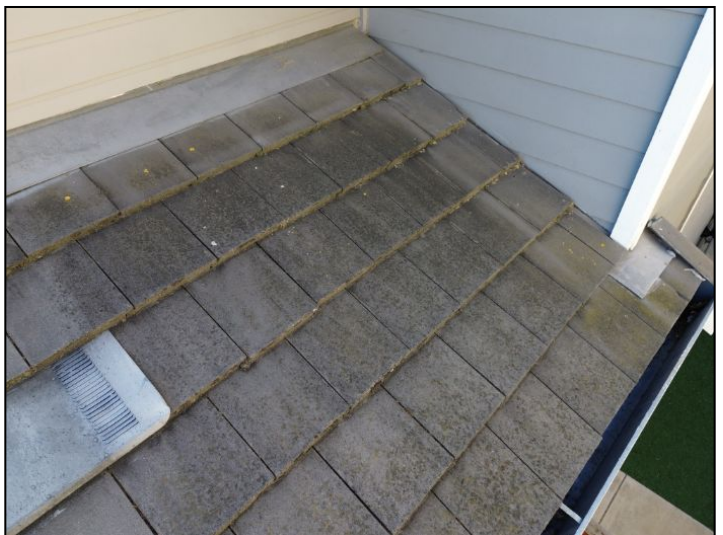
- The visible roof flashing appears to be in satisfactory condition. Flashing is an impervious material (usually galvanized sheet metal) that comes in a variety of shapes and sizes and is used to cover, waterproof, and direct water away from roof penetrations and from intersections between the roof covering and other materials.
- **CROWDED ROOF PENETRATIONS:** Multiple roof penetrations and attic vents were installed too close together, resulting in overlapping or improperly integrated flashings. This configuration may prevent proper water-shedding and increase the potential for moisture intrusion and concealed deterioration. Have a qualified roofing contractor evaluate the penetrations and reconfigure or properly integrate the flashings to provide a durable, watertight installation.

**CROWDED ROOF PENETRATIONS:** Multiple roof penetrations and attic vents were installed too close together, resulting in overlapping or improperly integrated flashings.

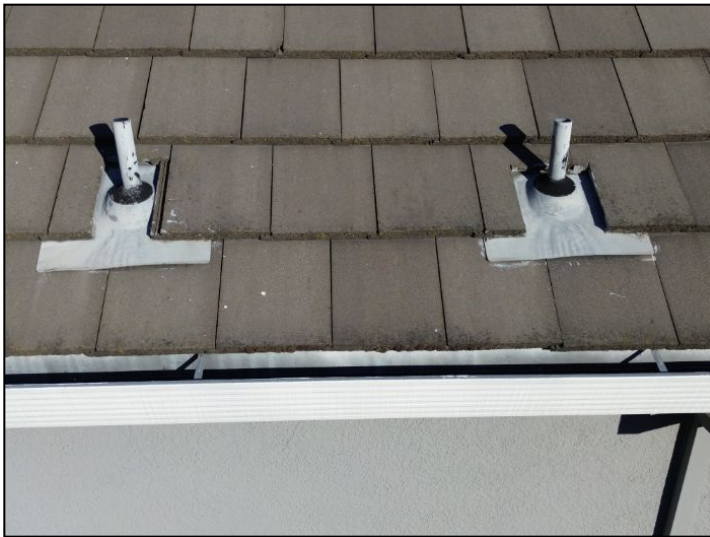
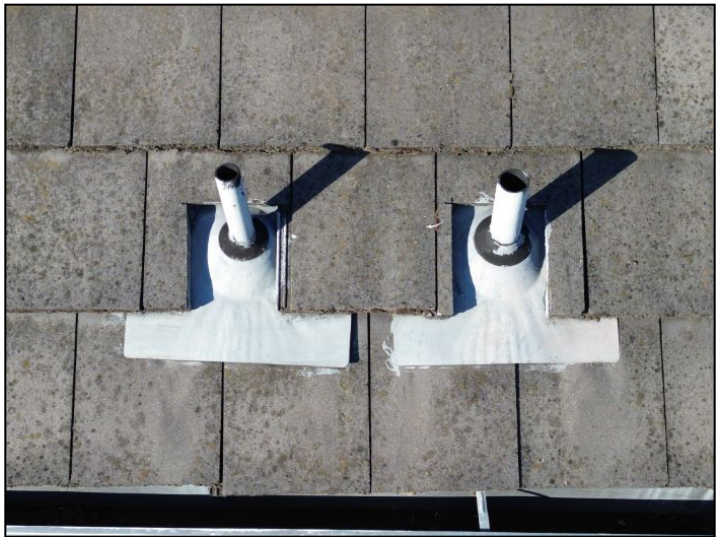
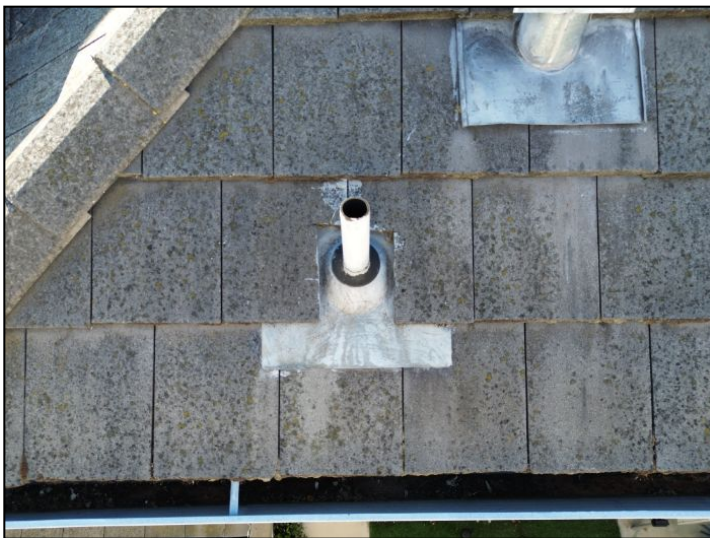
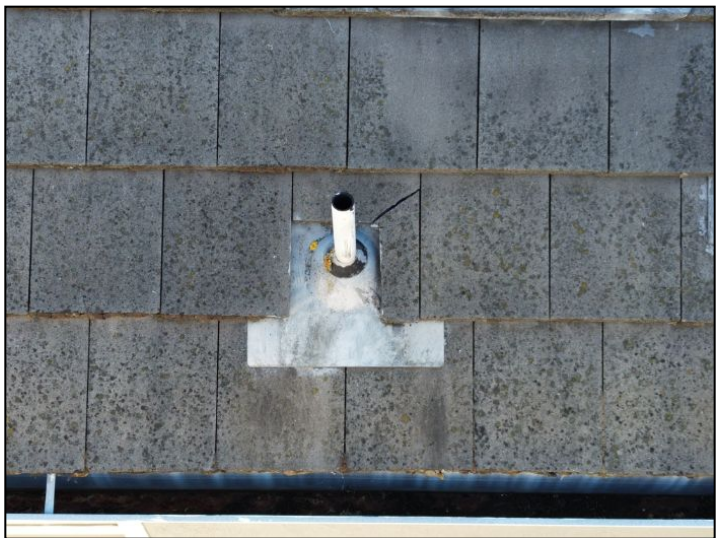
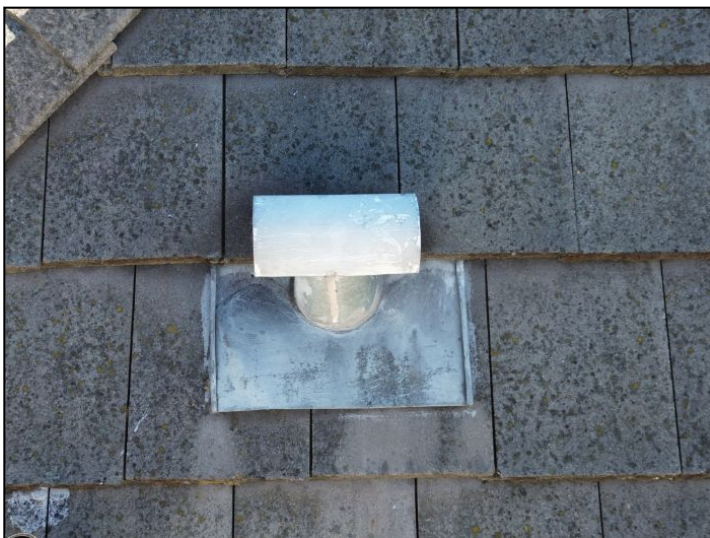
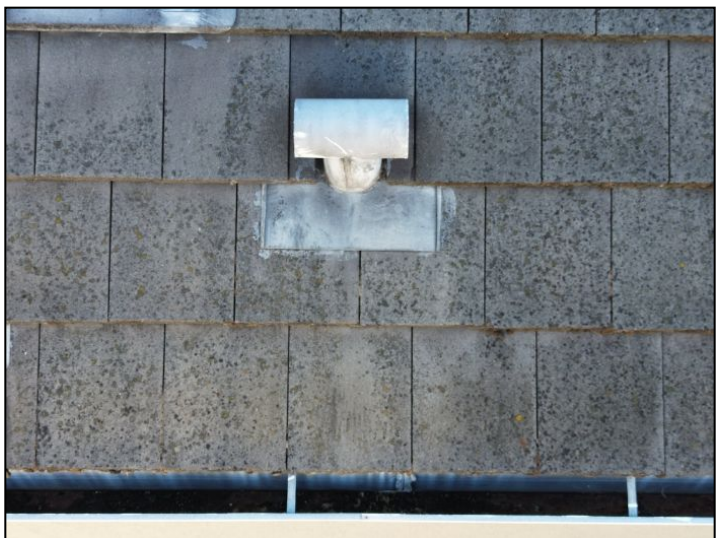
- The plumbing vent protrusions appeared to be well sealed, properly flashed and in satisfactory condition.
- The exhaust vent protrusions appeared to be well sealed, properly flashed and in satisfactory condition.

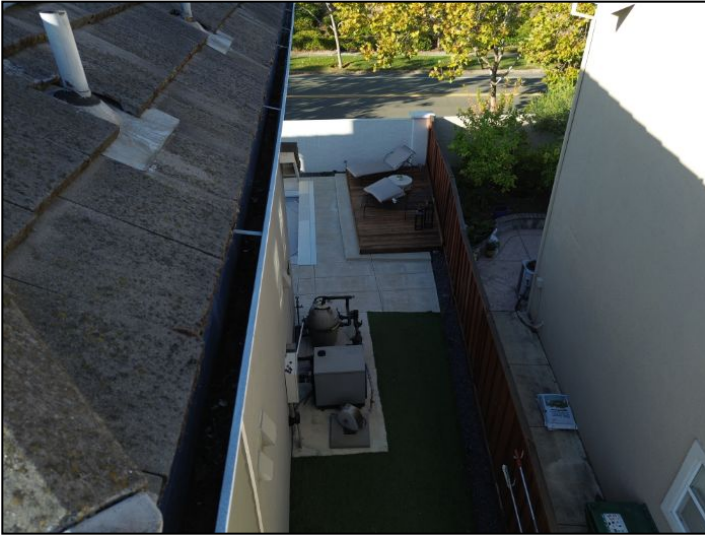
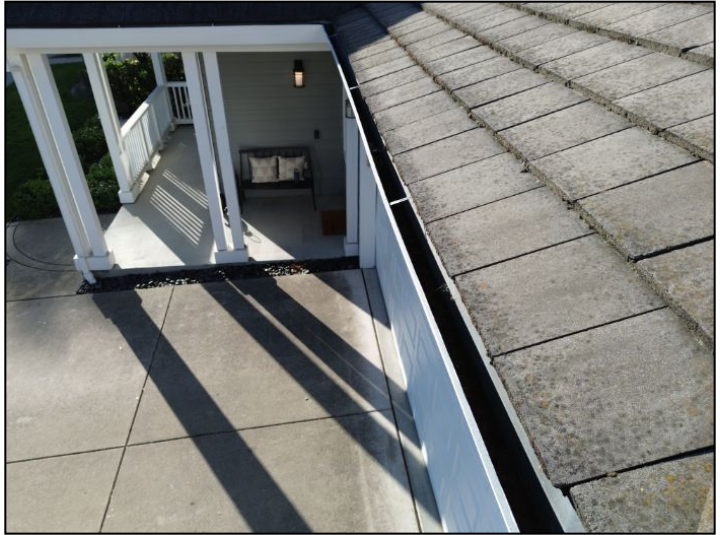
- The gutters and downspouts are clear and in satisfactory condition. This allows for proper water drainage and helps prevent potential water damage to the property. Regular inspections and maintenance should be continued to ensure they remain in good working order.

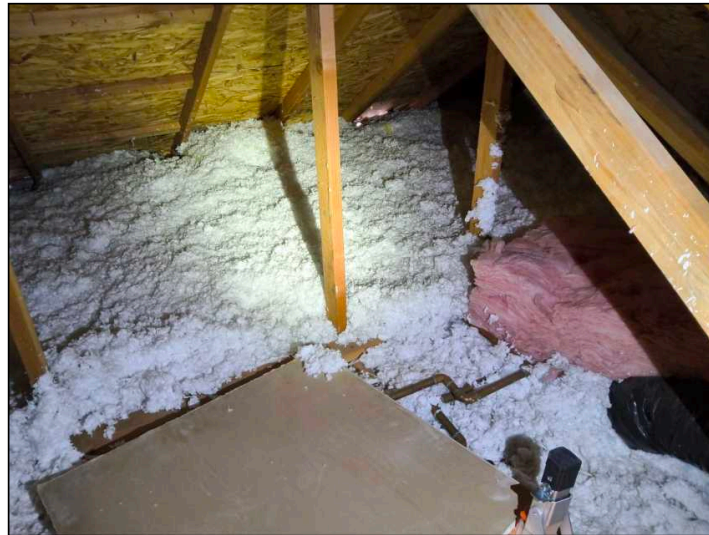
- The visible attic insulation appeared to be adequately and relatively evenly distributed at the time of the inspection. No significant visible deficiencies were observed unless otherwise noted in this report.

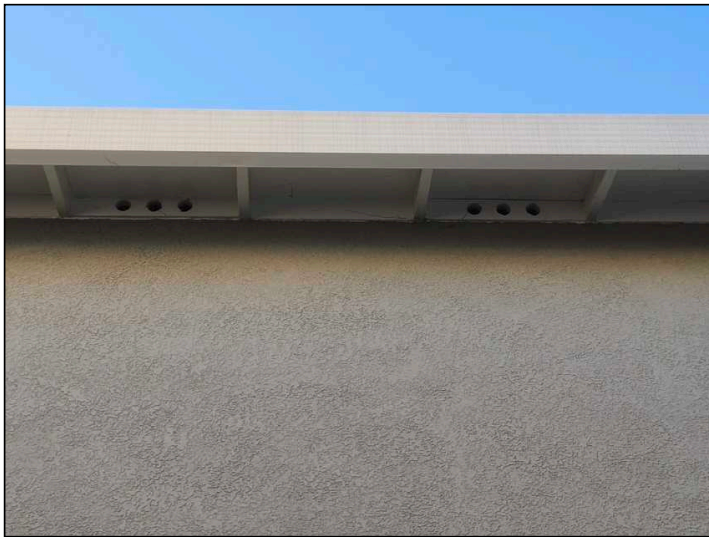
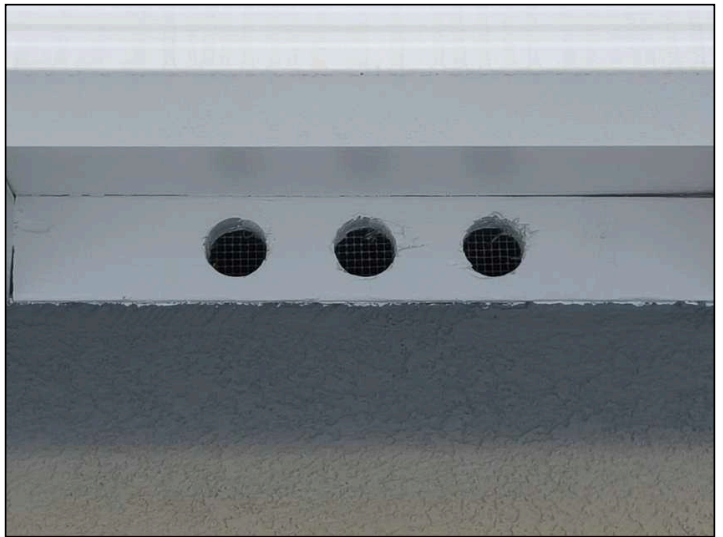
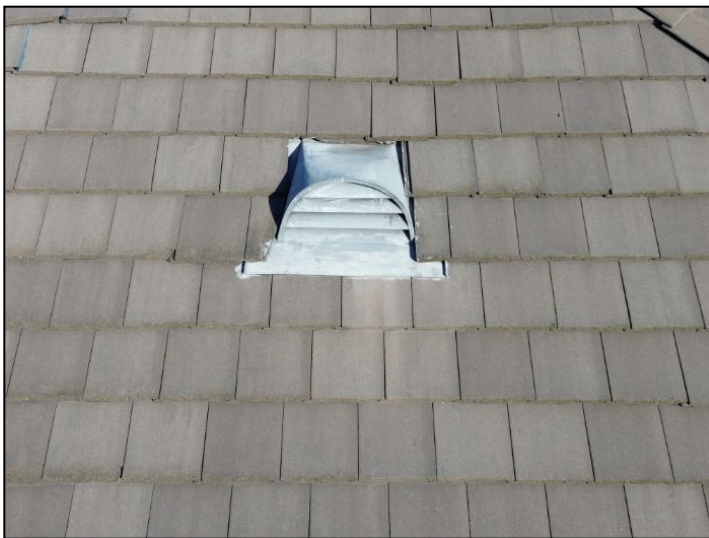
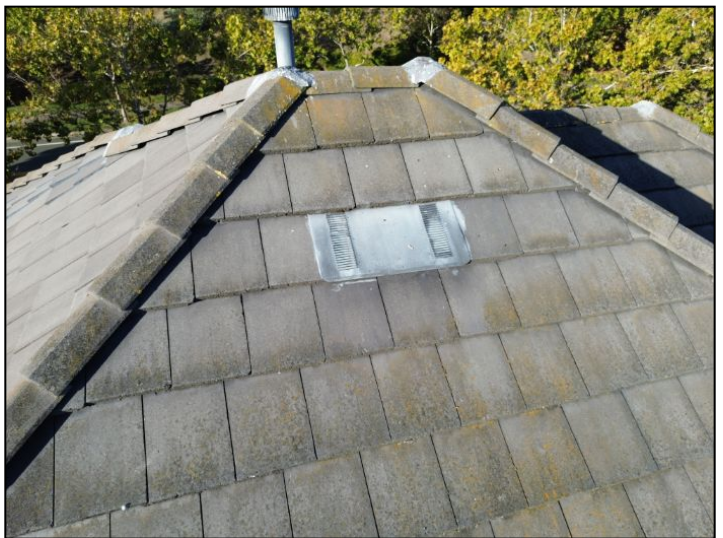
- The visible attic ventilation provisions appeared adequate at the time of the inspection. No significant visible deficiencies were observed unless otherwise noted in this report.
